Facilities Access Compliance Survey Report for the Santa Clara Valley Open Space Authority

Santa Clara Valley Open Space Access Compliance Survey Report

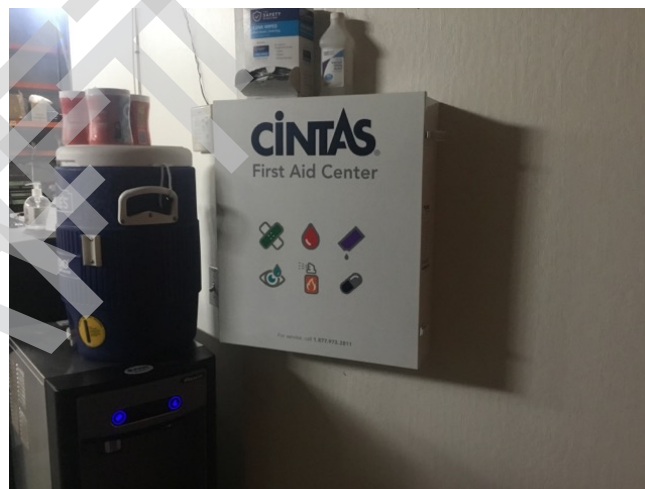
2462

- 3** Protruding objects more than 4" from wall, when bottom of object more than 27" or less than 80" above finished floor.

- 4** • **As-Built: 5.75" at 43" AFF**

Ensure all items in the first aid kit remain a minimum of 15 inches AFF. The top latch is 62 inches AFF.

Lower first aid kit so The bottom edge is below 27 inches AFF and the top latch is below 48 inches AFF.

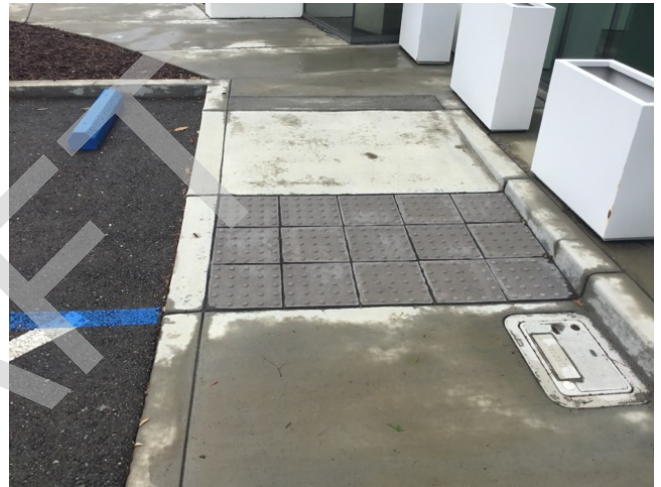
2504

Cross slope more than 1":48" (2.083%).

- *As-Built:* **4.7%**
- *Proposed Solution:*

Modify cross slope.

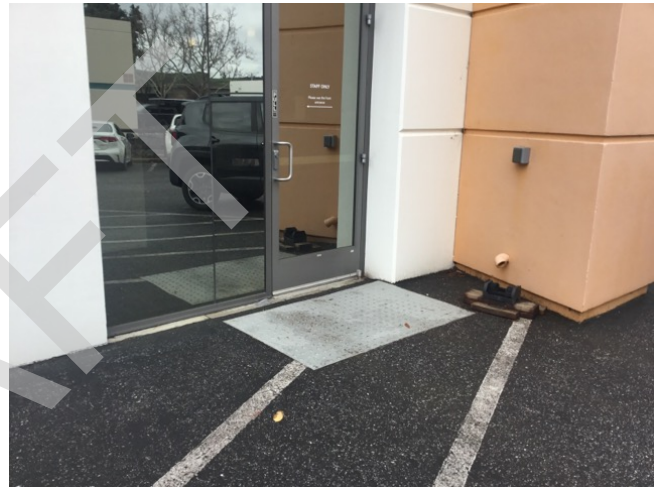
Item no., Rm no. and Name	Existing Architectural Barrier and Proposed Solution	Codes / Mitigation Info	Qty	Unit	Cost	Total
Door						
2503	<ul style="list-style-type: none"> • <i>As-Built Description:</i> Surface of required maneuvering clearance at door slopes more than 1/4":12" (2.0%). • <i>As-Built:</i> 0.2" level changes in door maneuvering clearance. Caused by detectable warnings. • <i>Proposed Solution:</i> Relocate detectable warnings outside the door maneuvering clearance. 	PCODE ID11 ADAAG 91 4.13.6 ADA 2010 404.2.4.4 CBC 2007 1133B.2.4 CBC 2019 11B-404.2.4	25	SF	\$120	\$3,000
						Priority 1 Severity 3

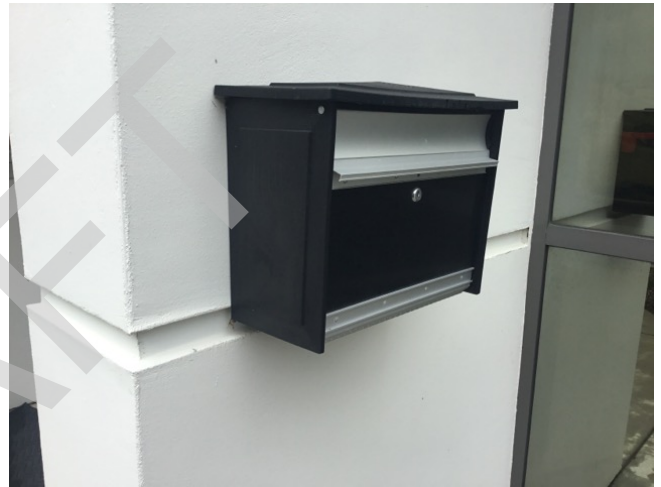
Item no., Rm no. and Name	Existing Architectural Barrier and Proposed Solution	Codes / Mitigation Info	Qty	Unit	Cost	Total
<u>Protrusion Limits</u>						
2502	<ul style="list-style-type: none"> • <i>As-Built Description:</i> Protruding objects more than 4" from wall, when bottom of object more than 27" or less than 80" above finished floor. • <i>As-Built:</i> 8.5" at 61" AFF • <i>Proposed Solution:</i> Add cane detection. 	PCODE EG04 ADAAG 91 4.4.1 ADA 2010 307.2 CBC 2007 1133B.8.6.1 CBC 2019 11B-307.2	1	JOB	\$300	\$300
					Priority	1
					Severity	1

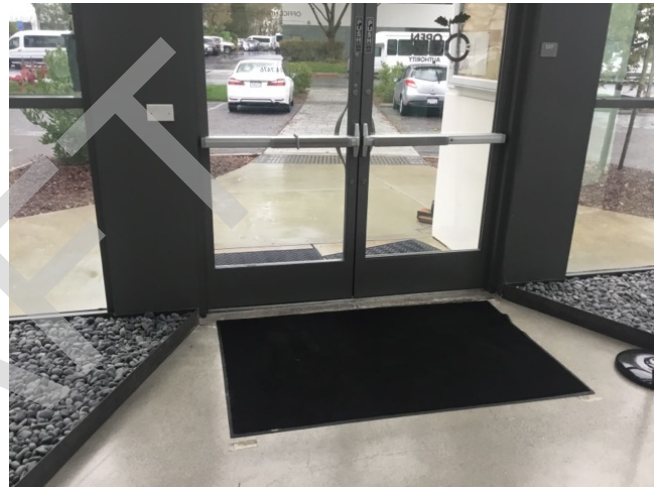
Item no., Rm no. and Name	Existing Architectural Barrier and Proposed Solution	Codes / Mitigation Info	Qty	Unit	Cost	Total
Door Threshold						
2436	<ul style="list-style-type: none"> • <i>As-Built Description:</i> Door inaccessible due to threshold or step at door exceeding 1/2". .62" • <i>Proposed Solution:</i> Modify threshold. 	PCODE ID02A ADAAG 91 4.13.8 ADA 2010 404.2.5 CBC 2007 1133B.2.4.1 CBC 2019 11B-404.2.5	1	JOB	\$1,200	\$1,200
					Priority	1
					Severity	1

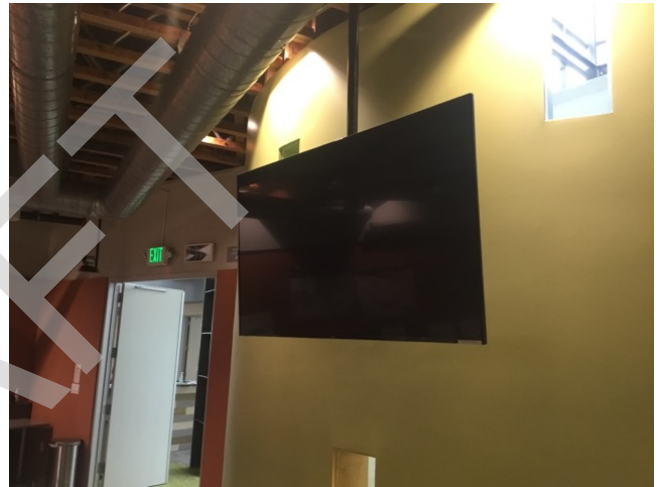
Item no., Rm no. and Name	Existing Architectural Barrier and Proposed Solution	Codes / Mitigation Info	Qty	Unit	Cost	Total
<u>Protrusion Limits</u>						
2441	<ul style="list-style-type: none"> • <i>As-Built Description:</i> Protruding objects more than 4" from wall, when bottom of object more than 27" or less than 80" above finished floor. • <i>As-Built:</i> 17" at 70" AFF. • <i>Proposed Solution:</i> Provide cane-detectable railing to mark area of low clearance. 	PCODE EG04A ADAAG 91 4.4.1 ADA 2010 307.2 CBC 2007 1133B.8.6.1 CBC 2019 11B-307.2	6	LF	\$300	\$1,800
						Priority 1
						Severity 1

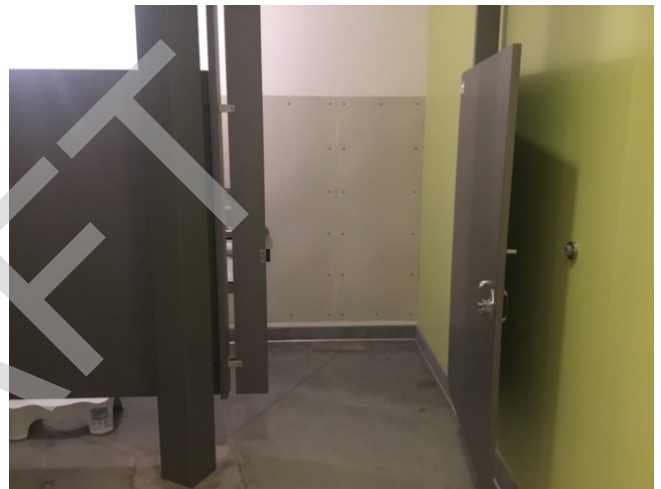
<i>Item no., Rm no. and Name</i>	<i>Existing Architectural Barrier and Proposed Solution</i>	<i>Codes / Mitigation Info</i>	<i>Qty</i>	<i>Unit</i>	<i>Cost</i>	<i>Total</i>
<u>Stall Door</u>						
2452	<ul style="list-style-type: none"> • <i>As-Built Description:</i> Stall door to accessible compartment not self closing. • <i>Proposed Solution:</i> Adjust closer. 	<i>PCODE</i> WB05B <i>ADAAG 91</i> 4.22.4 <i>ADA 2010</i> 604.8.1.2 <i>CBC 2007</i> 1115B.3.1.4.4 <i>CBC 2019</i> 11B-604.8.1.2	1	JOB	\$75	\$75
					Priority	2
					Severity	4

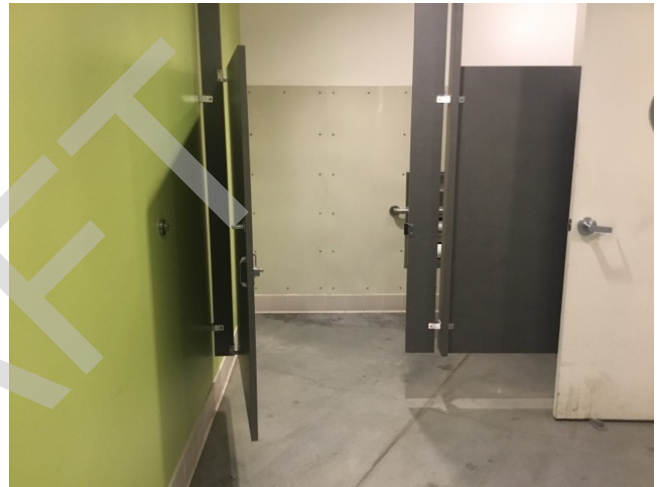
<i>Item no., Rm no. and Name</i>	<i>Existing Architectural Barrier and Proposed Solution</i>	<i>Codes / Mitigation Info</i>	<i>Qty</i>	<i>Unit</i>	<i>Cost</i>	<i>Total</i>
<u>Stall Door</u>						
2458	<ul style="list-style-type: none"> • <i>As-Built Description:</i> Stall door to accessible compartment not self closing. • <i>Proposed Solution:</i> Adjust closer. 	<i>PCODE</i> WB05B <i>ADAAG 91</i> 4.22.4 <i>ADA 2010</i> 604.8.1.2 <i>CBC 2007</i> 1115B.3.1.4.4 <i>CBC 2019</i> 11B-604.8.1.2	1	JOB	\$75	\$75
					Priority	2
					Severity	4

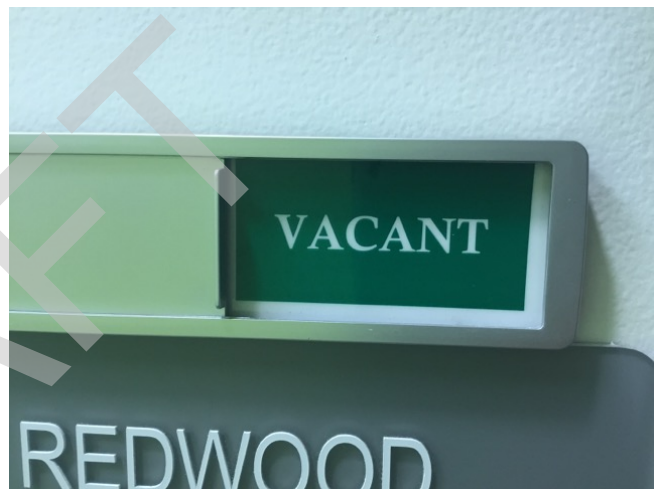
Item no., Rm no. and Name	Existing Architectural Barrier and Proposed Solution	Codes / Mitigation Info	Qty	Unit	Cost	Total
Signage						
2471	<ul style="list-style-type: none"> As-Built Description: Sign characters not readable because they are not sized for viewing distance. As-Built: 3/8" high characters. Proposed Solution: Provide compliant signage. 	PCODE SA02A ADAAG 91 4.30.3 ADA 2010 703.5.5 CBC 2007 1117B.5.4 CBC 2019 11B-306.1 & 11B-902.3	1	JOB	\$270	\$270
					Priority	1
					Severity	3

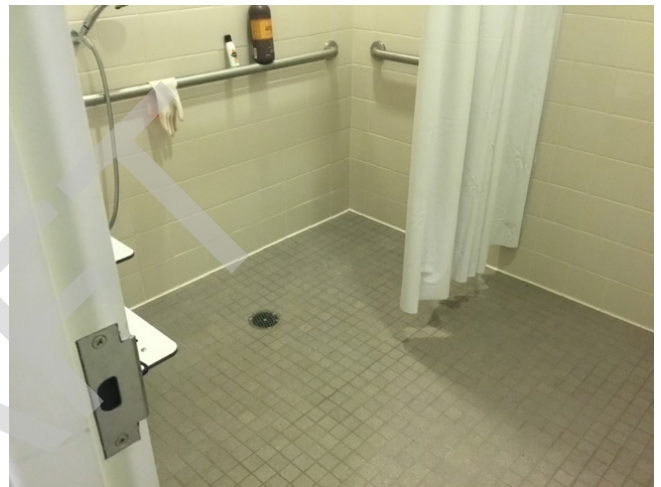
Item no., Rm no. and Name	Existing Architectural Barrier and Proposed Solution	Codes / Mitigation Info	Qty	Unit	Cost	Total
<u>Shower</u>						
2483	<ul style="list-style-type: none"> • <i>As-Built Description:</i> Floor surface sloped greater than 2.0% (1:48) due to drain. • <i>As-Built:</i> 3% • <i>Proposed Solution:</i> Remodel floor surface to compliance. 	PCODE WF06A ADA 2010 608.9 CBC 2019 11B-608.9	1	JOB	\$1,500	\$1,500
					Priority	2
					Severity	4

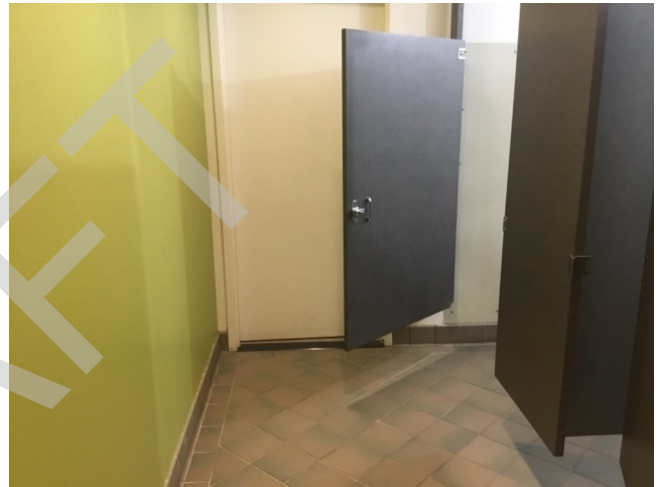
<i>Item no., Rm no. and Name</i>	<i>Existing Architectural Barrier and Proposed Solution</i>	<i>Codes / Mitigation Info</i>	<i>Qty</i>	<i>Unit</i>	<i>Cost</i>	<i>Total</i>
<u>Door Swing</u>						
2485	<ul style="list-style-type: none"> • <i>As-Built Description:</i> Front approach: At pull side, door does not have clear and level maneuvering space measuring door width plus 18" x 60". (24" x 60" at exterior doors). • <i>As-Built:</i> 53" • <i>Proposed Solution:</i> Remodel compartment. 	<i>PCODE</i> ID23B <i>ADAAG 91</i> Fig. 25(a) <i>ADA 2010</i> 404.2.4 <i>CBC 2007</i> 11B-26A(a) <i>CBC 2019</i> 11B-404.2.4	1	JOB	\$16,800	\$16,800
						Priority 2 Severity 3

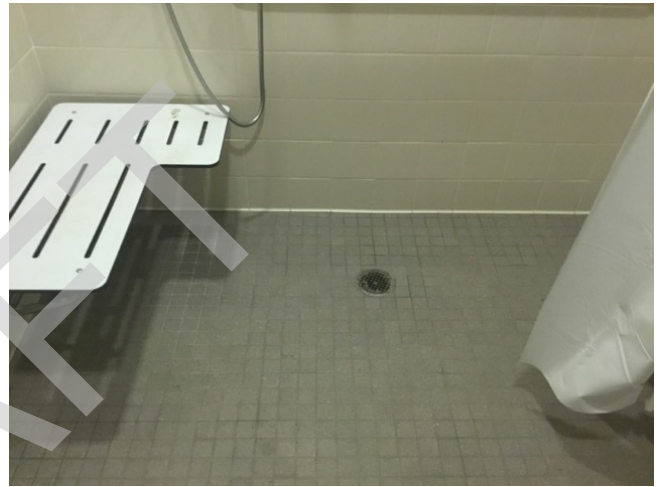
2490	<ul style="list-style-type: none"> • <i>As-Built Description:</i> Floor surface sloped greater than 2.0% (1:48) due to drain. • <i>As-Built:</i> 2.9% • <i>Proposed Solution:</i> Remodel floor surface to compliance. 	PCODE WF06A ADA 2010 608.9 CBC 2019 11B-608.9	1	JOB	\$1,500	\$1,500
						Priority 2 Severity 4

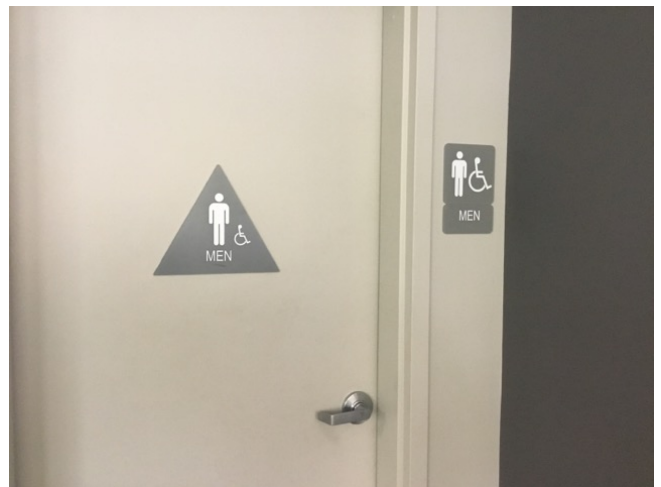
2484	<ul style="list-style-type: none"> • <i>As-Built Description:</i> Signs containing tactile characters is not located so that a clear floor space of 18" min x 18" min., centered on the tactile characters, is provided beyond the arc of any door swing between the closed position and 45 degree open position. • <i>As-Built:</i> 4.5" to the wall. • <i>Proposed Solution:</i> Relocate compliant signage on latch side of door located at compliant height with a clear floor space. • Notes: This may have complied at the time of construction based on a technicality. 	PCODE SA07B ADA 2010 703.4.2 CBC 2019 11B-703.4.2	1	JOB	\$150	\$150
						Priority 2 Severity 4

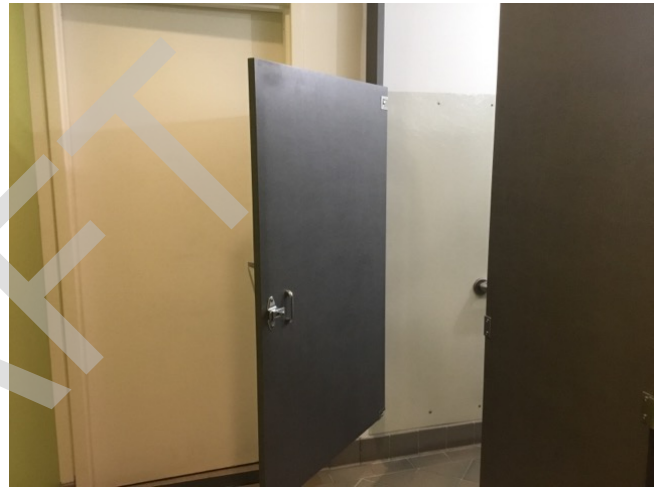
<i>Item no., Rm no. and Name</i>	<i>Existing Architectural Barrier and Proposed Solution</i>	<i>Codes / Mitigation Info</i>	<i>Qty</i>	<i>Unit</i>	<i>Cost</i>	<i>Total</i>
<u>Stall Door</u>						
2486	<ul style="list-style-type: none"> • <i>As-Built Description:</i> Stall door to accessible compartment not self closing. • <i>Proposed Solution:</i> Adjust closer. 	<i>PCODE</i> WB05B <i>ADAAG 91</i> 4.22.4 <i>ADA 2010</i> 604.8.1.2 <i>CBC 2007</i> 1115B.3.1.4.4 <i>CBC 2019</i> 11B-604.8.1.2	1	JOB	\$75	\$75
						Priority 2 Severity 3

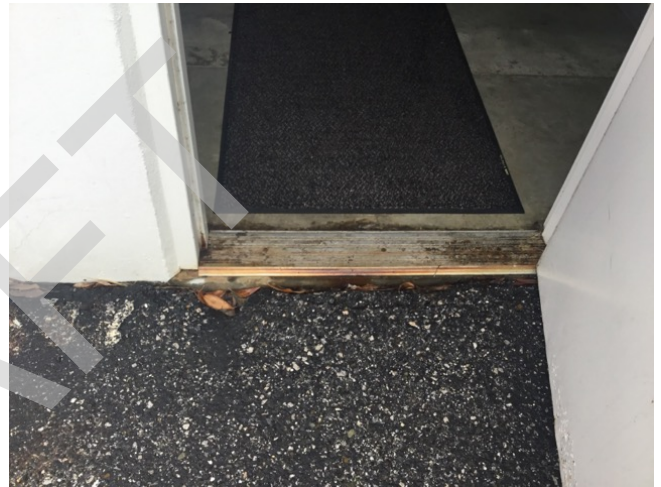
<i>Item no., Rm no. and Name</i>	<i>Existing Architectural Barrier and Proposed Solution</i>	<i>Codes / Mitigation Info</i>	<i>Qty</i>	<i>Unit</i>	<i>Cost</i>	<i>Total</i>
<u>Door Threshold</u>						
2498	<ul style="list-style-type: none"> • <i>As-Built Description:</i> Door inaccessible due to threshold or step at door exceeding 1/2". • <i>As-Built:</i> 3" • <i>Proposed Solution:</i> Repair the surface. 	<i>PCODE</i> ID02A <i>ADAAG 91</i> 4.13.8 <i>ADA 2010</i> 404.2.5 <i>CBC 2007</i> 1133B.2.4.1 <i>CBC 2019</i> 11B-404.2.5	1	JOB	\$1,200	\$1,200
						Priority 1 Severity 1

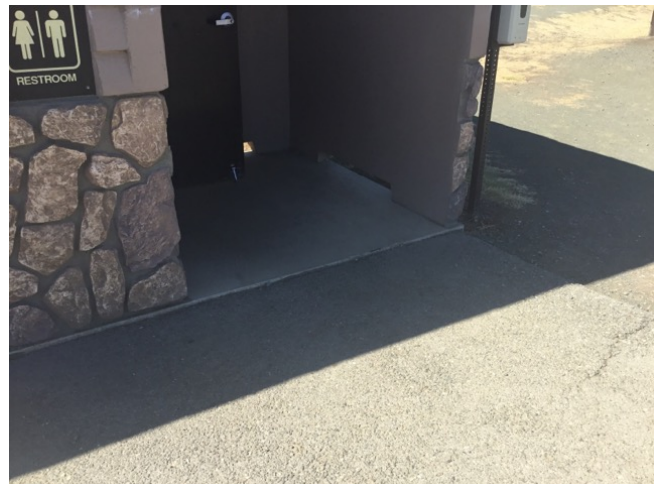
2282	<ul style="list-style-type: none"> • <i>As-Built Description:</i> Walk: Pavement dislocation creates abrupt change in level exceeding 1/2" in accessible route. • <i>As-Built:</i> 1" • <i>Proposed Solution:</i> Remove, replace or repair area of pavement sufficient to correct abrupt change in level. 	PCODE EF03 ADAAG 91 4.3.8 ADA 2010 403.4 CBC 2007 1133B.7.4 CBC 2019 11B-403.4	40	SF	\$63	\$2,520
						Priority 2 Severity 1

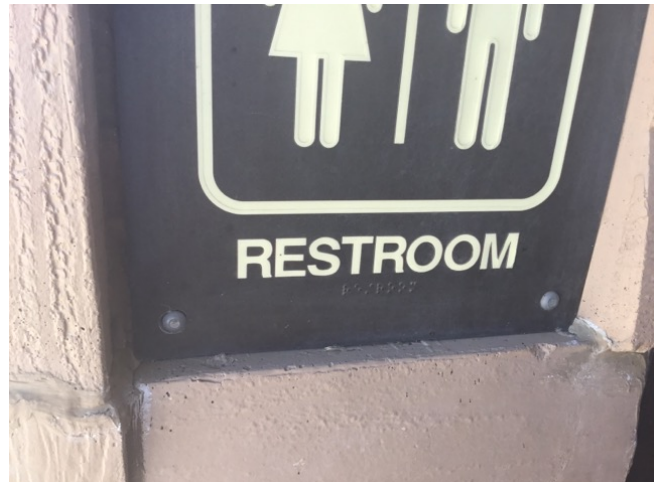
Signage						
2283	<ul style="list-style-type: none"> As-Built Description: Entrance to toilet or bathing facility not identified with ADAAG compliant signage. As-Built: Braille.25" from tactile characters. Braille and dots are nearly touching each other. Proposed Solution: Provide ADA compliant sign mounted at 48" min. above to baseline of the lowest Braille cells and 60" max. to baseline of the highest line of raised characters on nearest adjacent wall, on latch side of a single door (located not to cause a Braille reader to stand within the door swing). 	PCODE SA11A ADAAG 91 4.1.3(16)(a) ADA 2010 216.8 CBC 2019 11B-216.8	1	JOB	\$270	\$270
						Priority 2 Severity 3

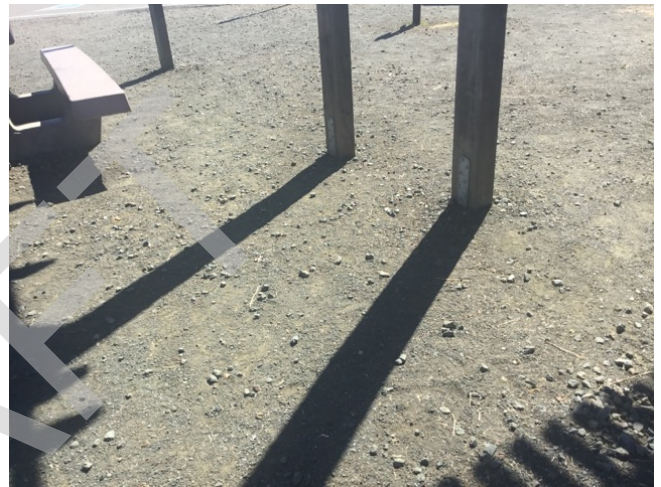
Item no., Rm no. and Name	Existing Architectural Barrier and Proposed Solution	Codes / Mitigation Info	Qty	Unit	Cost	Total
2292	<ul style="list-style-type: none"> As-Built Description: Walk: Pavement dislocation creates abrupt change in level exceeding 1/2" in accessible route. As-Built: To 1" caused by large aggregate. Proposed Solution: Install smaller aggregate. 	PCODE EF03 ADAAG 91 4.3.8 ADA 2010 403.4 CBC 2007 1133B.7.4 CBC 2019 11B-403.4	1	JOB	\$6,000	\$6,000
						Priority 1
						Severity 1

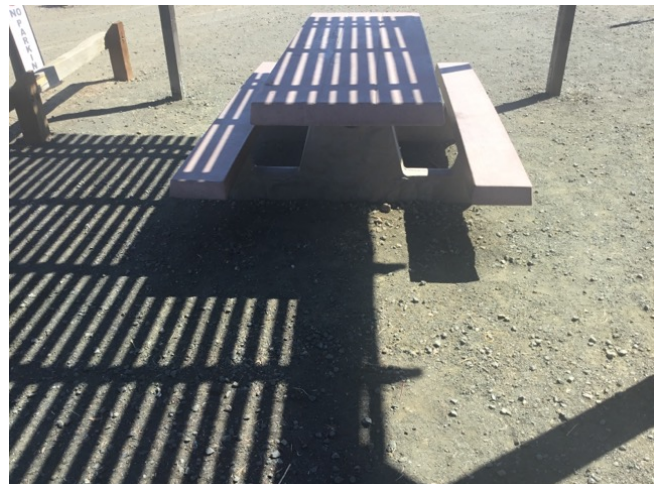
2293	<ul style="list-style-type: none"> As-Built Description: Clear space has slopes greater than 1:48. As-Built: To 10% caused by uneven surface Proposed Solution: Grade surface. 	PCODE NI07 ADAAG 91 16.6.6 ADA 2010 305.2 CBC 2007 1132B.1 CBC 2019 11B-305.2	1	JOB		
						Priority 1
						Severity 3

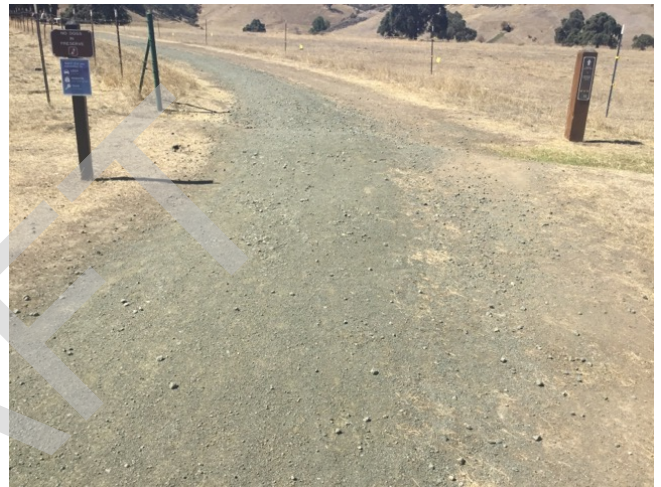
Item no., Rm no. and Name	Existing Architectural Barrier and Proposed Solution	Codes / Mitigation Info	Qty	Unit	Cost	Total
2302	<ul style="list-style-type: none"> As-Built Description: Walk: Pavement dislocation creates abrupt change in level exceeding 1/2" in accessible route. As-Built: To 1" caused by aggregate. Proposed Solution: Install smaller aggregate. Notes: A section approximately 500 feet from the trailhead has 3" aggregate. 	PCODE EF03REF ADAAG 91 4.3.8 ADA 2010 403.4 CBC 2007 1133B.7.4 CBC 2019 11B-403.4		REF		
Priority 1 Severity 1

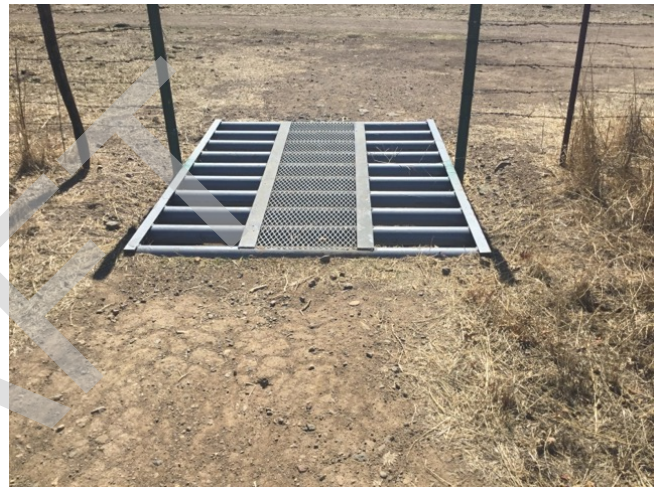
Item no., Rm no. and Name	Existing Architectural Barrier and Proposed Solution	Codes / Mitigation Info	Qty	Unit	Cost	Total
2306	<ul style="list-style-type: none"> As-Built Description: Walk: Grating has grid openings greater than 1/2" along the line of traffic flow. As-Built: 5" Proposed Solution: Replace grates. Install gates at cattle guards. 	PCODE EF04 ADAAG 91 4.3.6; 4.5.4 ADA 2010 403.2; 302.3 CBC 2007 1133B.7.2 CBC 2019 11B-403.2; 11B-302.3	2	JOB	\$4,500	\$9,000
Priority 1 Severity 3

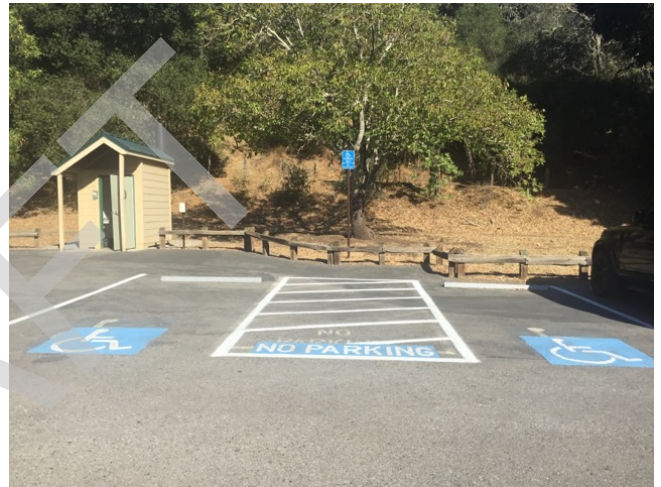
Item no., Rm no. and Name	Existing Architectural Barrier and Proposed Solution	Codes / Mitigation Info	Qty	Unit	Cost	Total
Identification						
2312	<ul style="list-style-type: none"> • <i>As-Built Description:</i> Sign for accessible parking space is missing or non-compliant. • <i>Proposed Solution:</i> Provide compliant parking signage. • Notes: Signs should be placed at the head of each space. 	PCODE EA04B ADAAG 91 4.6.4 ADA 2010 502.6 CBC 2007 1129B.4 CBC 2019 11B-502.6	2	JOB	\$945	\$1,890
						Priority 3 Severity 3

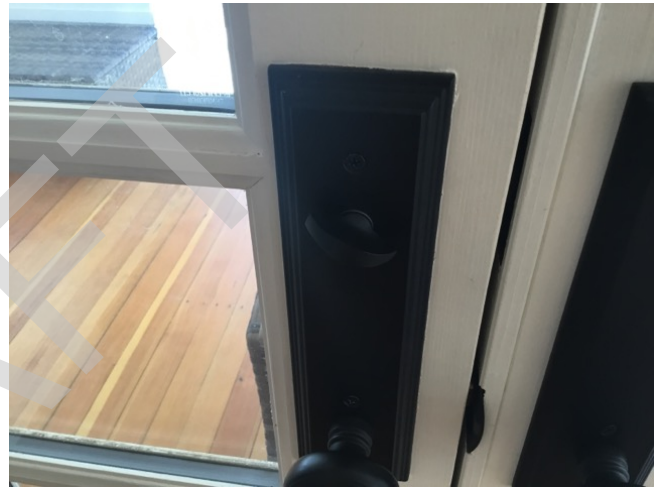
2378	<ul style="list-style-type: none"> • <i>As-Built Description:</i> Operable part(s) require tight grasping, pinching, or twisting of the wrist with one hand. • <i>As-Built:</i> 10lbs • <i>Proposed Solution:</i> Modify or replace the operable part(s) to not require tight grasping, pinching, or twisting of the wrist with one hand. 	PCODE IC02 ADAAG 91 4.27.4 ADA 2010 309.4 CBC 2007 1117B.6.4 CBC 2019 11B-309.4	5	JOB	\$900	\$4,500
------	---	---	---	-----	-------	----------------

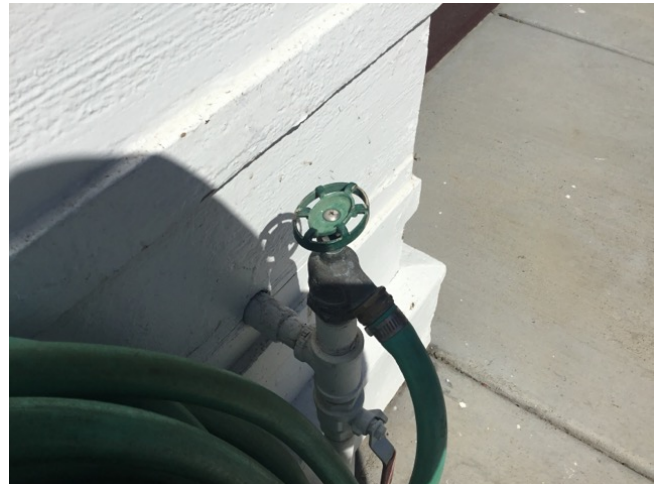
2408	<ul style="list-style-type: none"> • <i>As-Built Description:</i> Operable part(s) require tight grasping, pinching, or twisting of the wrist with one hand. • <i>As-Built:</i> Not operable without grasping. • <i>Proposed Solution:</i> Modify or replace the operable part(s) to not require tight grasping, pinching, or twisting of the wrist with one hand. 	PCODE IC02 ADAAG 91 4.27.4 ADA 2010 309.4 CBC 2007 1117B.6.4 CBC 2019 11B-309.4	1	JOB	\$900	\$900
------	--	---	---	-----	-------	--------------

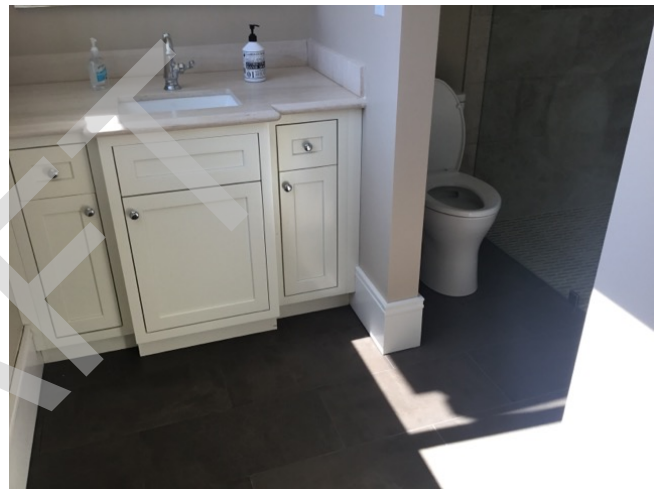
Item no., Rm no. and Name	Existing Architectural Barrier and Proposed Solution	Codes / Mitigation Info	Qty	Unit	Cost	Total
Restroom						
2383	<ul style="list-style-type: none"> • <i>As-Built Description:</i> Single accommodation restroom not accessible; multiple compliance violations. • <i>Proposed Solution:</i> Remodel area to provide single-occupant accessible restroom. 	PCODE WA01 ADAAG 91 4.22 ADA 2010 603.1 CBC 2007 1115B.3.2 CBC 2019 11B-603.1	1	JOB	\$90,000	\$90,000
						Priority 2 Severity 3

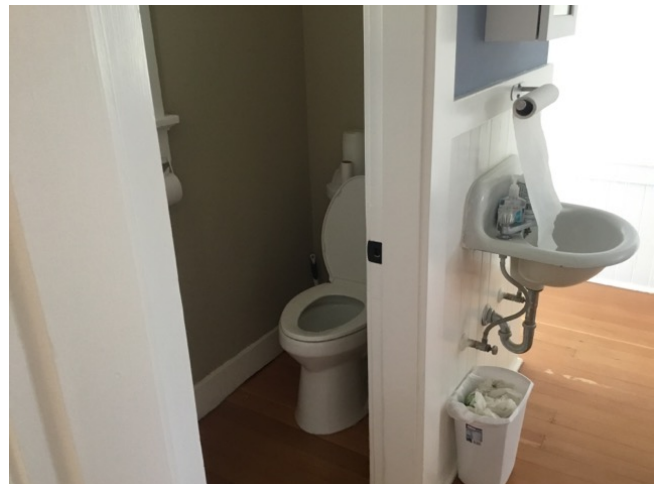
2380	<ul style="list-style-type: none"> • <i>As-Built Description:</i> Single accommodation restroom not accessible; multiple compliance violations. • <i>As-Built:</i> 32" x 71" • <i>Proposed Solution:</i> Provide directional signage to accessible restroom. Or Remodel area to provide single-occupant accessible restroom. 	PCODE WA01REF ADAAG 91 4.22 ADA 2010 603.1 CBC 2007 1115B.3.2 CBC 2019 11B-603.1	REF			
						Priority 2 Severity 2

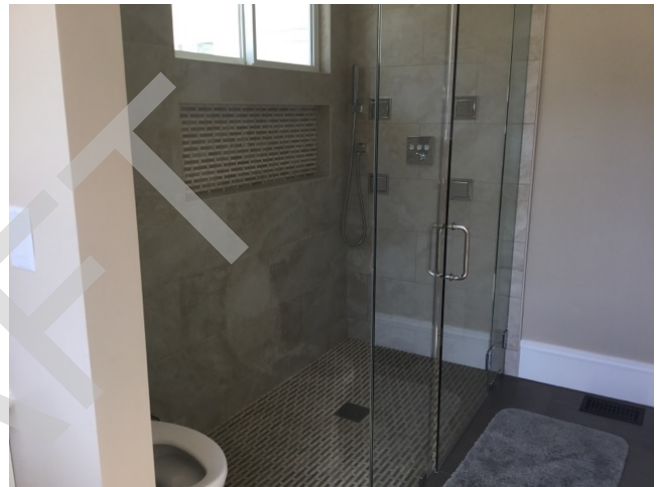
Item no., Rm no. and Name	Existing Architectural Barrier and Proposed Solution	Codes / Mitigation Info	Qty	Unit	Cost	Total
<u>Shower</u>						
2384	<ul style="list-style-type: none"> As-Built Description: Shower not accessible; multiple compliance violations. Proposed Solution: Provide accessible shower. 	PCODE WF01REF ADAAG 91 4.21 ADA 2010 608.1 CBC 2019 11B-608.1		REF		
				Priority	2	
				Severity	3

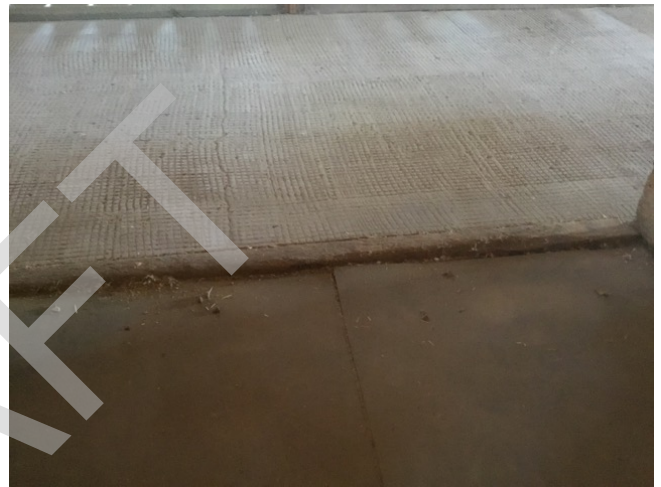
Item no., Rm no. and Name	Existing Architectural Barrier and Proposed Solution	Codes / Mitigation Info	Qty	Unit	Cost	Total
2428	<ul style="list-style-type: none"> As-Built Description: Walk: Pavement dislocation creates abrupt change in level exceeding 1/2" in accessible route. As-Built: 2" Proposed Solution: Remove, replace or repair area of pavement sufficient to correct abrupt change in level. 	PCODE EF03 ADAAG 91 4.3.8 ADA 2010 403.4 CBC 2007 1133B.7.4 CBC 2019 11B-403.4	40	SF	\$63	\$2,520
						Priority 1
						Severity 3
