Facilities Access Compliance Survey Report for the Santa Clara Valley Open Space Authority

Santa Clara Valley Open Space Access Compliance Survey Report

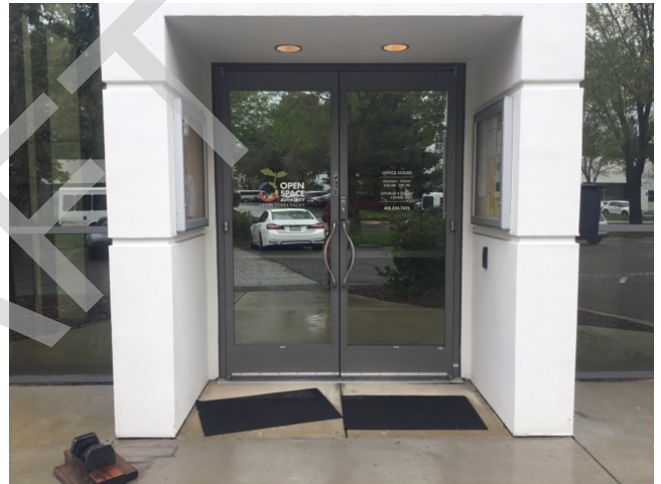
PCODE **G102**ADAAG 91 **4.1.3(19)(b)**ADA 2010 **703.7.2.4**CBC 2007 **1104B.2.4**CBC 2019 **11B-703.7.2.4**1 JOB \$300 **\$300****Priority****1****Severity****3**

Provide assistive listening signage.

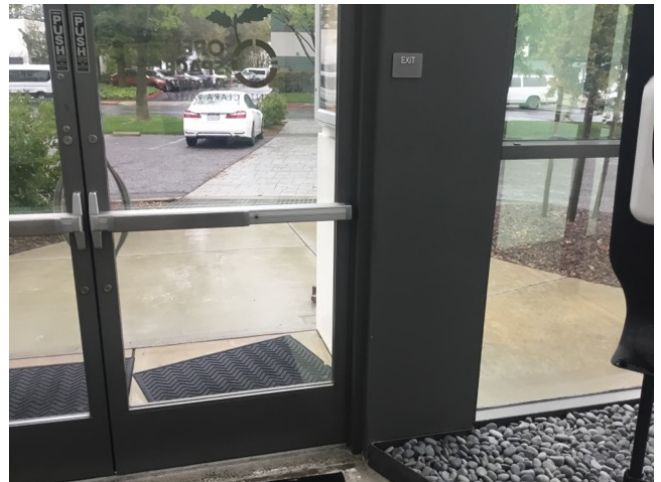
2437	<ul style="list-style-type: none"> • <i>As-Built Description:</i> Signs containing tactile characters is not located so that a clear floor space of 18" min x 18" min., centered on the tactile characters, is provided beyond the arc of any door swing between the closed position and 45 degree open position. • <i>As-Built:</i> Stones obstruct the CLFS. • <i>Proposed Solution:</i> Modify stone display. 	PCODE SA07B ADA 2010 703.4.2 CBC 2019 11B-703.4.2	1	JOB	\$1,500	\$1,500
					Priority	1
					Severity	1

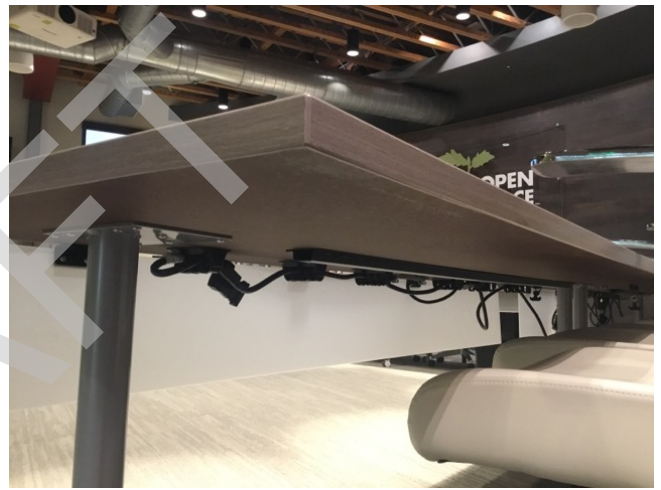
2440	<ul style="list-style-type: none"> • <i>As-Built Description:</i> Accessible non-fixed table or desk (top 28" to 34" high; knee space at least 27" high x 19" deep x 30" wide) not provided. • <i>As-Built:</i> 26.7" AFF at 14" deep. • <i>Proposed Solution:</i> Remove or relocate the unused electric cord chase under the table. 	PCODE IN02A ADAAG 91 4.32.3 & .4 ADA 2010 306.1 CBC 2007 112B.3 & 4 CBC 2019 11B-306.1 & 11B-902.3	1	JOB	\$30	\$30
------	---	--	---	-----	------	------

Priority 1**Severity** 4

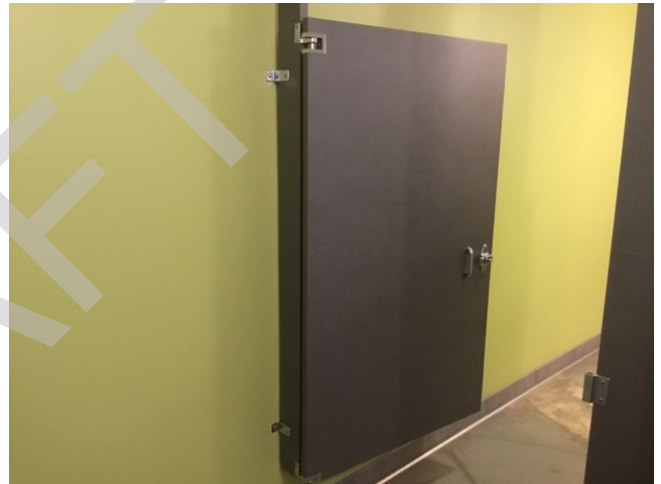
PCODE **WB05D**ADAAG 91 **4.17.3 & Fig.**ADA 2010 **604.8.1.2**CBC 2007 **1115B.3.1.4.3**CBC 2019 **11B-604.8.1.2**1 JOB \$1,500 **\$1,500****Priority** **2****Severity** **4**

Remodel compartment.

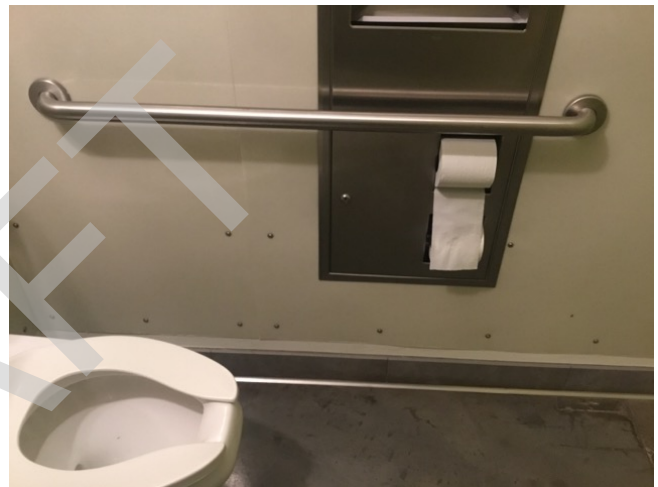
2453	<ul style="list-style-type: none"> • <i>As-Built Description:</i> Side grab bar less than 42" long, or located more than 12 inches max. from the rear wall, or extending less than 54" from rear wall (CA only: front end min. 24" in front of water closet). • <i>As-Built:</i> Extends 51" • <i>Proposed Solution:</i> Provide or relocate accessible side grab bar. 	PCODE WB07A ADAAG 91 Fig. 29(b) ADA 2010 604.5.1 CBC 2007 1115B.4.1.3.1 CBC 2019 11B-604.5.1	1	JOB	\$780	\$780
------	--	--	---	-----	-------	-------

Priority **2****Severity** **3**

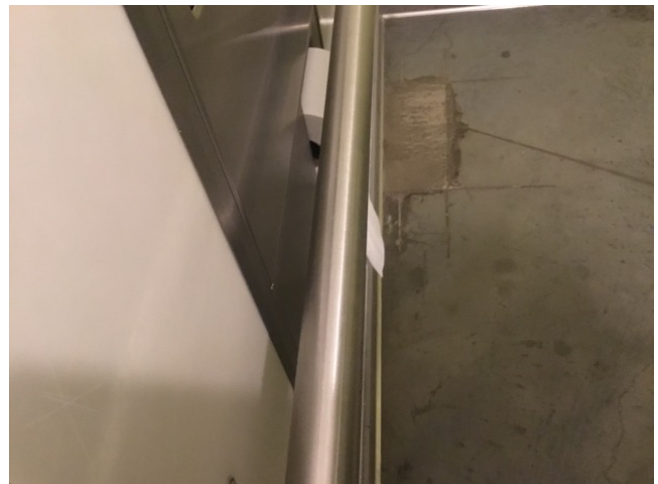
2455	<ul style="list-style-type: none"> • <i>As-Built Description:</i> Accessories/dispensers in accessible stall located closer than 1-1/2" below or 12" above grab bar impedes its use. • <i>As-Built:</i> 1.325" to toilet paper dispenser enclosure. • <i>Proposed Solution:</i> Relocate accessories/dispensers to be no closer than 1-1/2" below and 12" above grab bars (except if accessories are recessed, flush with wall, and have no sharp edges). 	PCODE WB07I ADAAG 91 4.26.2 ADA 2010 609.3 CBC 2007 1133B.4.2.5 CBC 2019 11B-609.3	1	JOB	\$225	\$225
------	---	--	---	-----	-------	-------

Priority **2****Severity** **4**

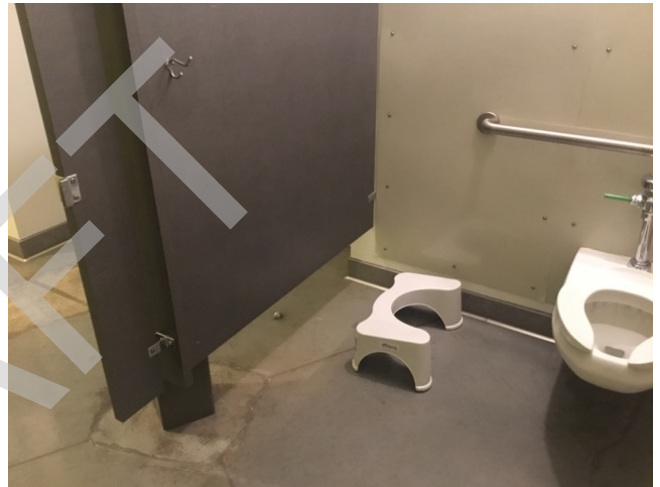
Item no., Rm no. and Name	Existing Architectural Barrier and Proposed Solution	Codes / Mitigation Info	Qty	Unit	Cost	Total
Toilet Stall						
2449	<ul style="list-style-type: none"> • <i>As-Built Description:</i> Toilet stall less than 60" wide. • <i>As-Built:</i> 58" wide at 47" from rear wall. Obstructed by cross support. • <i>Proposed Solution:</i> Provide new accessible stall. 	PCODE WB06 ADAAG 91 4.17.3 ADA 2010 604.8.1.1 CBC 2007 1115B.3.1.4.1 CBC 2019 11B-604.8.1.1	1	JOB	\$4,500	\$4,500
					Priority	2
					Severity	3

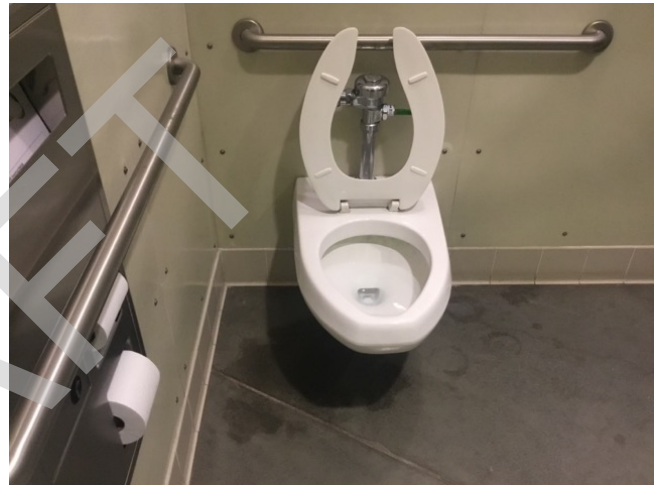
PCODE **WB02C**ADAAG 91 **Fig. 28**ADA 2010 **604.2**CBC 2007 **1115B.4.1.1**CBC 2019 **11B-604.2**1 JOB \$1,500 **\$1,500****Priority** **2****Severity** **3**

Relocate existing water closet and plumbing, remount with offset closet flange to provide 18" max. from side wall.

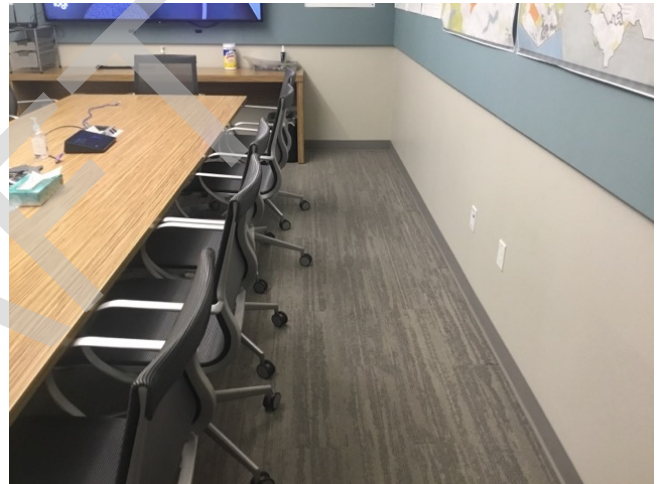
PCODE **IH03A**ADAAG 91 **4.3.3**ADA 2010 **403.5.1**CBC 2007 **1133B.3.1**CBC 2019 **11B-403.5.1**1 JOB \$150 **\$150****Priority****1****Severity****1**

Remove or relocate furniture and storage items.

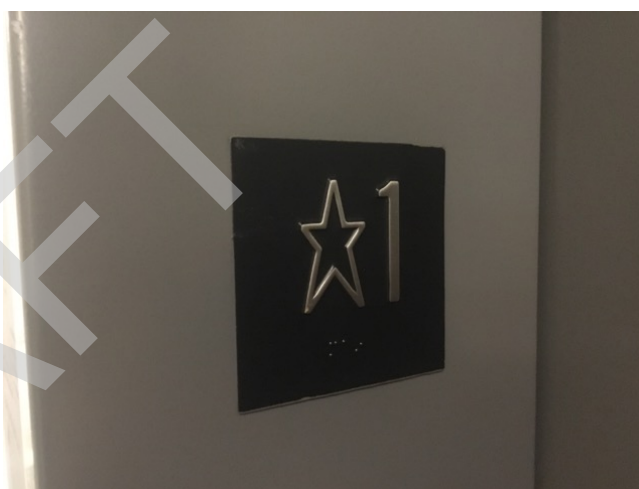
Item no., Rm no. and Name	Existing Architectural Barrier and Proposed Solution	Codes / Mitigation Info	Qty	Unit	Cost	Total
Signage						
2468	<ul style="list-style-type: none"> As-Built Description: Sign does not have non-glare finish and/or good color contrast (dark on light or light on dark). As-Built: Hoistway signs on both floors have glare. Proposed Solution: Provide compliant signage. 	PCODE SA03 ADAAG 91 4.30.5 ADA 2010 703.5.1 CBC 2007 1117B.5.5 CBC 2019 11B -407.4.7.1.3	2	JOB	\$270	\$540
					Priority	1
					Severity	4

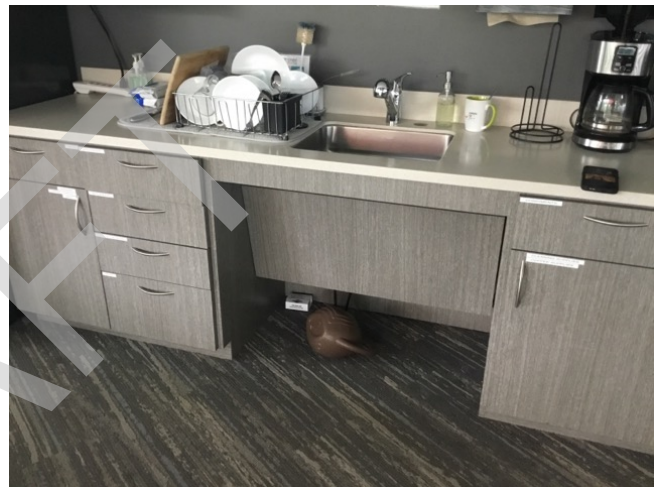
2472	<ul style="list-style-type: none"> • <i>As-Built Description:</i> Reach height to control or access point, exceeds 48" or is less than 15". • <i>As-Built:</i> 18" deep toe clearance. 20" reach to faucet handle. • <i>Proposed Solution:</i> Provide 20" minimum toe clearance or relocate the faucet handle. 	PCODE IE01 ADAAG 91 4.2.5 ADA 2010 308.2.1 CBC 2007 1118B.5 CBC 2019 11B-308.2.1	1	JOB	\$300	\$300
------	---	--	---	-----	-------	-------

Priority **4****Severity** **3**

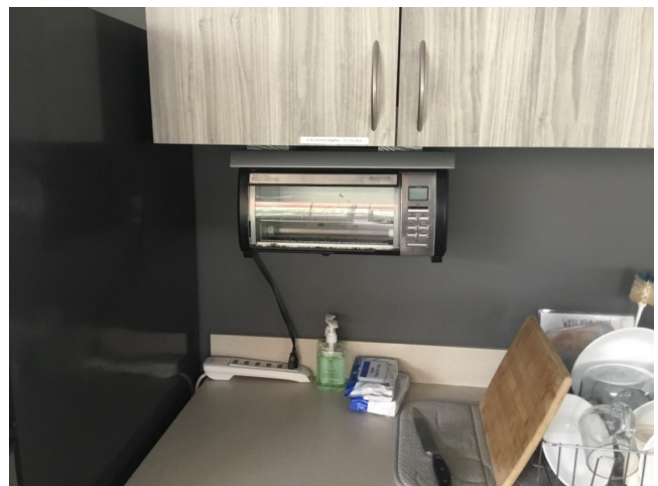
2473	<ul style="list-style-type: none"> • <i>As-Built Description:</i> Reach height to control or access point, where side approach is available, exceeds 48" or is less than 15" in height, or exceeds 10" in depth. • <i>As-Built:</i> 56" AFF • <i>Proposed Solution:</i> Relocate the toaster. 	PCODE IE02 ADAAG 91 4.2.6 ADA 2010 308.3.1 CBC 2007 1118B.6 CBC 2019 11B-308.3	1	JOB	\$300	\$300
------	---	--	---	-----	-------	-------

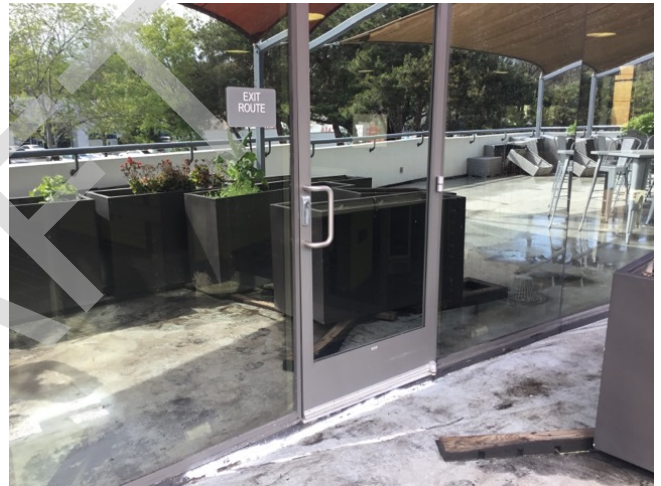
14 Roof Deck

Door Threshold

Door inaccessible due to threshold or step at door exceeding 1/2".

- *As-Built:* **3"**

Provide ramp and landing.

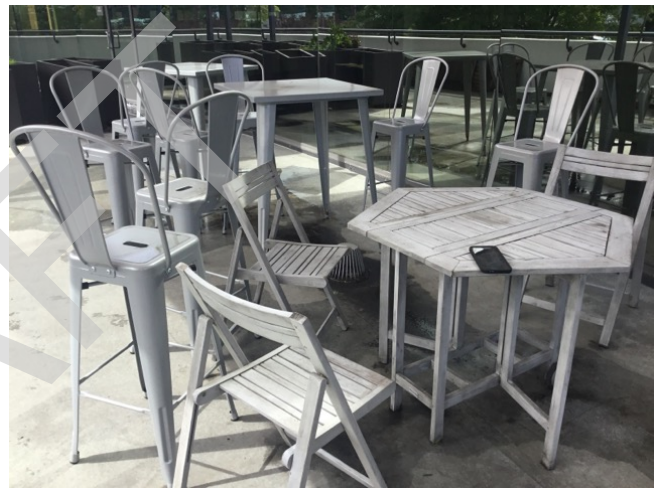
Non-Fixed Desk

Accessible non-fixed table or desk (top 28" to 34" high; knee space at least 27" high x 19" deep x 30" wide) not provided.

- *As-Built:* **41" to the top. 4" knee clearance.**

Provide table or desk with accessible dimensions when purchasing new furniture.

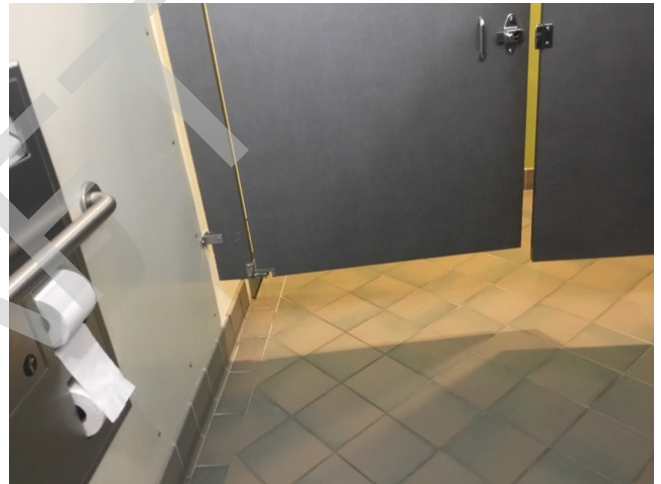
15 Women's Restroom

Accessible Compartment

The location of the stall door is not in front of the clear space (next to the water closet), with a maximum stile width of 4".

- *As-Built:* **Not opposite. 6" stile.**

Remodel compartment.

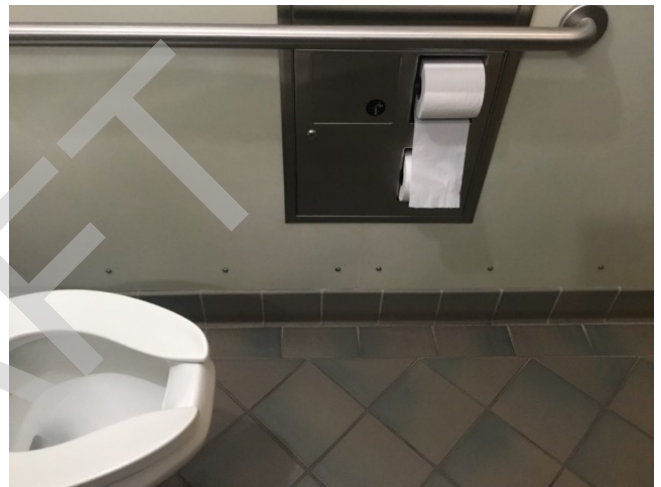
Accessories

Toilet paper dispenser less than 15" (CA: 19") or more than 48" above floor or not within 7" to 9" from front of water closet (Note: CA pre-2010 is allowed within 12" from front of water closet).

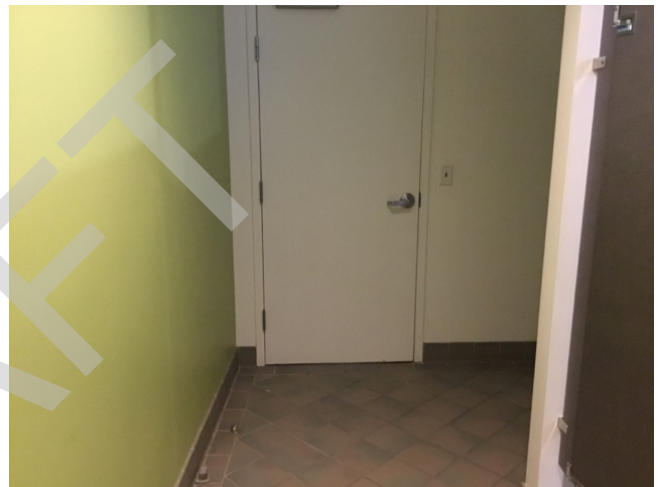
2477	<ul style="list-style-type: none"> • <i>As-Built Description:</i> Front approach: At pull side, door does not have clear and level maneuvering space measuring door width plus 18" x 60". (24" x 60" at exterior doors). • <i>As-Built:</i> 54" • <i>Proposed Solution:</i> Change door swing. 	PCODE ID23 ADAAG 91 Fig. 25(a) ADA 2010 404.2.4 CBC 2007 11B-26A(a) CBC 2019 11B-404.2.4	1	JOB	\$1,500	\$1,500
------	--	--	---	-----	---------	----------------

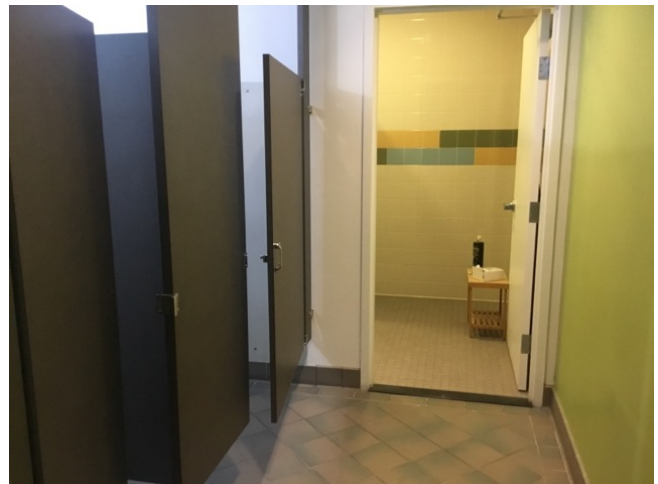
2478	<ul style="list-style-type: none"> • <i>As-Built Description:</i> Front approach: At pull side, door does not have clear and level maneuvering space measuring door width plus 18" x 60". (24" x 60" at exterior doors). • <i>As-Built:</i> 54" • <i>Proposed Solution:</i> Remove standard compartment and completely remodel the accessible compartment. 	PCODE ID23B ADAAG 91 Fig. 25(a) ADA 2010 404.2.4 CBC 2007 11B-26A(a) CBC 2019 11B-404.2.4	1	JOB	\$16,800	\$16,800
------	--	---	---	-----	----------	-----------------

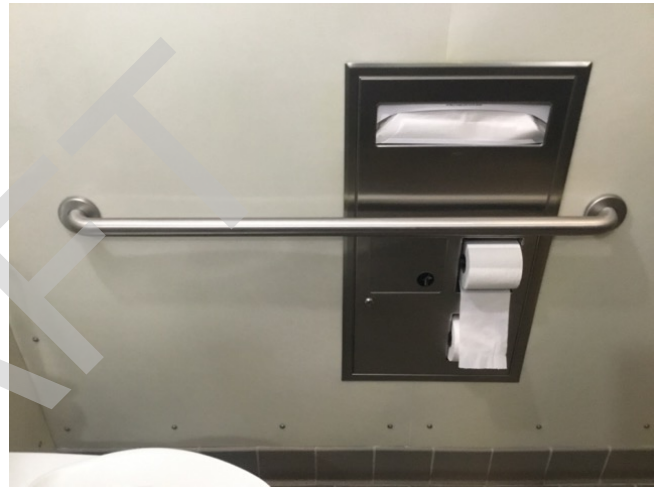
2492	<ul style="list-style-type: none"> • <i>As-Built Description:</i> Side grab bar less than 42" long, or located more than 12 inches max. from the rear wall, or extending less than 54" from rear wall (CA only: front end min. 24" in front of water closet). • <i>As-Built:</i> Extends 51" • <i>Proposed Solution:</i> Provide or relocate accessible side grab bar. 	PCODE WB07A ADAAG 91 Fig. 29(b) ADA 2010 604.5.1 CBC 2007 1115B.4.1.3.1 CBC 2019 11B-604.5.1	1	JOB	\$780	\$780
------	--	--	---	-----	-------	-------

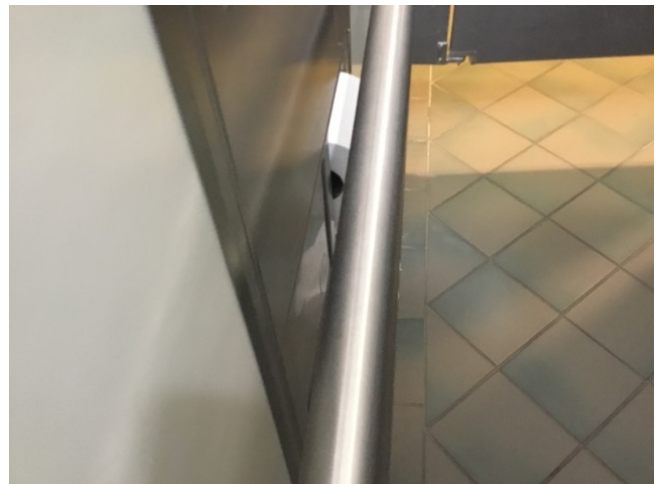
2493	<ul style="list-style-type: none"> • <i>As-Built Description:</i> Accessories/dispensers in accessible stall located closer than 1-1/2" below or 12" above grab bar impedes its use. • <i>As-Built:</i> 1.125" • <i>Proposed Solution:</i> Relocate accessories/dispensers to be no closer than 1-1/2" below and 12" above grab bars (except if accessories are recessed, flush with wall, and have no sharp edges). 	PCODE WB07I ADAAG 91 4.26.2 ADA 2010 609.3 CBC 2007 1133B.4.2.5 CBC 2019 11B-609.3	1	JOB	\$225	\$225
------	--	--	---	-----	-------	-------

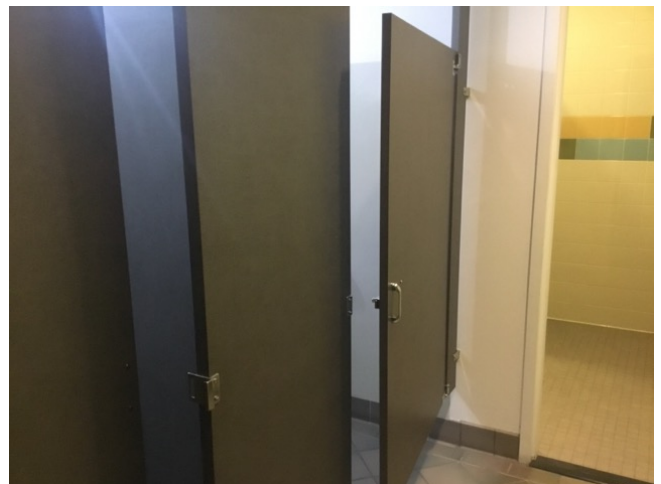
<u>Stall Door</u>						
2479	<ul style="list-style-type: none"> • <i>As-Built Description:</i> Stall door to accessible compartment not self closing. • <i>Proposed Solution:</i> Adjust closer. 	PCODE WB05B ADAAG 91 4.22.4 ADA 2010 604.8.1.2 CBC 2007 1115B.3.1.4.4 CBC 2019 11B-604.8.1.2	1	JOB	\$75	\$75
					Priority	2
					Severity	3

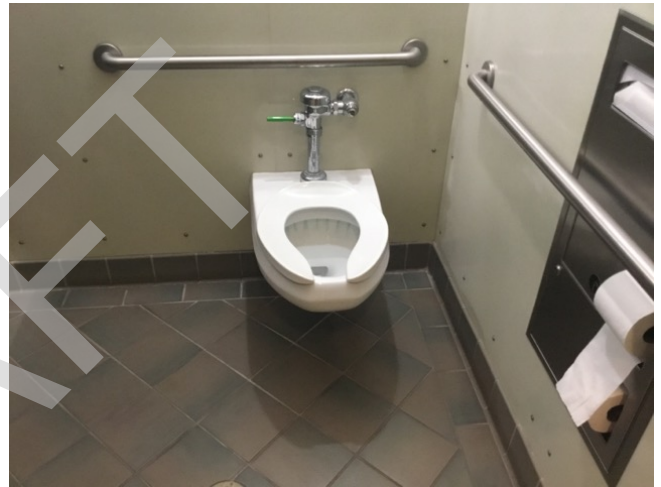
Possibly complied with CA tolerance at the time of construction.

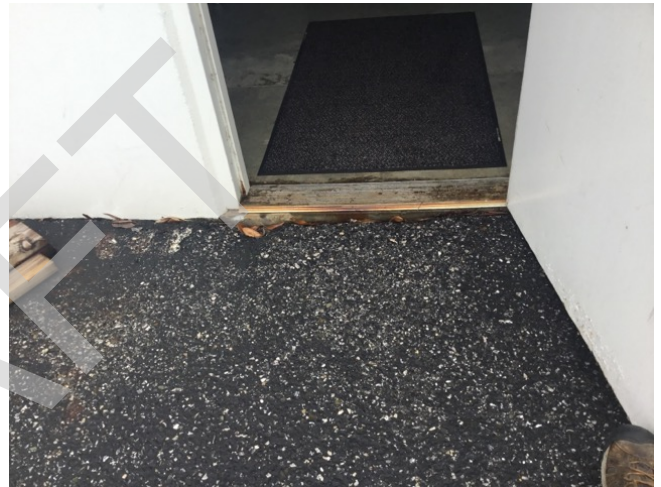
<i>Item no., Rm no. and Name</i>	<i>Existing Architectural Barrier and Proposed Solution</i>	<i>Codes / Mitigation Info</i>	<i>Qty</i>	<i>Unit</i>	<i>Cost</i>	<i>Total</i>
<u>Door</u>						
2499	<ul style="list-style-type: none"> • <i>As-Built Description:</i> Surface of required maneuvering clearance at door slopes more than 1/4":12" (2.0%). • <i>As-Built:</i> 4% • <i>Proposed Solution:</i> Modify surface slope at door. 	<i>PCODE ID11</i> <i>ADAAG 91 4.13.6</i> <i>ADA 2010 404.2.4.4</i> <i>CBC 2007 1133B.2.4</i> <i>CBC 2019 11B-404.2.4</i>	20	SF	\$120	\$2,400
						Priority 1
						Severity 3

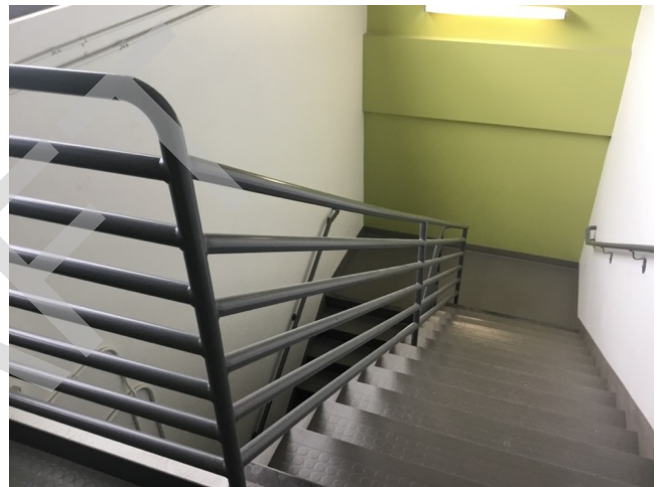
Item no., Rm no. and Name	Existing Architectural Barrier and Proposed Solution	Codes / Mitigation Info	Qty	Unit	Cost	Total
<u>Handrail</u>						
2495	<ul style="list-style-type: none"> • <i>As-Built Description:</i> Guards (42" high) not provided at side of ramp or landing where drop-off to adjacent grade or floor exceeds 30" height (California building code requirement only). • <i>Proposed Solution:</i> Provide new guards, including handrail at ramp. 	PCODE ED08 CBC 2007 1133B.5.7 CBC 2019 Section 1013.2; 1013.3	20	LF	\$360	\$7,200
						Priority 1 Severity 1

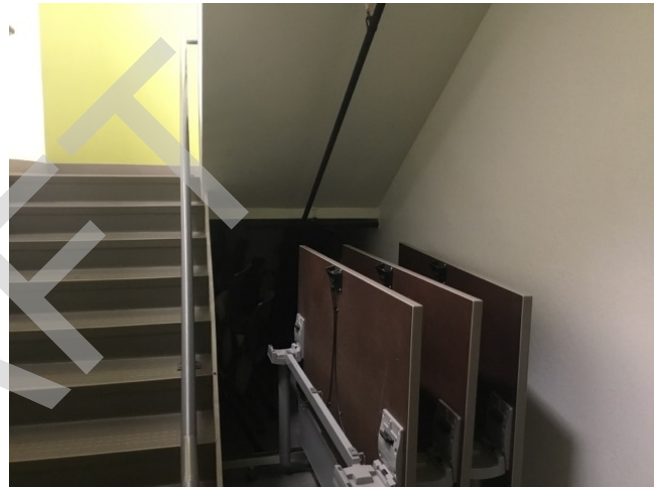
Item no., Rm no. and Name	Existing Architectural Barrier and Proposed Solution	Codes / Mitigation Info	Qty	Unit	Cost	Total
Vertical Clearance						
2496	<ul style="list-style-type: none"> As-Built Description: Overhead clearance less than 80" above finished floor. As-Built: Between 27" and 80" AFF Proposed Solution: Provide cane-detectable railing to mark area of low clearance. 	PCODE EG01A ADAAG 91 4.4.2 ADA 2010 307.4 CBC 2007 1133B.8.6.2 CBC 2019 11B-307.4	4	LF	\$300	\$1,200
						Priority 1 Severity 1

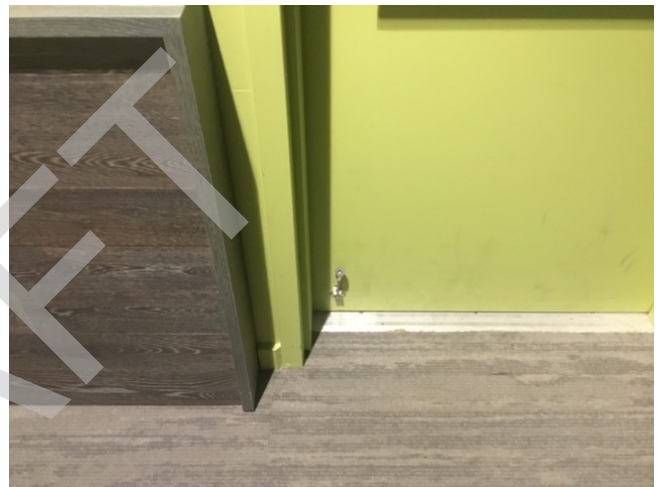
Item no., Rm no. and Name	Existing Architectural Barrier and Proposed Solution	Codes / Mitigation Info	Qty	Unit	Cost	Total
<u>Door Stopper</u>						
2445	<ul style="list-style-type: none"> • <i>As-Built Description:</i> At push side of door on accessible route, bottom 10" does not have a smooth, uninterrupted surface. • <i>Proposed Solution:</i> Relocate doorstop. 	PCODE ID06A ADA 2010 404.2.10 CBC 2007 1133B.2.6 CBC 2019 11B-404.2.10	10	JOB	\$1,800	\$18,000
						Priority 1 Severity 3

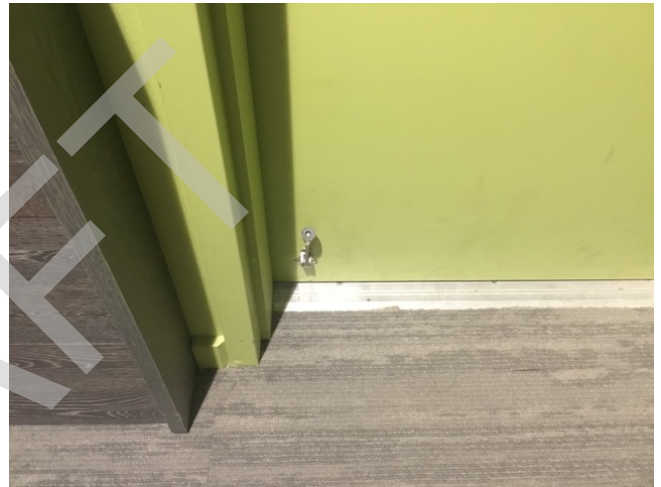
Item no., Rm no. and Name	Existing Architectural Barrier and Proposed Solution	Codes / Mitigation Info	Qty	Unit	Cost	Total
Reach Range						
2447	<ul style="list-style-type: none"> As-Built Description: Reach height to control or access point, where side approach is available, exceeds 48" or is less than 15" in height, or exceeds 10" in depth. As-Built: 3" AFF Proposed Solution: Modify equipment or mounting. 	PCODE IE02REF ADAAG 91 4.2.6 ADA 2010 308.3.1 CBC 2007 1118B.6 CBC 2019 11B-308.3				REF
						Priority 1 Severity 3

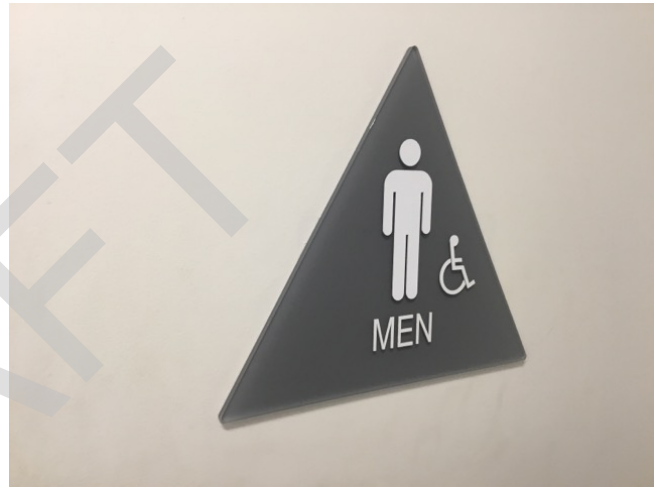
2448	<ul style="list-style-type: none"> As-Built Description: Required in CA only: identification symbol centered 58" to 60" high on sanitary facility door that contrasts with the door not provided (women: 12" ø circle, men: 12" triangle, unisex: combined symbol). As-Built: Edges are not eased or rounded. Proposed Solution: Provide properly mounted sanitary facility symbol when altering area. If wheelchair accessible, include International Symbol of Accessibility on sign. 	PCODE SA15 CBC 2007 1115B.6 CBC 2019 11B-703.7.2.6	6	JOB	\$450	\$2,700
Priority 1						
Severity 1

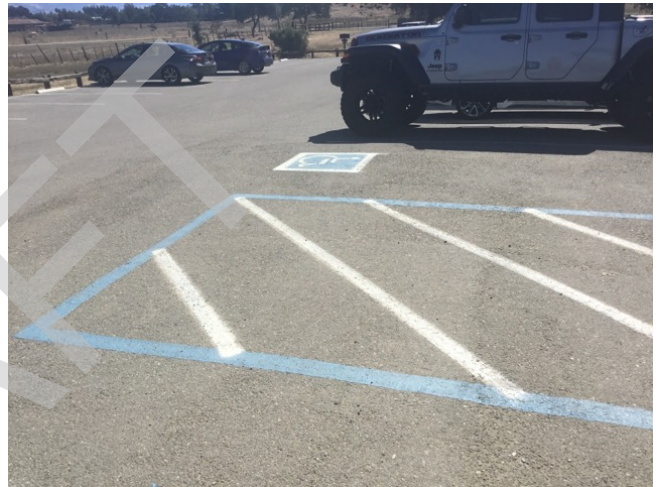
Item no., Rm no. and Name	Existing Architectural Barrier and Proposed Solution	Codes / Mitigation Info	Qty	Unit	Cost	Total
<u>Floor or Ground Surfaces</u>						
2279	<ul style="list-style-type: none"> • <i>As-Built Description:</i> Accessible parking space has slope greater than 1/4":12" (2%). • <i>As-Built:</i> To 9% • <i>Proposed Solution:</i> Modify slope at accessible parking space. 	PCODE EA05 ADAAG 91 4.6.3 ADA 2010 502.4 CBC 2007 1129B.3.3 CBC 2019 11B-502.4	15	SF	\$36	\$540
						Priority 3 Severity 2

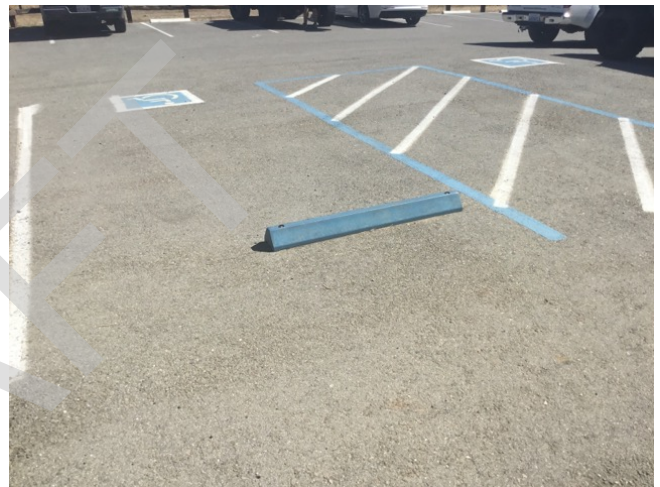
Item no., Rm no. and Name	Existing Architectural Barrier and Proposed Solution	Codes / Mitigation Info	Qty	Unit	Cost	Total
Parking						
2280	<ul style="list-style-type: none"> As-Built Description: Accessible parking space smaller than 8' wide (CA only: 9' x 18'). As-Built: 106.5"-107" wide Proposed Solution: Modify parking space(s) to create accessible space. 	PCODE EA02A ADAAG 91 4.6.3 ADA 2010 502.2 CBC 2007 1129B.3.1 CBC 2019 11B-502.2	2	JOB	\$600	\$1,200
						Priority 3 Severity 3

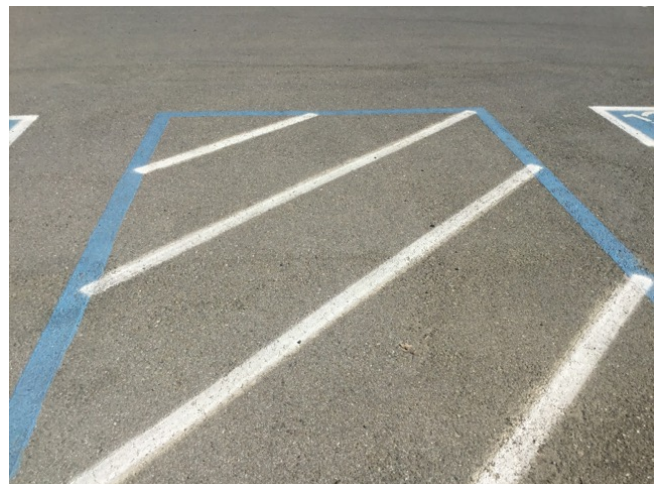
2281	<ul style="list-style-type: none"> As-Built Description: The words "NO PARKING" not painted on the ground within loading and unloading access aisle (12" min high white letters), located so that it is visible to traffic enforcement officials (required in CA only). Proposed Solution: Provide the words "NO PARKING" in each access aisle, painted in 12" high letters, when altering area. 	PCODE EA04D CBC 2007 1129B.3.1 CBC 2019 11B-502.3.3	1	JOB	\$300	\$300
						Priority 3 Severity 4

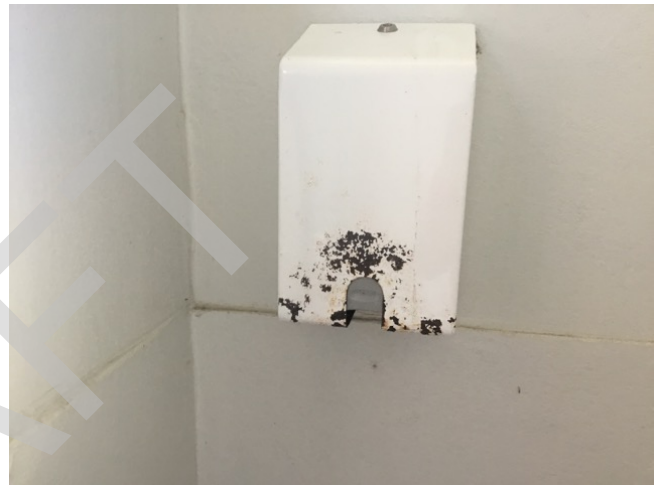
Item no., Rm no. and Name	Existing Architectural Barrier and Proposed Solution	Codes / Mitigation Info	Qty	Unit	Cost	Total
2287	<ul style="list-style-type: none"> • <i>As-Built Description:</i> Dispensers in sanitary facilities, such as for towels, soap, sanitary napkins, seat covers, etc., and waste receptacles more than 48" (CA only: 40") from floor to highest operating slot or control. • <i>As-Built:</i> 51" • <i>Proposed Solution:</i> Relocate existing restroom accessories. 	PCODE WG01A ADAAG 91 4.23.7 ADA 2010 308.2.1 CBC 2007 1115B.8.3 CBC 2019 11B-603.5	1	JOB	\$300	\$300
						Priority 2 Severity 3

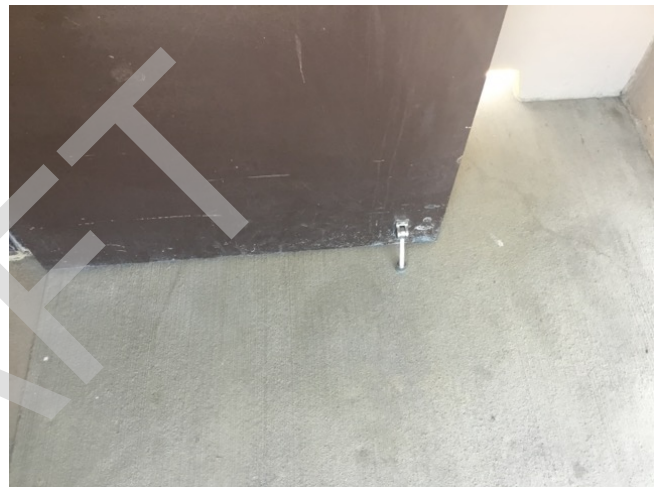
Item no., Rm no. and Name	Existing Architectural Barrier and Proposed Solution	Codes / Mitigation Info	Qty	Unit	Cost	Total
<u>Door Stopper</u>						
2285	<ul style="list-style-type: none"> • <i>As-Built Description:</i> At push side of door on accessible route, bottom 10" does not have a smooth, uninterrupted surface. • <i>Proposed Solution:</i> Remove door stopper when altering area. Provide rubber wedge. 	PCODE ID06A ADA 2010 404.2.10 CBC 2007 1133B.2.6 CBC 2019 11B-404.2.10	1	JOB	\$75	\$75
						Priority 2 Severity 3

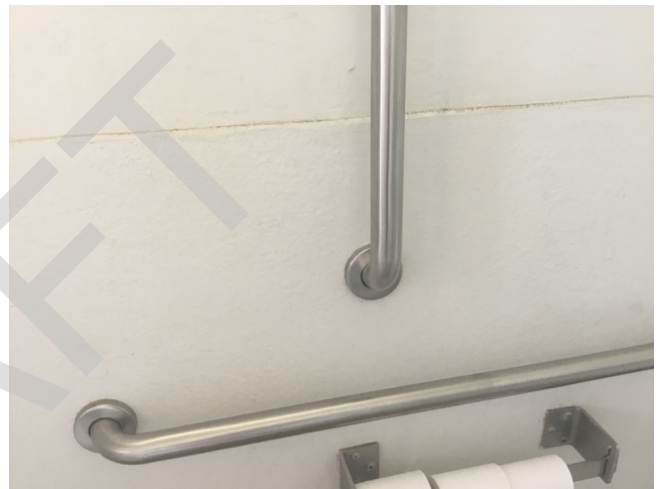
Item no., Rm no. and Name	Existing Architectural Barrier and Proposed Solution	Codes / Mitigation Info	Qty	Unit	Cost	Total
Grab Bars						
2288	<ul style="list-style-type: none"> • <i>As-Built Description:</i> Accessories/dispensers in accessible stall located closer than 1-1/2" below or 12" above grab bar impedes its use. • <i>As-Built:</i> 6" • <i>Proposed Solution:</i> Remove the vertical grab bar. 	PCODE WB07I ADAAG 91 4.26.2 ADA 2010 609.3 CBC 2007 1133B.4.2.5 CBC 2019 11B-609.3	1	JOB	\$225	\$225
					Priority	2
					Severity	3

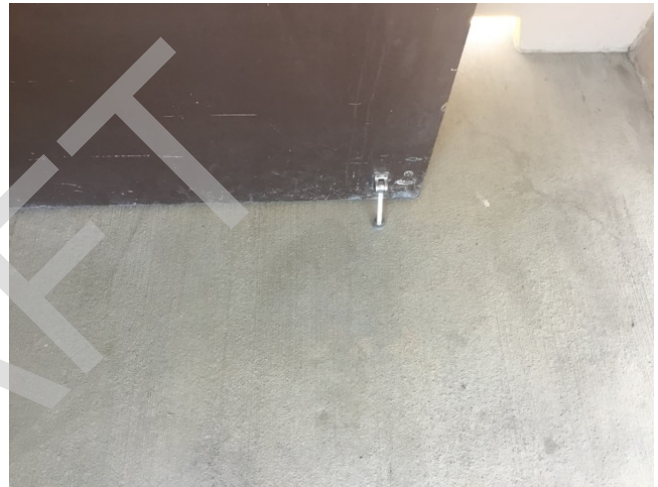
Item no., Rm no. and Name	Existing Architectural Barrier and Proposed Solution	Codes / Mitigation Info	Qty	Unit	Cost	Total
Reach Range						
2284	<ul style="list-style-type: none"> As-Built Description: Reach height to control or access point, where side approach is available, exceeds 48" or is less than 15" in height, or exceeds 10" in depth. As-Built: 5" Proposed Solution: Relocate door stop. 	PCODE IE02 ADAAG 91 4.2.6 ADA 2010 308.3.1 CBC 2007 1118B.6 CBC 2019 11B-308.3	1	JOB	\$300	\$300
						Priority 2 Severity 3

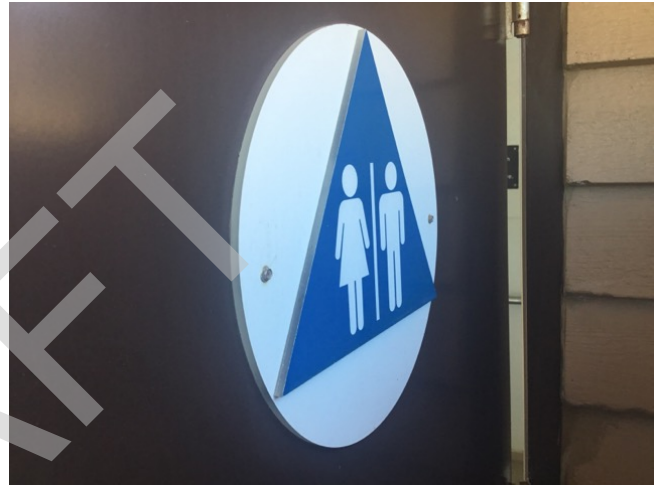
Item no., Rm no. and Name	Existing Architectural Barrier and Proposed Solution	Codes / Mitigation Info	Qty	Unit	Cost	Total
2289	<ul style="list-style-type: none"> • <i>As-Built Description:</i> Required in CA only: identification symbol centered 58" to 60" high on sanitary facility door that contrasts with the door not provided (women: 12" ø circle, men: 12" triangle, unisex: combined symbol). • <i>As-Built:</i> Not beveled. • <i>Proposed Solution:</i> Provide properly mounted sanitary facility symbol when altering area. If wheelchair accessible, include International Symbol of Accessibility on sign. 	PCODE SA15 CBC 2007 1115B.6 CBC 2019 11B-703.7.2.6	1	JOB	\$270	\$270

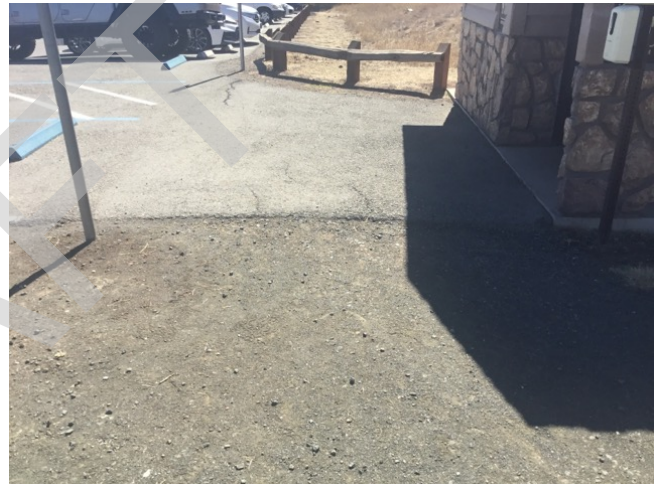
2290

Walk: Pavement dislocation creates abrupt change in level exceeding 1/2" in accessible route.

- *As-Built:* **To 3"**

Install surface material to the level of asphalt.

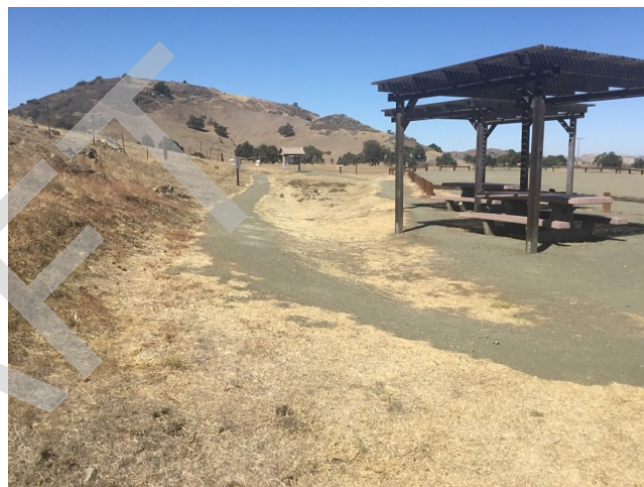
2294

Cross slope more than 1":48" (2.083%).

- *As-Built:* **To 13%**

**Occurs on both trails from picnic and restrooms
to information and trail head.**

Modify cross slope.

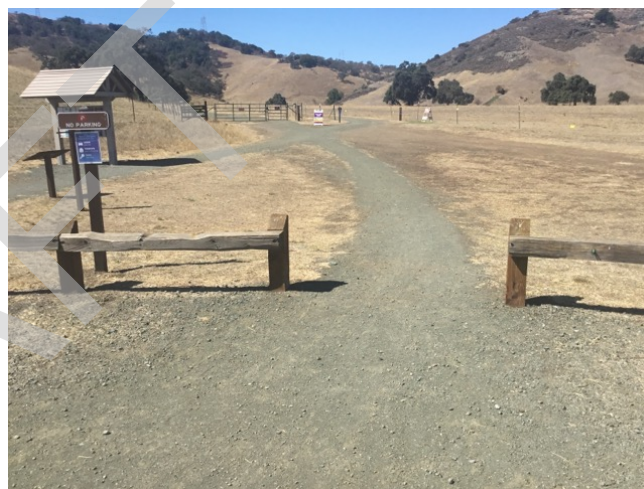
2296

36" wide band of truncated domes not provided at walkway or crossing adjoining a vehicular way, if surfaces are not separated by a curb, railing, or other element.

Provide 36" wide, contrasting color, band of truncated domes between pedestrian and vehicular area.

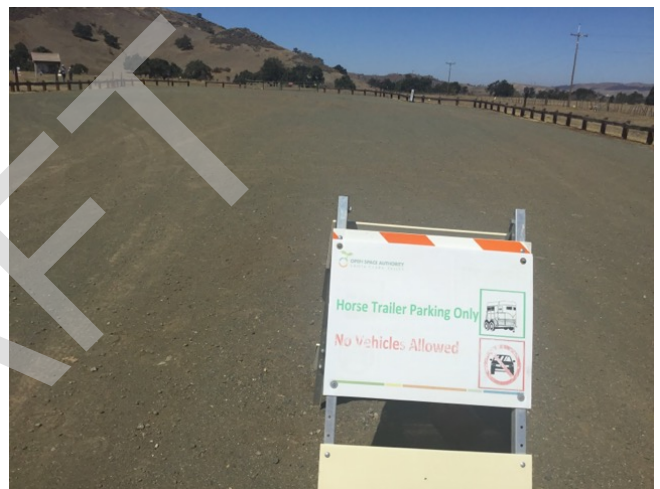
Item no., Rm no. and Name	Existing Architectural Barrier and Proposed Solution	Codes / Mitigation Info	Qty	Unit	Cost	Total
<u>Minimum Number</u>						
2295	<ul style="list-style-type: none"> <i>As-Built Description:</i> At parking lot with 1-25 spaces, the number of accessible spaces is less than required by code; 1 space required <i>Proposed Solution:</i> Provide required accessible parking space with sign including a minimum of one van space. 	PCODE EA01A ADAAG 91 4.1.2(5) ADA 2010 208.2 CBC 2007 Tbl. 11B-6 CBC 2019 11B-208.2 Tbl. 11B-208.2	1	JOB	\$9,000	\$9,000
						Priority 3 Severity 3

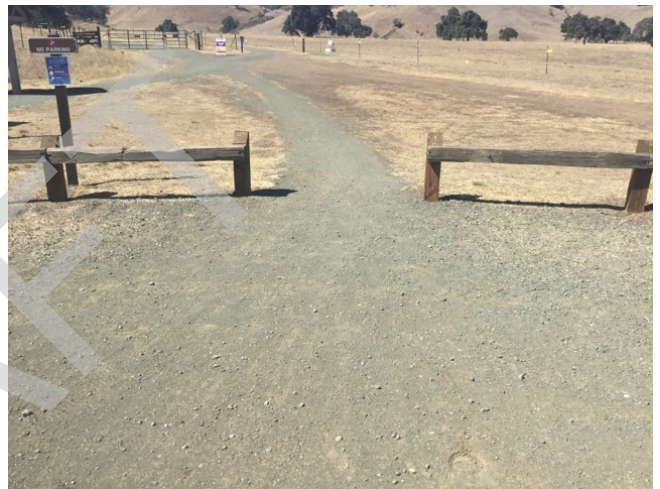
Item no., Rm no. and Name	Existing Architectural Barrier and Proposed Solution	Codes / Mitigation Info	Qty	Unit	Cost	Total
Walk						
2297	<ul style="list-style-type: none"> As-Built Description: Walk: Slope greater than 1:20 (5.0%), and walk does not comply with requirements for ramps. As-Built: 10.5% Proposed Solution: Grade surface. 	PCODE EF01 ADAAG 91 4.3.7 ADA 2010 403.3 CBC 2007 1133B.7.3 CBC 2019 11B-403.3	20	SF	\$75	\$1,500
						Priority 1 Severity 3

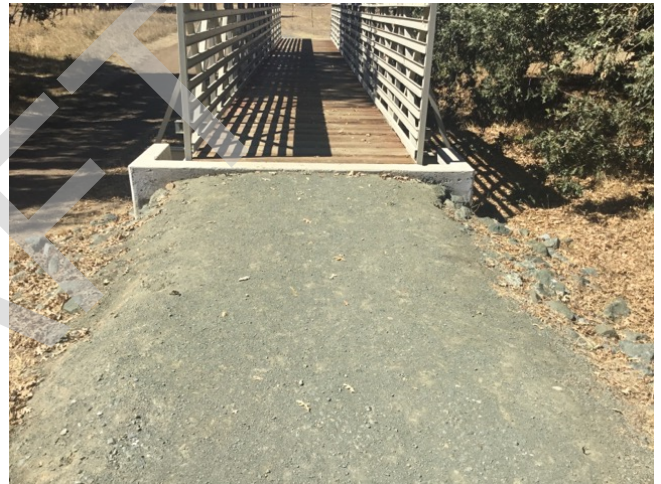
2304

Walk: Pavement dislocation creates abrupt change in level exceeding 1/2" in accessible route.

- *As-Built:* **To 3"**

Install surface material to level of the concrete.

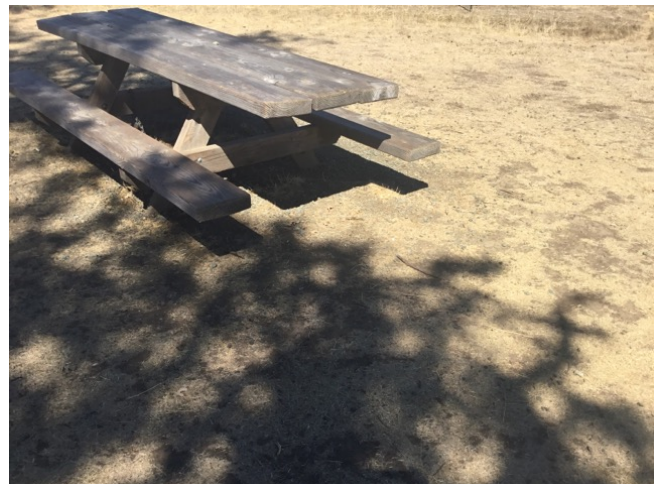
2300	<ul style="list-style-type: none"> As-Built Description: Clear space has slopes greater than 1:48. As-Built: To 9% at picnic tables. Proposed Solution: Grade surface. 	PCODE NI07 ADAAG 91 16.6.6 ADA 2010 305.2 CBC 2007 1132B.1 CBC 2019 11B-305.2	1	JOB	\$1,200	\$1,200
Priority 1 Severity 3

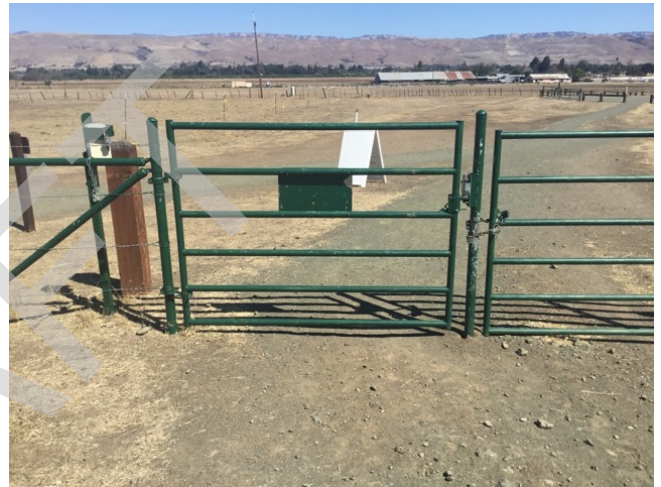
Item no., Rm no. and Name	Existing Architectural Barrier and Proposed Solution	Codes / Mitigation Info	Qty	Unit	Cost	Total
Door						
2309	<ul style="list-style-type: none"> <i>As-Built Description:</i> At push side of door on accessible route, bottom 10" does not have a smooth, uninterrupted surface. <i>Proposed Solution:</i> Provide 10" min. "kick plate" covering width of door when altering area. 	PCODE ID06 ADA 2010 404.2.10 CBC 2007 1133B.2.6 CBC 2019 11B-404.2.10	2	JOB	\$300	\$600
						Priority 1 Severity 3

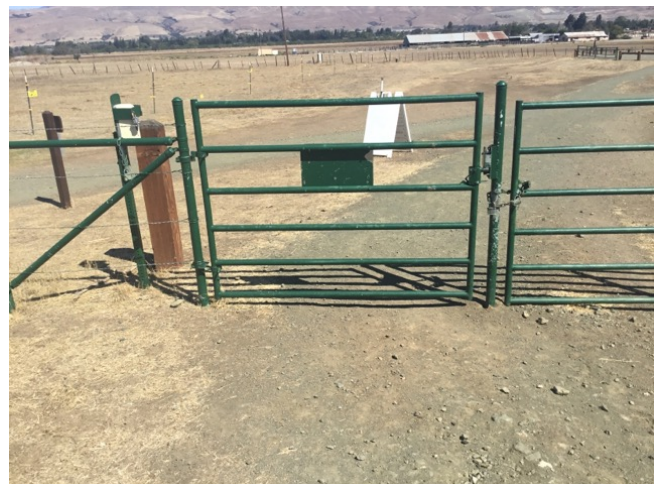
2308	<ul style="list-style-type: none"> <i>As-Built Description:</i> Surface of required maneuvering clearance at door slopes more than 1/4":12" (2.0%). <i>As-Built:</i> 11% <i>Proposed Solution:</i> Modify surface slope at door. 	PCODE ID11REF ADAAG 91 4.13.6 ADA 2010 404.2.4.4 CBC 2007 1133B.2.4 CBC 2019 11B-404.2.4	REF			
						Priority 1 Severity 3

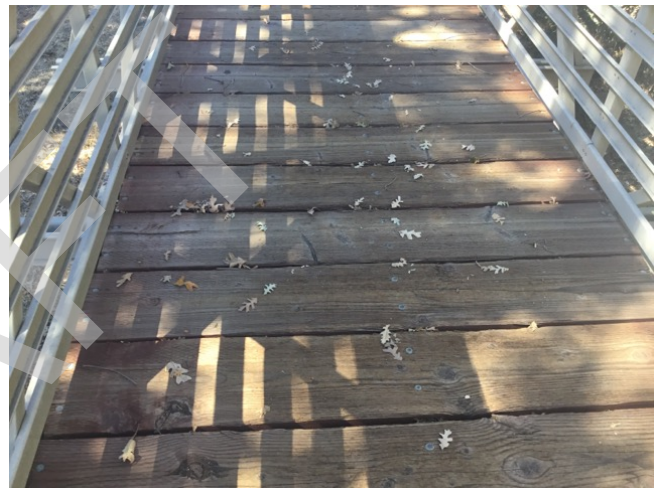
Item no., Rm no. and Name	Existing Architectural Barrier and Proposed Solution	Codes / Mitigation Info	Qty	Unit	Cost	Total
Floor or Ground Surface						
2305	<ul style="list-style-type: none"> • <i>As-Built Description:</i> Walk: Grating has grid openings greater than 1/2" along the line of traffic flow. • <i>Proposed Solution:</i> Relocate and add surface material. 	PCODE EF04 ADAAG 91 4.3.6; 4.5.4 ADA 2010 403.2; 302.3 CBC 2007 1133B.7.2 CBC 2019 11B-403.2; 11B-302.3	1	JOB	\$9,000	\$9,000
						Priority 1 Severity 3

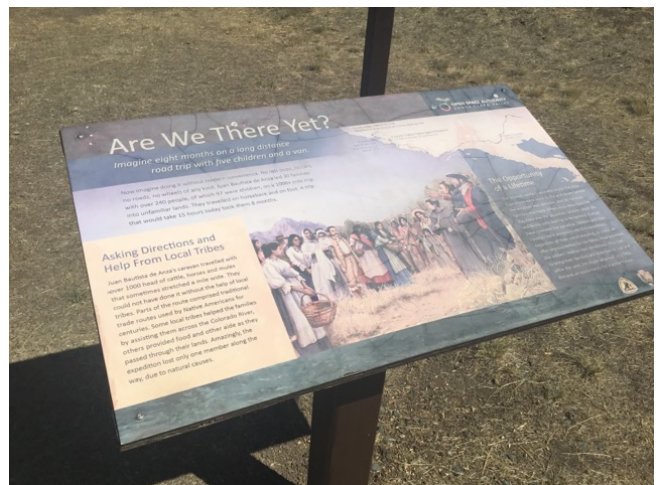
2298	<ul style="list-style-type: none"> As-Built Description: Sign characters not readable because they are not sized for viewing distance. .25" characters Proposed Solution: Provide compliant signage. 	PCODE SA02A ADAAG 91 4.30.3 ADA 2010 703.5.5 CBC 2007 1117B.5.4 CBC 2019 11B-403.3	1	JOB	\$3,000	\$3,000
Priority 1 Severity 3

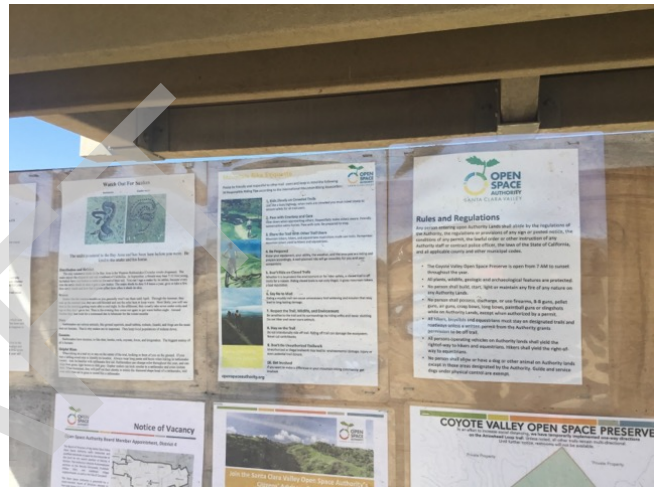
Item no., Rm no. and Name	Existing Architectural Barrier and Proposed Solution	Codes / Mitigation Info	Qty	Unit	Cost	Total
2299	<ul style="list-style-type: none"> As-Built Description: Sign characters not readable because they are not sized for viewing distance. .125" Proposed Solution: Provide compliant signage. 	PCODE SA02A ADAAG 91 4.30.3 ADA 2010 703.5.5 CBC 2007 1117B.5.4 CBC 2019 11B-403.3	1	JOB	\$4,500	\$4,500
Priority 1 Severity 3

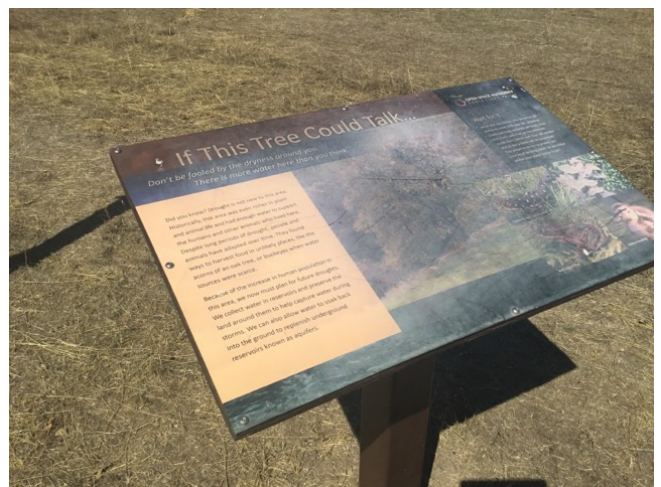
2301	<ul style="list-style-type: none"> As-Built Description: Sign characters not readable because they are not sized for viewing distance. .25" characters Proposed Solution: Provide compliant signage. 	PCODE SA02A ADAAG 91 4.30.3 ADA 2010 703.5.5 CBC 2007 1117B.5.4 CBC 2019 11B-305.2	1	JOB	\$3,000	\$3,000
Priority 1 Severity 3

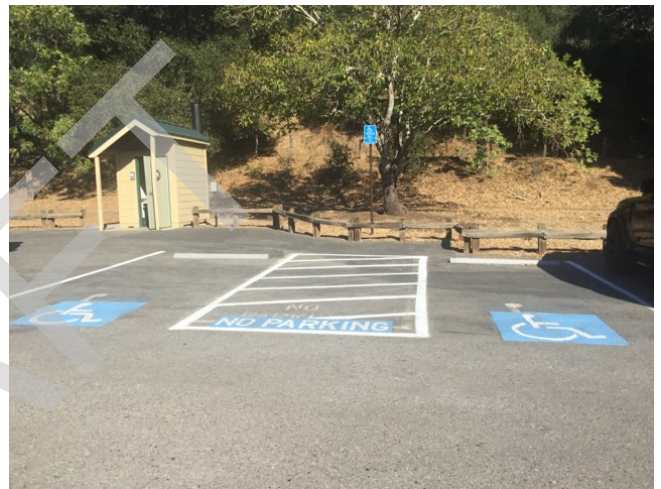
Item no., Rm no. and Name	Existing Architectural Barrier and Proposed Solution	Codes / Mitigation Info	Qty	Unit	Cost	Total
Floor or Ground Surfaces						
2311	<ul style="list-style-type: none"> As-Built Description: Accessible parking space has slope greater than 1/4":12" (2%). As-Built: To 4% Proposed Solution: Modify slope at accessible parking space. 	PCODE EA05 ADAAG 91 4.6.3 ADA 2010 502.4 CBC 2007 1129B.3.3 CBC 2019 11B-502.4	468	SF	\$36	\$16,848
						Priority 3 Severity 3

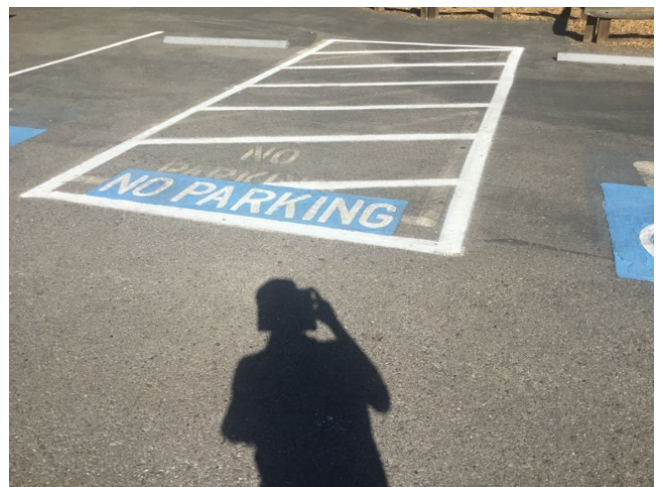
2314	<ul style="list-style-type: none"> As-Built Description: An accessible parking space shall be outlined or painted blue (required in CA only). Proposed Solution: Identify accessible parking space using blue markings. 	PCODE EA04K CBC 2019 11B-502.6	1	JOB	\$360	\$360
						Priority 3 Severity 3
