Facilities Access Compliance Survey Report for the Santa Clara Valley Open Space Authority

Santa Clara Valley Open Space Access Compliance Survey Report

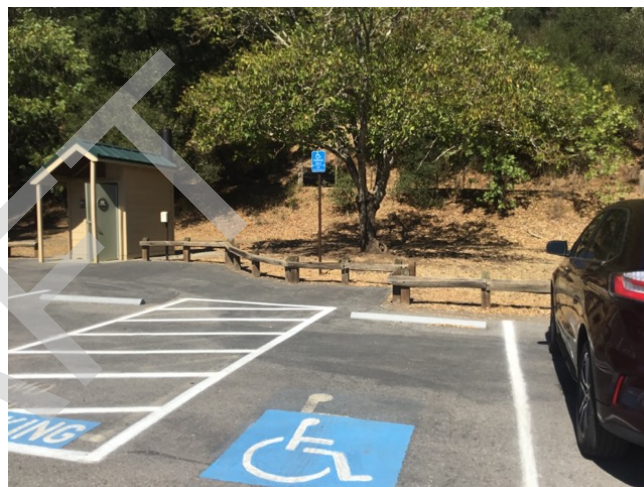
Item no., Rm no. and Name	Existing Architectural Barrier and Proposed Solution	Codes / Mitigation Info	Qty	Unit	Cost	Total
<u>Parking Signage</u>						
2345	<ul style="list-style-type: none"> • <i>As-Built Description:</i> No "Tow Away" sign at parking lot entrance (required in CA only). • <i>Proposed Solution:</i> Provide "Tow Away" sign at parking lot entrance when altering area. 	PCODE EA04C CBC 2007 1129B.4 CBC 2019 11B-502.8.2	1	JOB	\$975	\$975
						Priority 3 Severity 3

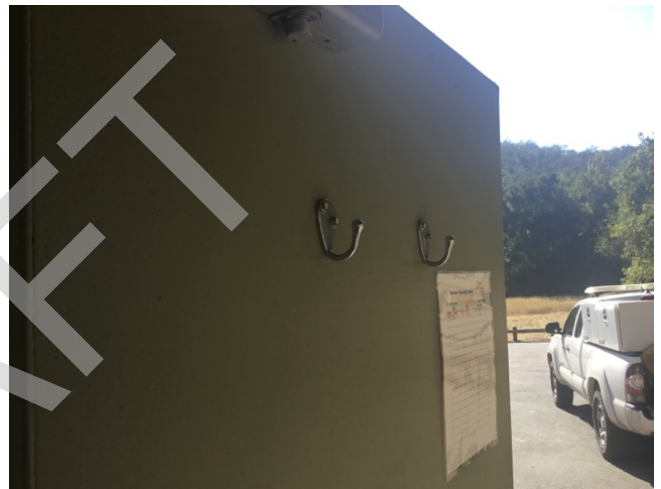
<i>Item no., Rm no. and Name</i>	<i>Existing Architectural Barrier and Proposed Solution</i>	<i>Codes / Mitigation Info</i>	<i>Qty</i>	<i>Unit</i>	<i>Cost</i>	<i>Total</i>
<u>Coat Hook</u>						
2322	<ul style="list-style-type: none"> • <i>As-Built Description:</i> Accessible coat hook not within reach range. • <i>As-Built:</i> 68" • <i>Proposed Solution:</i> Adjust existing or provide new coat hook at maximum 48" height. 	<i>PCODE</i> WG03A <i>ADAAG 91</i> 4.2.5 <i>ADA 2010</i> 603.4 <i>CBC 2007</i> 1118B.5 <i>CBC 2019</i> 11B-603.4	1	JOB	\$150	\$150
					Priority	2
					Severity	3

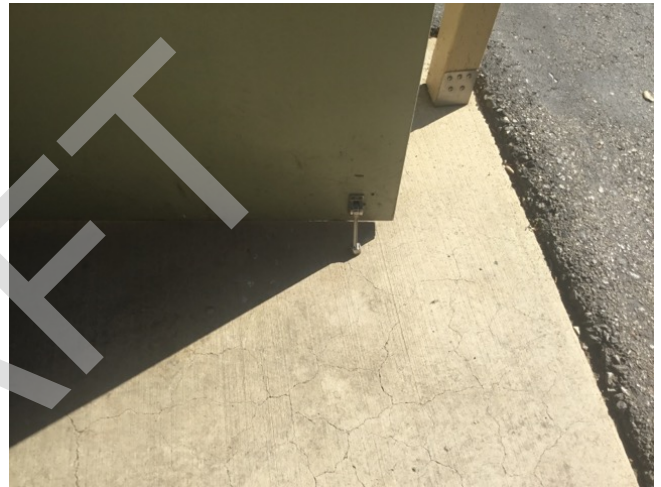
Item no., Rm no. and Name	Existing Architectural Barrier and Proposed Solution	Codes / Mitigation Info	Qty	Unit	Cost	Total
Reach Range						
2320	<ul style="list-style-type: none"> • <i>As-Built Description:</i> Reach height to control or access point, where side approach is available, exceeds 48" or is less than 15" in height, or exceeds 10" in depth. • <i>As-Built:</i> 5" • <i>Proposed Solution:</i> Relocate the door stop. 	PCODE IE02 ADAAG 91 4.2.6 ADA 2010 308.3.1 CBC 2007 1118B.6 CBC 2019 11B-308.3	1	JOB	\$300	\$300
					Priority	2
					Severity	3

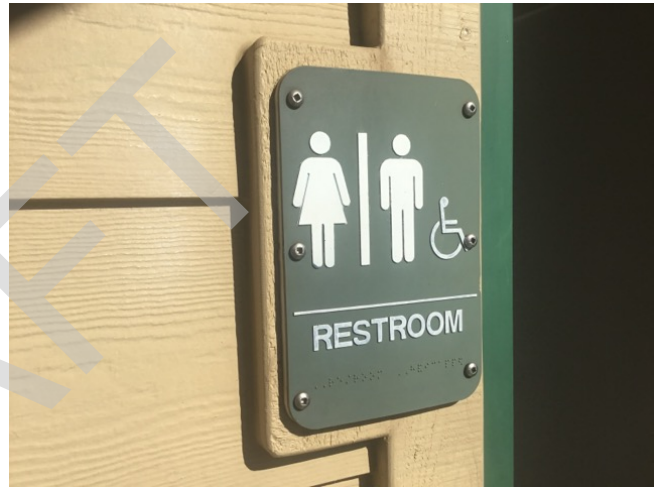
Item no., Rm no. and Name	Existing Architectural Barrier and Proposed Solution	Codes / Mitigation Info	Qty	Unit	Cost	Total
Signage						
2319	<ul style="list-style-type: none"> • <i>As-Built Description:</i> Sign characters are not sans serif, upper case, and/or raised 1/32" min. • <i>As-Built:</i> Spaces between tactile characters <1/16". Braille 3/4" from tactile characters. • <i>Proposed Solution:</i> Provide compliant signage. 	PCODE SA04 ADAAG 91 4.30.4 ADA 2010 703.2 CBC 2007 1117B.5.5 CBC 2019 11B-216.6	1	JOB	\$270	\$270
					Priority	2
					Severity	3

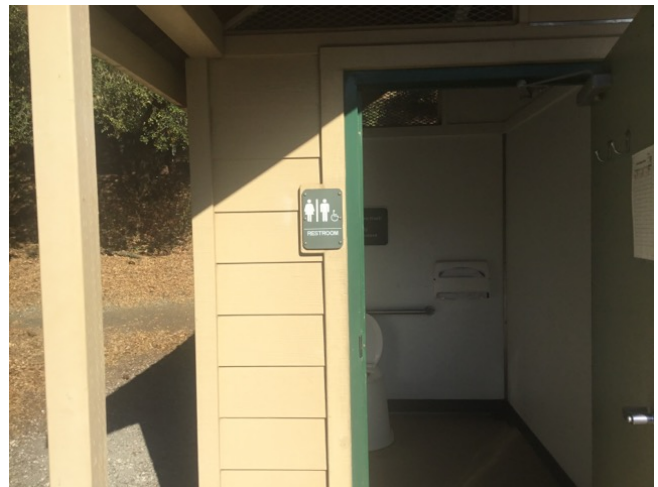
2318	<ul style="list-style-type: none"> • <i>As-Built Description:</i> Signs containing tactile characters is not located so that a clear floor space of 18" min x 18" min., centered on the tactile characters, is provided beyond the arc of any door swing between the closed position and 45 degree open position. • <i>As-Built:</i> 5.5" from door swing. • <i>Proposed Solution:</i> Relocate compliant signage on latch side of door located at compliant height with a clear floor space. 	PCODE SA07B ADA 2010 703.4.2 CBC 2019 11B-703.4.2	1	JOB	\$150	\$150
					Priority	2
					Severity	3

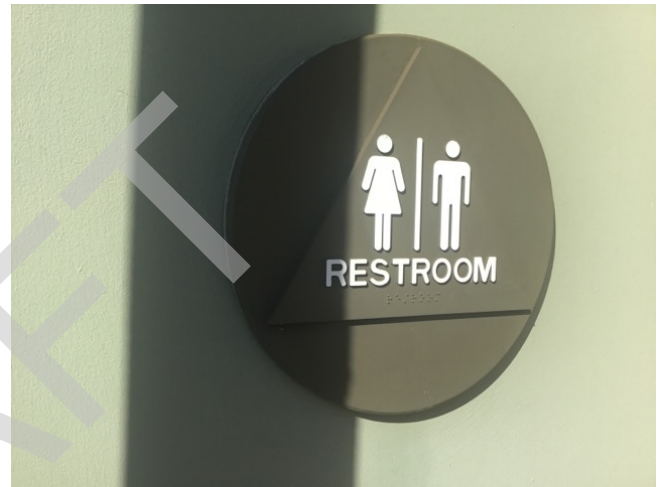
Item no., Rm no. and Name	Existing Architectural Barrier and Proposed Solution	Codes / Mitigation Info	Qty	Unit	Cost	Total
2316	<ul style="list-style-type: none"> • <i>As-Built Description:</i> Required in CA only: identification symbol centered 58" to 60" high on sanitary facility door that contrasts with the door not provided (women: 12" ø circle, men: 12" triangle, unisex: combined symbol). • <i>As-Built:</i> Triangle does not contrast from the circle. Not beveled or radiused. • <i>Proposed Solution:</i> Provide properly mounted sanitary facility symbol when altering area. If wheelchair accessible, include International Symbol of Accessibility on sign. 	PCODE SA15 CBC 2007 1115B.6 CBC 2019 11B-703.7.2.6	1	JOB	\$270	\$270

Priority 2
Severity 3

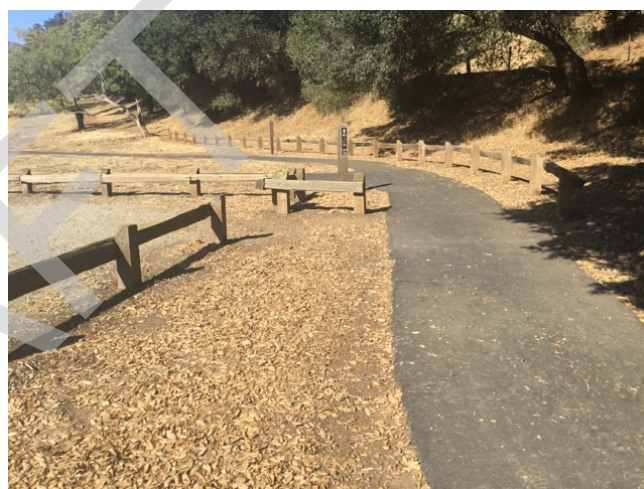
2328

Walk: Pavement dislocation creates abrupt change in level exceeding 1/2" in accessible route.

- *As-Built:* **To 2" where path meets soil.**

Priority **1****Severity** **1**

Remove, replace or repair area of pavement sufficient to correct abrupt change in level.

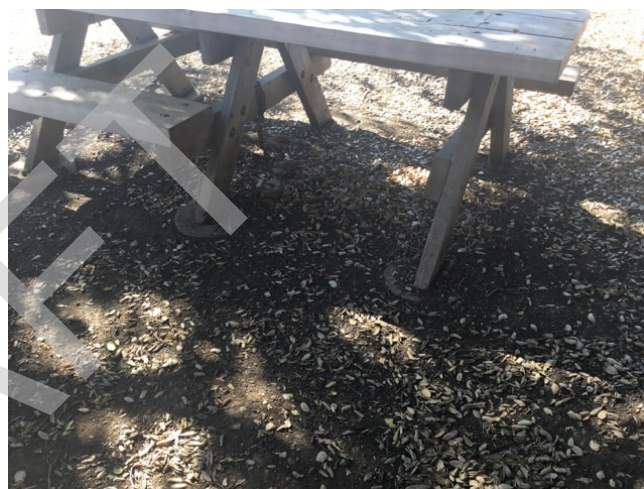
Item no., Rm no. and Name	Existing Architectural Barrier and Proposed Solution	Codes / Mitigation Info	Qty	Unit	Cost	Total
<u>Clear floor space</u>						
2331	<ul style="list-style-type: none"> As-Built Description: Clear space has slopes greater than 1:48. As-Built: 4% Proposed Solution: Modify surface. 	PCODE NI07 ADAAG 91 16.6.6 ADA 2010 305.2 CBC 2007 1132B.1 CBC 2019 11B-305.2	1	JOB		
					Priority	1
					Severity	3

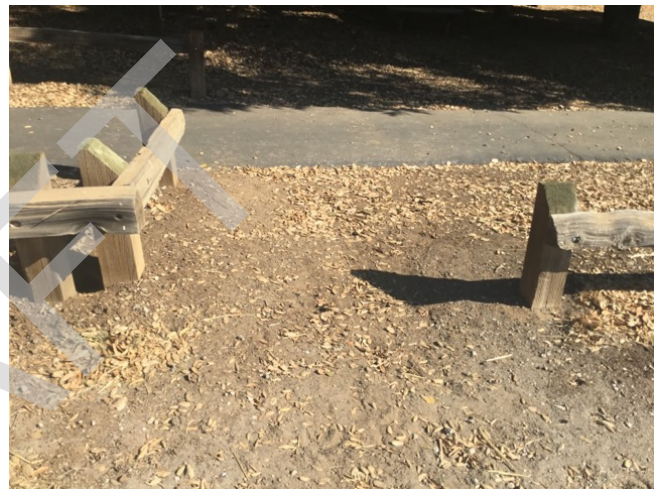
Item no., Rm no. and Name	Existing Architectural Barrier and Proposed Solution	Codes / Mitigation Info	Qty	Unit	Cost	Total
Cross Slope						
2329	<ul style="list-style-type: none"> As-Built Description: Cross slope more than 1":48" (2.083%). As-Built: 8% Proposed Solution: Modify cross slope. 	PCODE EF07 ADAAG 91 4.3.7 ADA 2010 403.3 CBC 2007 1133B.7.1.3 CBC 2019 11B-403.3	8	SF	\$75	\$600
						Priority 1 Severity 3

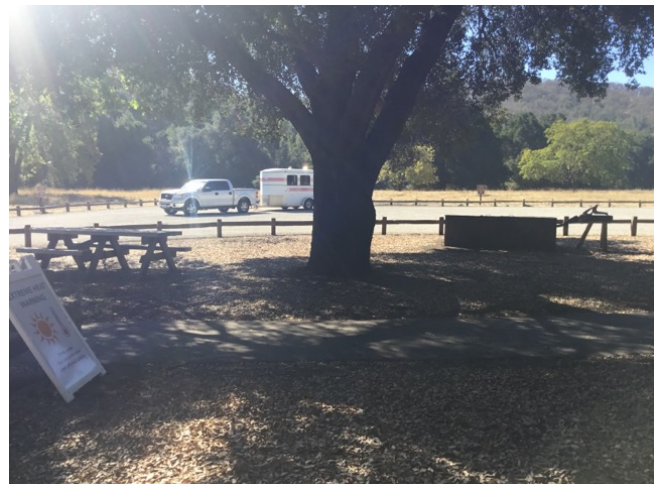
2332	<ul style="list-style-type: none"> As-Built Description: Cross slope more than 1":48" (2.083%). As-Built: 8% cross slope. Proposed Solution: Grade surface to and around the picnic table and saddle washer. Install firm surface. 	PCODE EF07 ADAAG 91 4.3.7 ADA 2010 403.3 CBC 2007 1133B.7.1.3 CBC 2019 11B-403.3	320	SF	\$75	\$24,000
						Priority 1 Severity 3

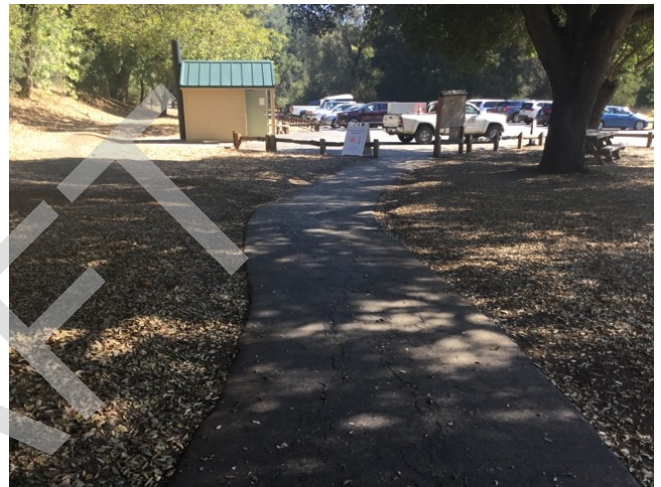
Item no., Rm no. and Name	Existing Architectural Barrier and Proposed Solution	Codes / Mitigation Info	Qty	Unit	Cost	Total
2335	<ul style="list-style-type: none"> As-Built Description: Cross slope more than 1":48" (2.083%). As-Built: 3.5% Proposed Solution: Modify cross slope. 	PCODE EF07 ADAAG 91 4.3.7 ADA 2010 403.3 CBC 2007 1133B.7.1.3 CBC 2019 11B-403.3	50	SF	\$75	\$3,750
						Priority 1 Severity 3

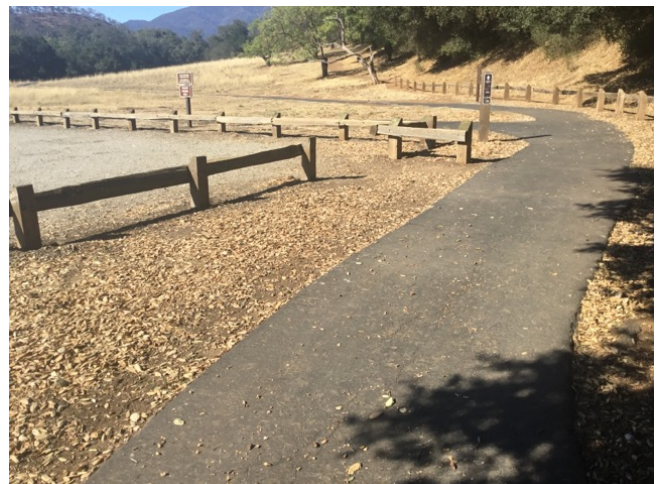
2327	<ul style="list-style-type: none"> As-Built Description: 36" wide band of truncated domes not provided at walkway or crossing adjoining a vehicular way, if surfaces are not separated by a curb, railing, or other element. Proposed Solution: Provide 36" wide, contrasting color, band of truncated domes between pedestrian and vehicular area. 	PCODE EG09 ADAAG 91 4.29.5 CBC 2007 1133B.8.5 CBC 2019 11B-705.1.2.5	10	LF	\$81	\$810
						Priority 1 Severity 1

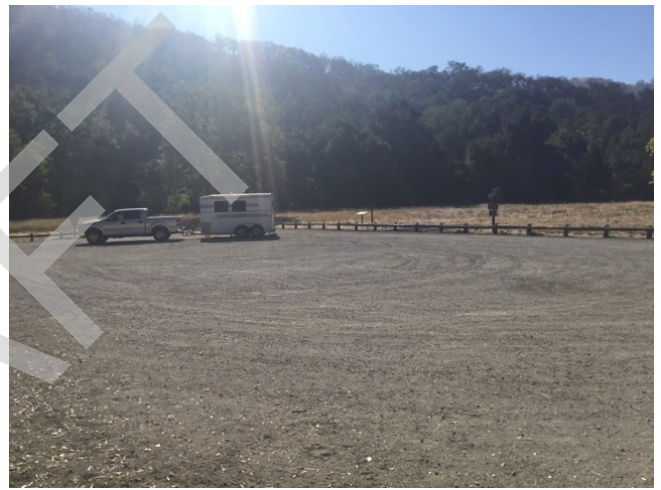
Item no., Rm no. and Name	Existing Architectural Barrier and Proposed Solution	Codes / Mitigation Info	Qty	Unit	Cost	Total
<u>Minimum Number</u>						
2330	<ul style="list-style-type: none"> • <i>As-Built Description:</i> At parking lot with 1-25 spaces, the number of accessible spaces is less than required by code; 1 space required • <i>Proposed Solution:</i> Provide required accessible parking space with sign including a minimum of one van space. 	PCODE EA01A ADAAG 91 4.1.2(5) ADA 2010 208.2 CBC 2007 Tbl. 11B-6 CBC 2019 11B-208.2 Tbl. 11B-208.2	1	JOB	\$9,000	\$9,000
						Priority 1 Severity 3

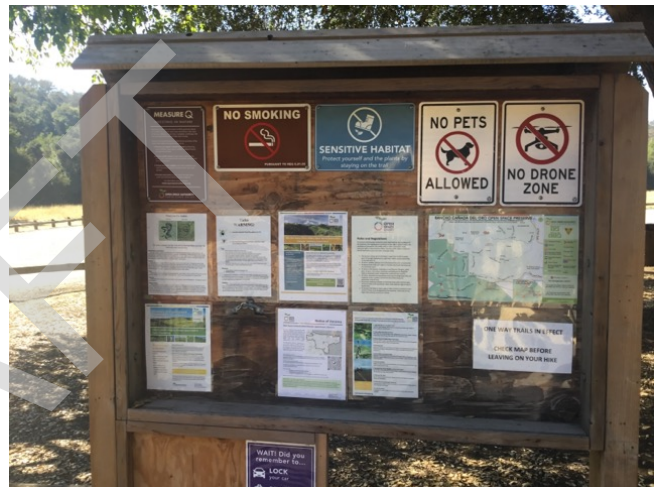
Item no., Rm no. and Name	Existing Architectural Barrier and Proposed Solution	Codes / Mitigation Info	Qty	Unit	Cost	Total
Signage						
2333	<ul style="list-style-type: none"> As-Built Description: Sign characters not readable because they are not sized for viewing distance. As-Built: 1/8" characters. Proposed Solution: Provide compliant signage. 	PCODE SA02A ADAAG 91 4.30.3 ADA 2010 703.5.5 CBC 2007 1117B.5.4 CBC 2019 11B-403.3	1	JOB	\$4,500	\$4,500
						Priority 1 Severity 3

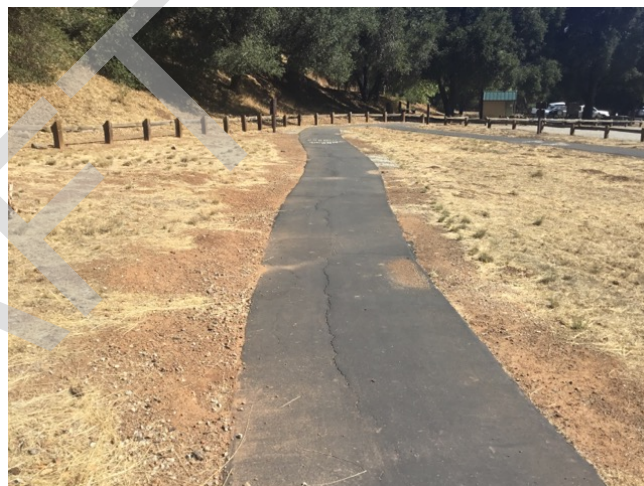
2334

Cross slope more than 1":48" (2.083%).

- *As-Built:* **3.5%**

Priority**1****Severity****3**

Modify cross slope.

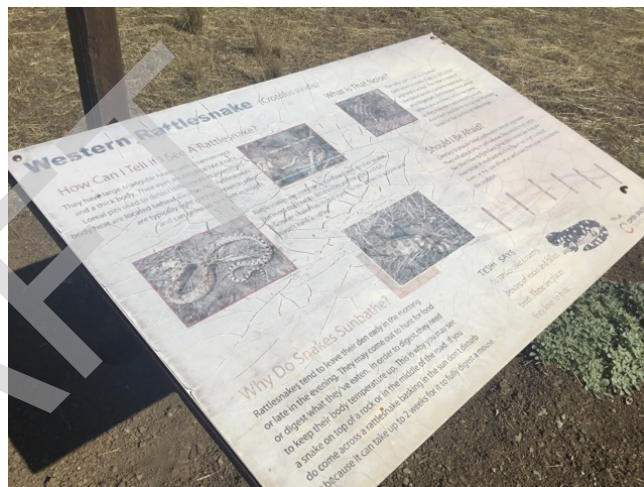
Item no., Rm no. and Name	Existing Architectural Barrier and Proposed Solution	Codes / Mitigation Info	Qty	Unit	Cost	Total
Signage						
2336	<ul style="list-style-type: none"> As-Built Description: Sign characters not readable because they are not sized for viewing distance. As-Built: 3/8" characters Proposed Solution: Provide compliant signage. 	PCODE SA02A ADAAG 91 4.30.3 ADA 2010 703.5.5 CBC 2007 1117B.5.4 CBC 2019 11B-403.3	1	JOB	\$2,400	\$2,400
Priority 1						
Severity 3

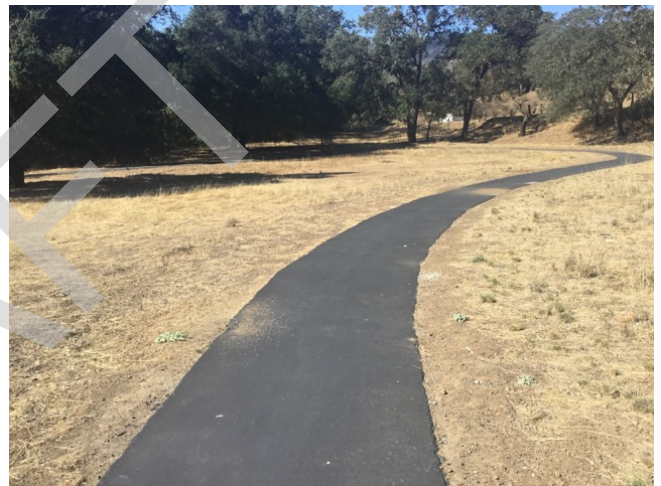
2337

Cross slope more than 1":48" (2.083%).

- *As-Built:* **To 4.2%**

Priority**1****Severity****3**

Modify cross slope.

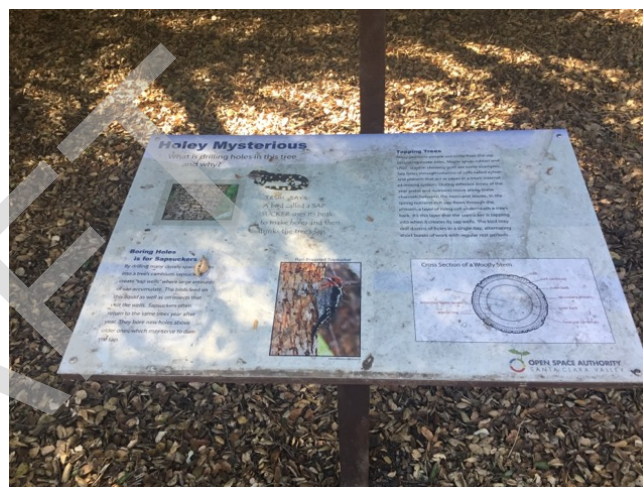
Item no., Rm no. and Name	Existing Architectural Barrier and Proposed Solution	Codes / Mitigation Info	Qty	Unit	Cost	Total
Signage						
2338	<ul style="list-style-type: none"> • <i>As-Built Description:</i> Sign characters not readable because they are not sized for viewing distance. • <i>As-Built:</i> 3/8" characters • <i>Proposed Solution:</i> Provide compliant signage. 	PCODE SA02A ADAAG 91 4.30.3 ADA 2010 703.5.5 CBC 2007 1117B.5.4 CBC 2019 11B-403.3	2	JOB	\$2,400	\$4,800
						Priority 1 Severity 3

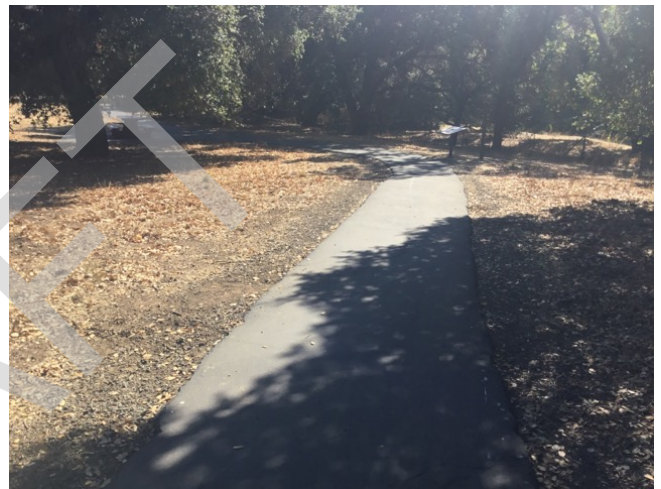
Item no., Rm no. and Name	Existing Architectural Barrier and Proposed Solution	Codes / Mitigation Info	Qty	Unit	Cost	Total
Walk						
2340	<ul style="list-style-type: none"> • <i>As-Built Description:</i> Walk: Slope greater than 1:20 (5.0%), and walk does not comply with requirements for ramps. • <i>As-Built:</i> 6.8% • <i>Proposed Solution:</i> Modify walk/sidewalk slope to 1:20 or less. 	PCODE EF01 ADAAG 91 4.3.7 ADA 2010 403.3 CBC 2007 1133B.7.3 CBC 2019 11B-403.3	100	SF	\$75	\$7,500
						Priority 1 Severity 3

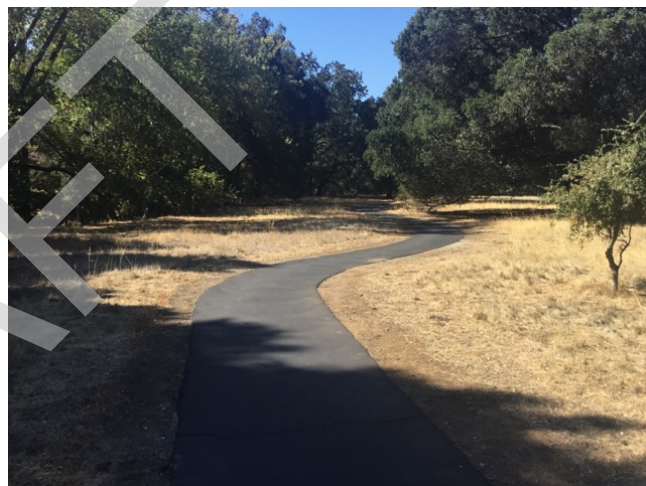
2341

Cross slope more than 1":48" (2.083%).

- *As-Built:* **3.1%**

Priority**1****Severity****3**

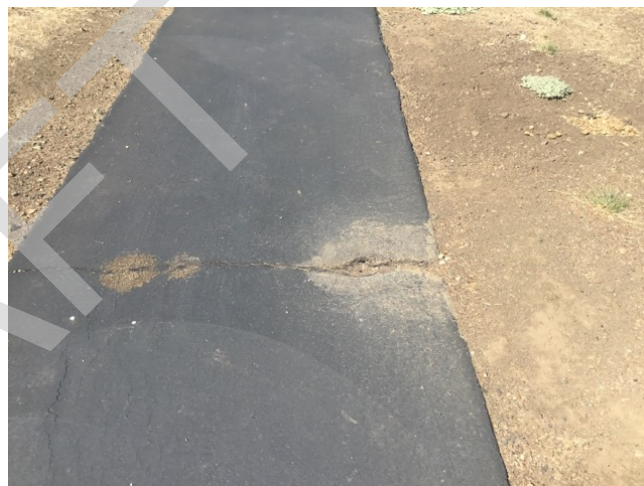
Priority **1****Severity** **1**

Remove, replace or repair area of pavement sufficient to correct abrupt change in level.

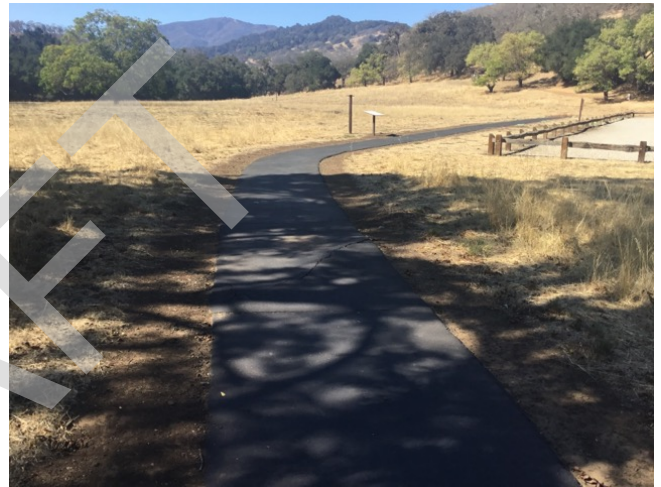
Item no., Rm no. and Name	Existing Architectural Barrier and Proposed Solution	Codes / Mitigation Info	Qty	Unit	Cost	Total
Cross Slope						
2342	<ul style="list-style-type: none"> As-Built Description: Cross slope more than 1":48" (2.083%). As-Built: To 6.8% Proposed Solution: Modify cross slope. 	PCODE EF07 ADAAG 91 4.3.7 ADA 2010 403.3 CBC 2007 1133B.7.1.3 CBC 2019 11B-403.3	20	SF	\$75	\$1,500
						Priority 1 Severity 3

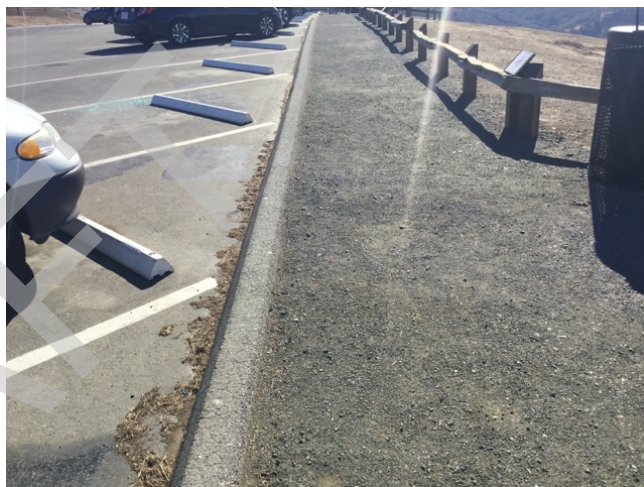
Item no., Rm no. and Name	Existing Architectural Barrier and Proposed Solution	Codes / Mitigation Info	Qty	Unit	Cost	Total
Cross Slope						
2270	<ul style="list-style-type: none"> As-Built Description: Cross slope more than 1":48" (2.083%). As-Built: To 4.4% Proposed Solution: Modify cross slope. Notes: Provide an accessible route to all elements including bike racks. 	PCODE EF07 ADAAG 91 4.3.7 ADA 2010 403.3 CBC 2007 1133B.7.1.3 CBC 2019 11B-403.3	1000	SF	\$75	\$75,000
						Priority 1 Severity 3

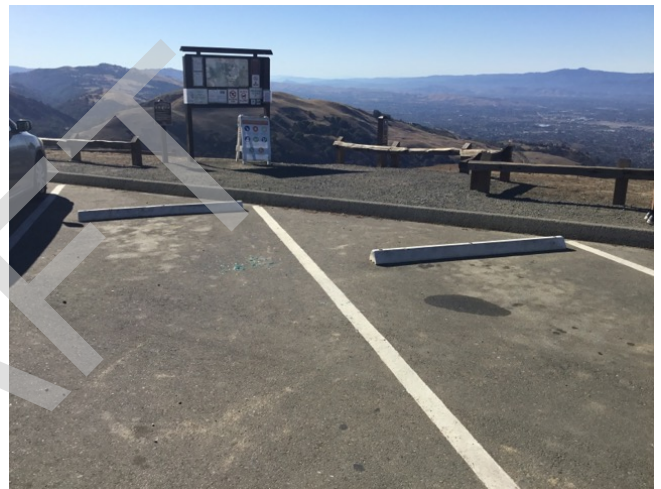
Item no., Rm no. and Name	Existing Architectural Barrier and Proposed Solution	Codes / Mitigation Info	Qty	Unit	Cost	Total
Curb Ramp						
2267	<ul style="list-style-type: none"> • <i>As-Built Description:</i> No curb ramp available where an accessible route crosses a curb. • <i>Proposed Solution:</i> Provide new curb ramp. 	PCODE EH01 ADAAG 91 4.7.1 ADA 2010 303.4 CBC 2007 1127B.5.1 CBC 2019 11B-402.2	1	JOB	\$7,500	\$7,500
						Priority 1 Severity 2

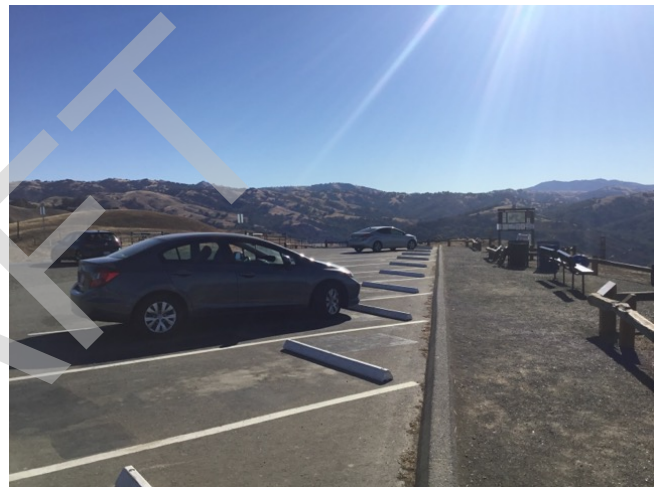
No parking spaces were found with slopes \leq 2.08%.

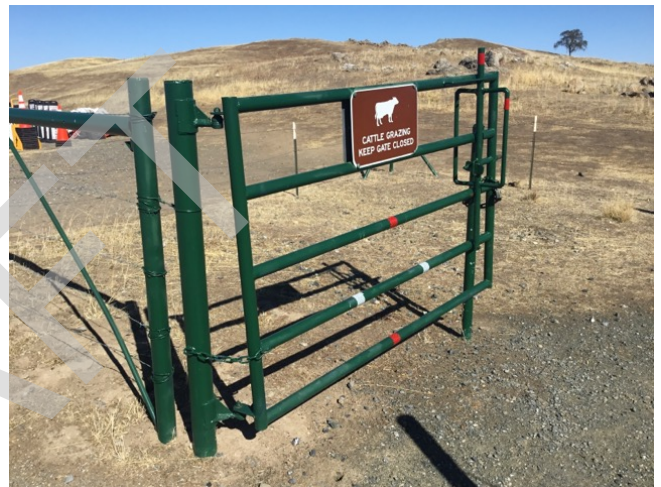
At push side of door on accessible route, bottom 10" does not have a smooth, uninterrupted surface.

The gate appears to be kept open during hours. Verify before altering.

Provide 10" min. "kick plate" covering width of door when altering area.

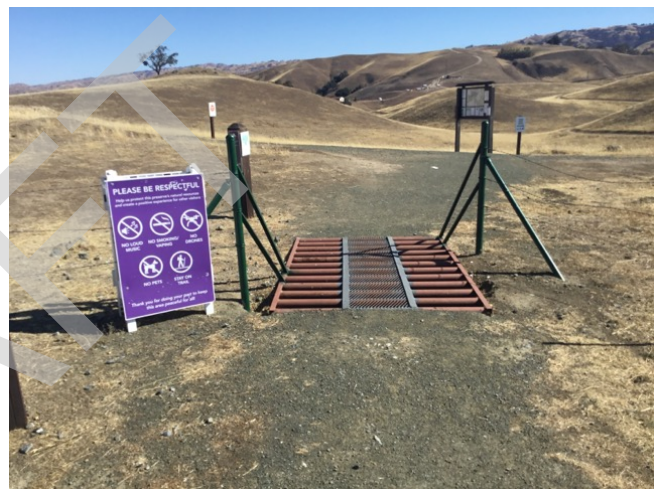
Item no., Rm no. and Name	Existing Architectural Barrier and Proposed Solution	Codes / Mitigation Info	Qty	Unit	Cost	Total
Floor or Ground Surface						
2274	<ul style="list-style-type: none"> • <i>As-Built Description:</i> Walk: Grating has grid openings greater than 1/2" along the line of traffic flow. • <i>As-Built:</i> 1.5"-5" • <i>Proposed Solution:</i> Provide gate and grate with .5" maximum openings. 	PCODE EF04 ADAAG 91 4.3.6; 4.5.4 ADA 2010 403.2; 302.3 CBC 2007 1133B.7.2 CBC 2019 11B-403.2; 11B-302.3	30	SF	\$240	\$7,200
						Priority 1
						Severity 1

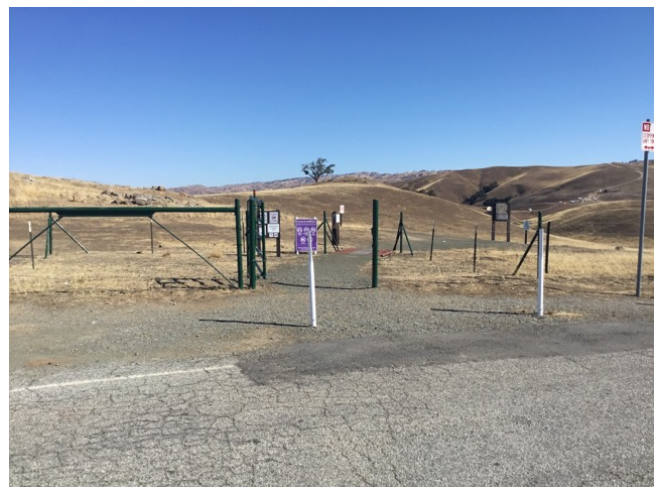
There is no parking provided on this side of the road and no accessible route from the parking to this trailhead.

- 2272
- *As-Built Description:*
Refer to notes for observation and recommendation.
 - *Proposed Solution:*
Consider providing accessible parking here and/or installing an accessible route from the existing parking lot.
 - **Notes:**

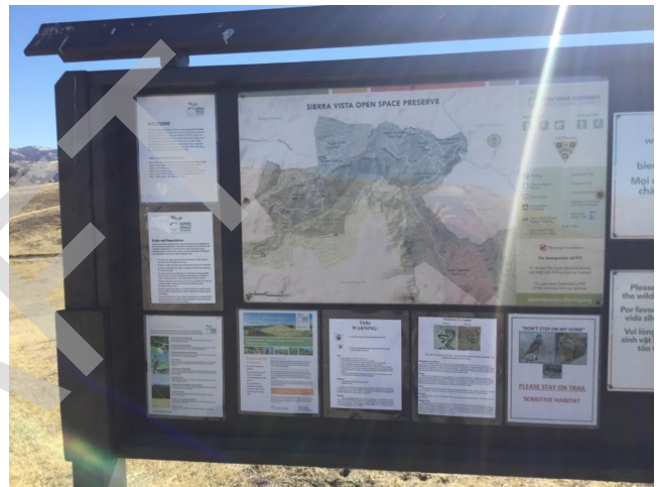
Item no., Rm no. and Name	Existing Architectural Barrier and Proposed Solution	Codes / Mitigation Info	Qty	Unit	Cost	Total
Signage						
2276	<ul style="list-style-type: none"> As-Built Description: Sign characters not readable because they are not sized for viewing distance. As-Built: 1/8"-3/8" characters. Proposed Solution: Provide compliant signage. 	PCODE SA02A ADAAG 91 4.30.3 ADA 2010 703.5.5 CBC 2007 1117B.5.4 CBC 2019 11B-403.3	1	JOB	\$4,500	\$4,500
						Priority 3 Severity 3

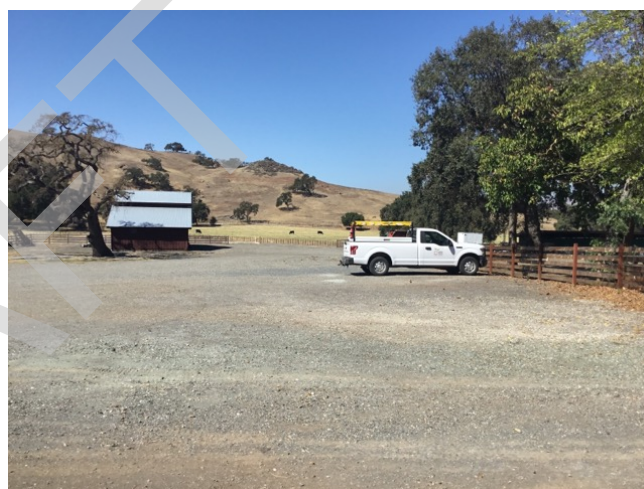
No walk / sidewalk provided to connect accessible facilities or elements that are on the same site.

• **Notes:****Coordinate accessible routes with parking design. Currently no stable, firm surfaces on site.**

Provide new 48" wide walk / sidewalk.

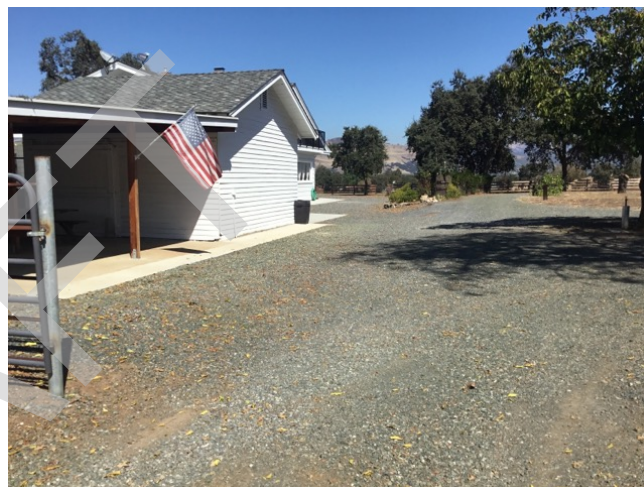
This condition occurs throughout the site.

Provide 36" wide, contrasting color, band of truncated domes between pedestrian and vehicular area.

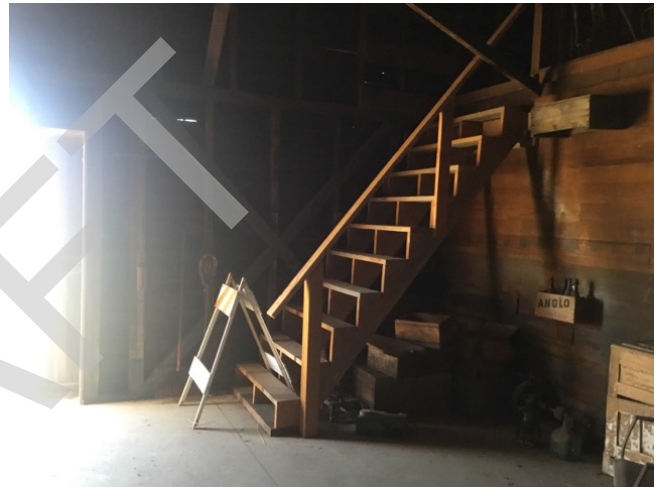
<i>Item no., Rm no. and Name</i>	<i>Existing Architectural Barrier and Proposed Solution</i>	<i>Codes / Mitigation Info</i>	<i>Qty</i>	<i>Unit</i>	<i>Cost</i>	<i>Total</i>
<u>Stairways</u>						
2349	<ul style="list-style-type: none"> • <i>As-Built Description:</i> Exterior stair substantially out of compliance. • <i>Proposed Solution:</i> Provide complete new stair, 4 ft. wide with landing and handrails. 	PCODE EC09 ADAAG 91 4.9 ADA 2010 504 CBC 2007 1133B.4 CBC 2019 11B-504	150	IN	\$270	\$40,500
						Priority 1
						Severity 2
NA if this remains a maintenance facility.

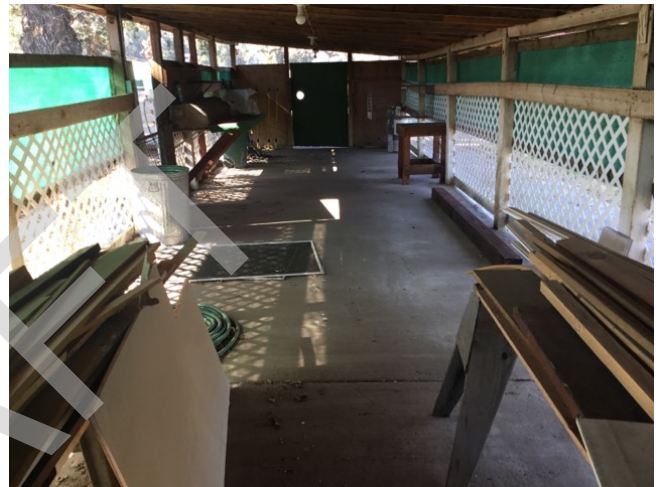
Item no., Rm no. and Name	Existing Architectural Barrier and Proposed Solution	Codes / Mitigation Info	Qty	Unit	Cost	Total
2357	<ul style="list-style-type: none"> • <i>As-Built Description:</i> Cross slope more than 1":48" (2.083%). • <i>As-Built:</i> 5.2% • <i>Proposed Solution:</i> Modify cross slope. • <i>Notes:</i> See exceptions for animal containment areas. 	PCODE EF07 ADAAG 91 4.3.7 ADA 2010 403.3 CBC 2007 1133B.7.1.3 CBC 2019 11B-403.3	500	SF	\$75	\$37,500
						Priority 1
						Severity 2

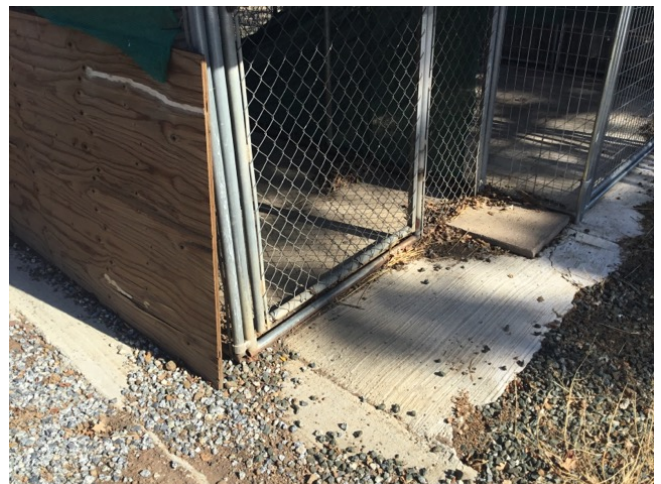
2356	<ul style="list-style-type: none"> • <i>As-Built Description:</i> At push side of door on accessible route, bottom 10" does not have a smooth, uninterrupted surface. • <i>Proposed Solution:</i> Provide 10" min. "kick plate" covering width of door when altering area. • <i>Notes:</i> This element complies with Safe Harbor if altered or constructed before March 15, 2012. See exceptions for animal containment areas. However accessibility should be provided if the public is provided access. 	PCODE ID06 ADA 2010 404.2.10 CBC 2007 1133B.2.6 CBC 2019 11B-404.2.10	1	JOB	\$300	\$300
						Priority 1
						Severity 3

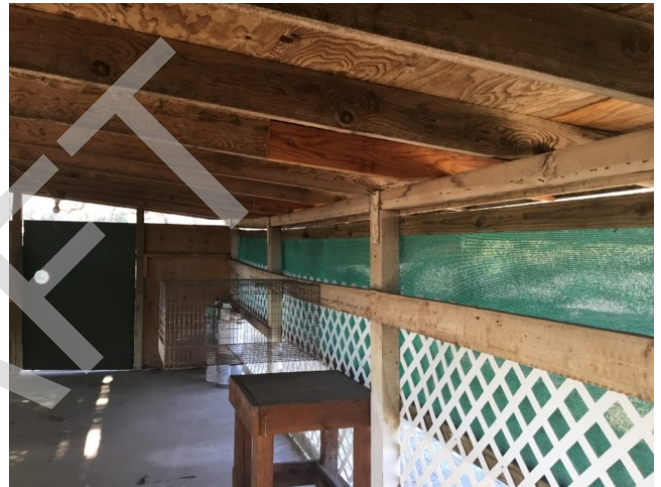
2350	<ul style="list-style-type: none"> • <i>As-Built Description:</i> Overhead clearance less than 80" above finished floor. • <i>As-Built:</i> 76" at ceiling. 70" at light bulbs. • <i>Proposed Solution:</i> Alter ceiling to be 80" minimum AFF. Recess lights. • <i>Notes:</i> See exceptions for animal containment areas. Consider modifications for safety . 	PCODE EG01A ADAAG 91 4.4.2 ADA 2010 307.4 CBC 2007 1133B.8.6.2 CBC 2019 11B-307.4	1	JOB	\$18,000	\$18,000
Priority 1						
Severity 1

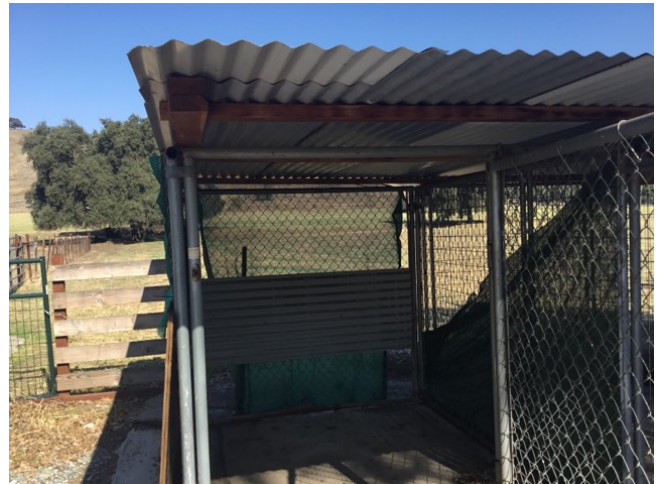
2353	<ul style="list-style-type: none"> • <i>As-Built Description:</i> Overhead clearance less than 80" above finished floor. • <i>As-Built:</i> 72" • <i>Proposed Solution:</i> Alter ceiling. • <i>Notes:</i> See exceptions for animal containment areas. Consider modifications for safety . 	PCODE EG01AREF ADAAG 91 4.4.2 ADA 2010 307.4 CBC 2007 1133B.8.6.2 CBC 2019 11B-307.4	REF			
Priority 1						
Severity 1

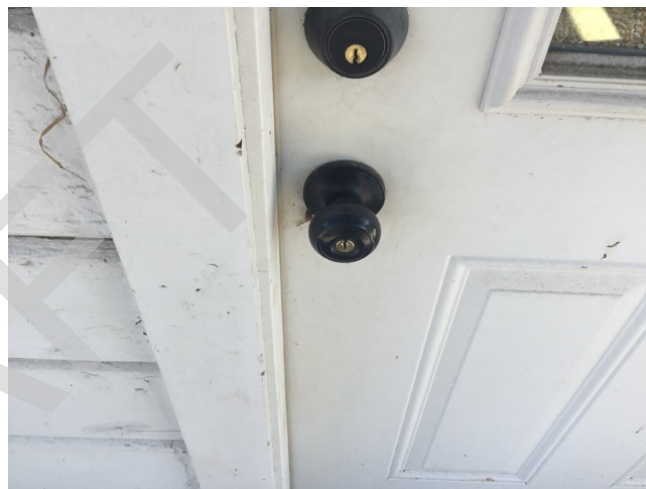
<i>Item no., Rm no. and Name</i>	<i>Existing Architectural Barrier and Proposed Solution</i>	<i>Codes / Mitigation Info</i>	<i>Qty</i>	<i>Unit</i>	<i>Cost</i>	<i>Total</i>
<u>Door Hardware</u>						
2358	<ul style="list-style-type: none"> • <i>As-Built Description:</i> Door does not have accessible operating hardware. • <i>Proposed Solution:</i> Provide lever handle or other accessible hardware. 	<i>PCODE ID07</i> <i>ADAAG 91 4.13.9</i> <i>ADA 2010 404.2.7</i> <i>CBC 2007 1133B.2.5.2</i> <i>CBC 2019 11B-404.2.7</i>	2	JOB	\$750	\$1,500
						Priority 1 Severity 3

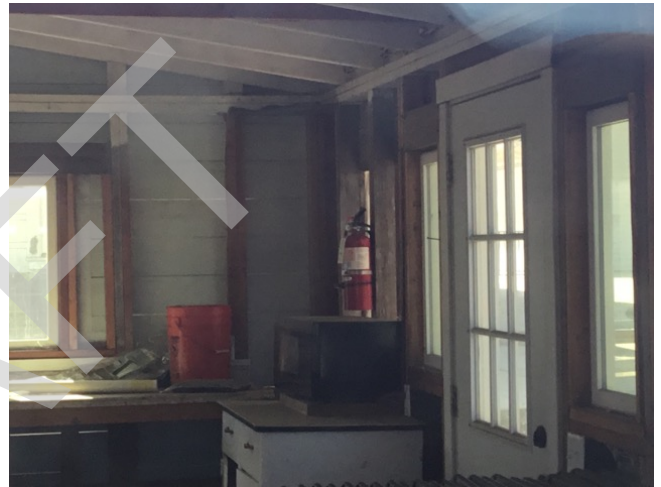
Item no., Rm no. and Name	Existing Architectural Barrier and Proposed Solution	Codes / Mitigation Info	Qty	Unit	Cost	Total
Reach Range						
2364	<ul style="list-style-type: none"> • <i>As-Built Description:</i> Reach height to control or access point, where side approach is available, exceeds 48" or is less than 15" in height, or exceeds 10" in depth. • <i>As-Built:</i> Fire extinguisher 65" AFF. • <i>Proposed Solution:</i> Modify equipment or mounting. 	PCODE IE02 ADAAG 91 4.2.6 ADA 2010 308.3.1 CBC 2007 1118B.6 CBC 2019 11B-308.3	1	JOB	\$300	\$300
						Priority 1 Severity 3

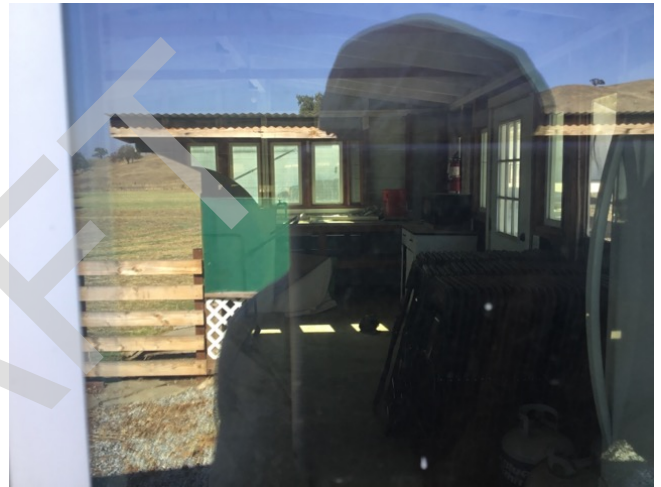
Item no., Rm no. and Name	Existing Architectural Barrier and Proposed Solution	Codes / Mitigation Info	Qty	Unit	Cost	Total
Sink						
2366	<ul style="list-style-type: none"> • <i>As-Built Description:</i> Sink rim higher than 34" above floor. • <i>As-Built:</i> 37" • <i>Proposed Solution:</i> Remodel sink cabinet to lower sink. • <i>Notes:</i> No access at time of survey. Approximation. 	PCODE IN06 ADAAG 91 4.24.2 ADA 2010 606.3 CBC 2007 1115B.4.7.1 CBC 2019 11B-606.3	1	JOB	\$5,250	\$5,250
						Priority 3 Severity 3

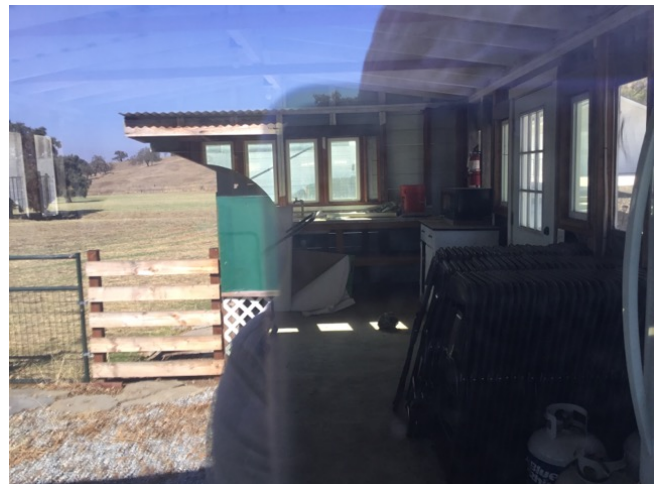
2367	<ul style="list-style-type: none"> • <i>As-Built Description:</i> Sink does not have knee space min. 27" high x 19" deep x 30" wide. • <i>Proposed Solution:</i> Remodel sink cabinet. 	PCODE IN06A ADAAG 91 4.24.3 ADA 2010 606.2 CBC 2007 1115B.4.7.1 CBC 2019 11B-606.2	1	JOB	\$5,250	\$5,250
						Priority 3 Severity 3

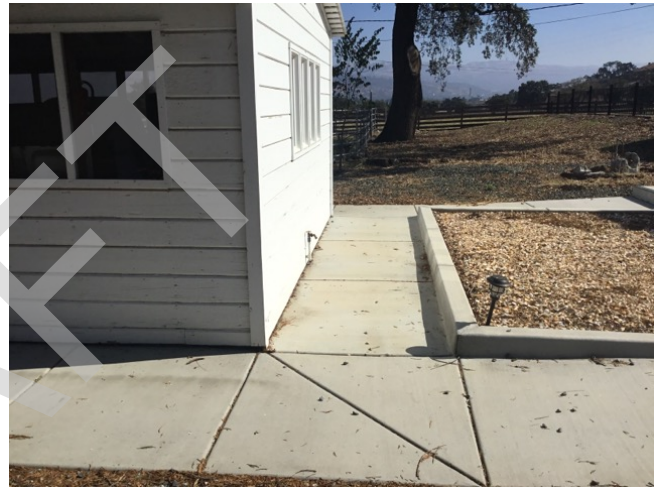
Item no., Rm no. and Name	Existing Architectural Barrier and Proposed Solution	Codes / Mitigation Info	Qty	Unit	Cost	Total
Walk						
2361	<ul style="list-style-type: none"> As-Built Description: Walk more than 36" but less than 48" wide (required in CA only). As-Built: 46" Proposed Solution: Enlarge width of walk to 48". 	PCODE EF08 CBC 2007 1133B.7.1 CBC 2019 11B-403.5.1.3	20	SF	\$135	\$2,700
						Priority 1 Severity 3

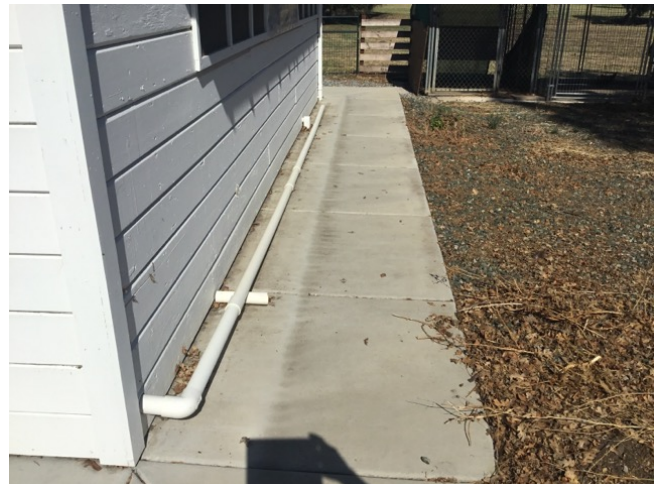
2362	<ul style="list-style-type: none"> As-Built Description: Walk more than 36" but less than 48" wide (required in CA only). As-Built: 39" to pipe 46" to wall. Proposed Solution: Enlarge width of walk to 48". 	PCODE EF08 CBC 2007 1133B.7.1 CBC 2019 11B-403.5.1.3	20	SF	\$135	\$2,700
						Priority 1 Severity 3

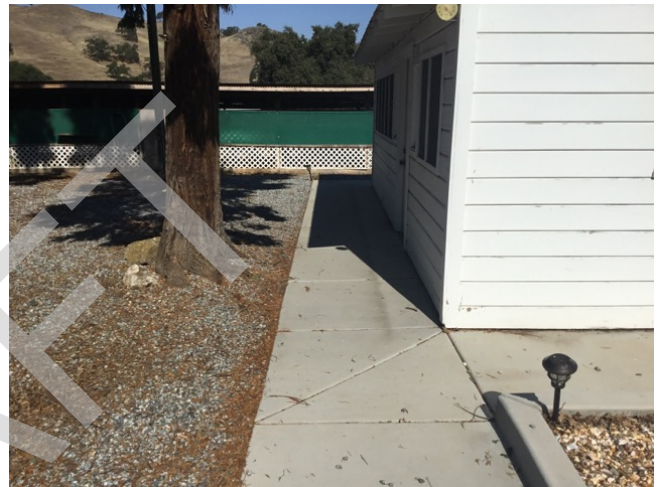
Item no., Rm no. and Name	Existing Architectural Barrier and Proposed Solution	Codes / Mitigation Info	Qty	Unit	Cost	Total
2359	<ul style="list-style-type: none"> • <i>As-Built Description:</i> Walk more than 36" but less than 48" wide (required in CA only). • <i>As-Built:</i> 47" • <i>Proposed Solution:</i> Enlarge width of walk to 48". 	PCODE EF08REF ADA 2010 403.5 CBC 2007 1133B.7.1 CBC 2019 11B-403.5.1.3		REF		
						Priority 1 Severity 3

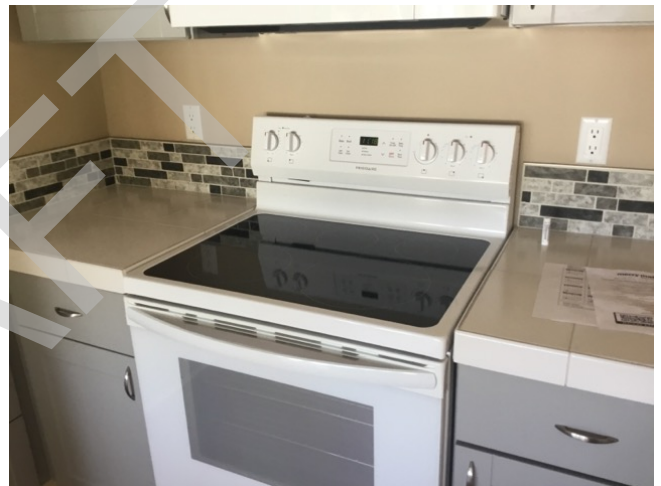
2370

Cooktop controls require reaching across the burners.

Provide cooktop with accessible controls.

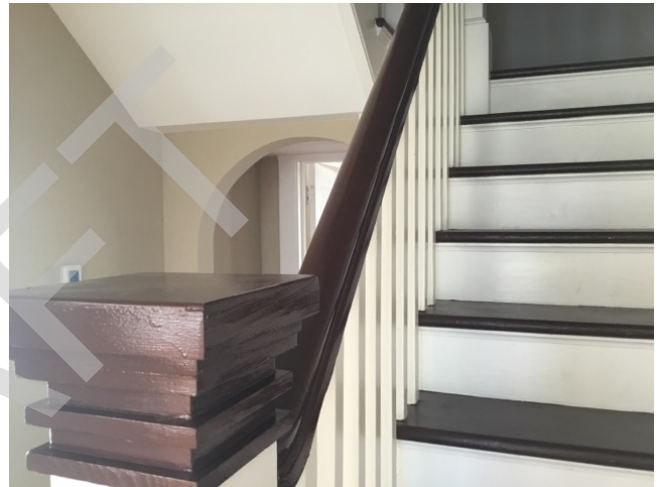
Item no., Rm no. and Name	Existing Architectural Barrier and Proposed Solution	Codes / Mitigation Info	Qty	Unit	Cost	Total
<u>Cross Section</u>						
2389	<ul style="list-style-type: none"> • <i>As-Built Description:</i> Non-circular cross-section: Perimeter dimension shall be between 4 inches and 6-1/4 inches. • <i>Proposed Solution:</i> Provide new handrail. • Notes: Handrail perimeter 12" 	<i>PCODE</i> ED16 <i>ADA 2010</i> 505.7.2 <i>CBC 2007</i> 1133B.4.2.6 <i>CBC 2019</i> 11B-505.7.2	20	LF	\$225	\$4,500
						Priority 3 Severity 3

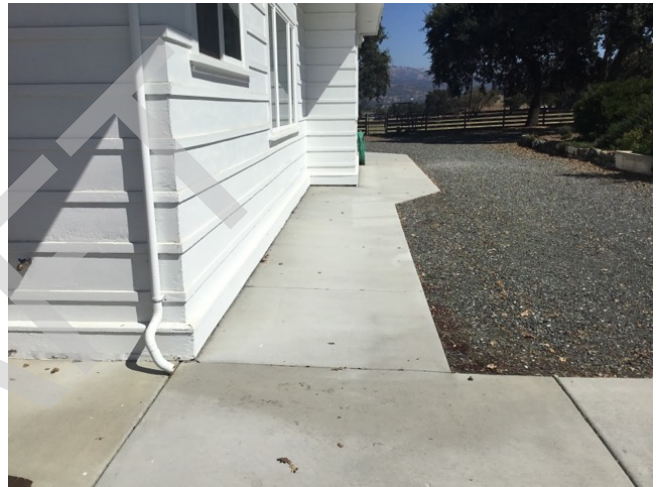
Item no., Rm no. and Name	Existing Architectural Barrier and Proposed Solution	Codes / Mitigation Info	Qty	Unit	Cost	Total
Cross Slope						
2409	<ul style="list-style-type: none"> As-Built Description: Cross slope more than 1":48" (2.083%). As-Built: 3.1% Proposed Solution: Modify cross slope. 	PCODE EF07 ADAAG 91 4.3.7 ADA 2010 403.3 CBC 2007 1133B.7.1.3 CBC 2019 11B-403.3	120	SF	\$75	\$9,000
						Priority 1 Severity 3

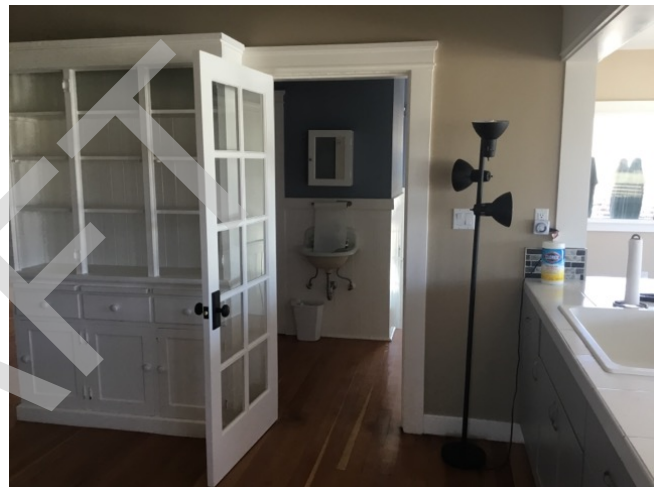
2372	<ul style="list-style-type: none"> • <i>As-Built Description:</i> Door on accessible route has less than 32" clear and 80" (78" min. to closer if provided) opening width when 90° open. • <i>As-Built:</i> 27"-30" wide • <i>Proposed Solution:</i> Provide new, larger door and frame with new accessible hardware. • <i>Notes:</i> Occurs throughout. 	PCODE ID01 ADAAG 91 4.13.5 ADA 2010 404.2.3 CBC 2007 1133B.1.1.1.1 CBC 2019 11B-404.2.3	10	JOB	\$7,800	\$78,000
Priority 1						
Severity 3

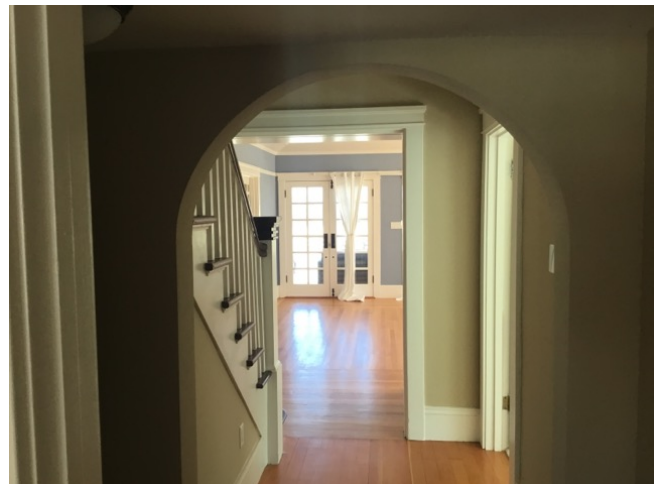
2390	<ul style="list-style-type: none"> • <i>As-Built Description:</i> Door on accessible route has less than 32" clear and 80" (78" min. to closer if provided) opening width when 90° open. • <i>As-Built:</i> 71" high at 32" wide • <i>Proposed Solution:</i> Provide new, larger door and frame with new accessible hardware. • <i>Notes:</i> Occurs at arched doorway. 	PCODE ID01 ADAAG 91 4.13.5 ADA 2010 404.2.3 CBC 2007 1133B.1.1.1.1 CBC 2019 11B-404.2.3	1	JOB	\$7,800	\$7,800
Priority 1						
Severity 3

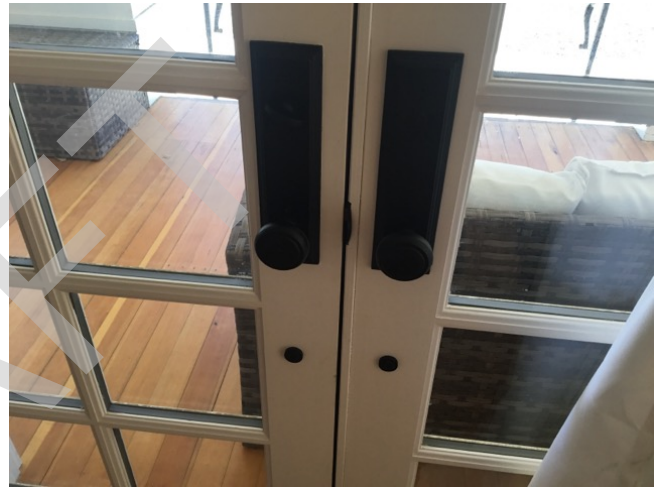
Item no., Rm no. and Name	Existing Architectural Barrier and Proposed Solution	Codes / Mitigation Info	Qty	Unit	Cost	Total
<u>Door Hardware</u>						
2375	<ul style="list-style-type: none"> • <i>As-Built Description:</i> Door does not have accessible operating hardware. • <i>Proposed Solution:</i> Provide lever handle or other accessible hardware. 	PCODE ID07 ADAAG 91 4.13.9 ADA 2010 404.2.7 CBC 2007 1133B.2.5.2 CBC 2019 11B-404.2.7	22	JOB	\$750	\$16,500
						Priority 1
						Severity 3

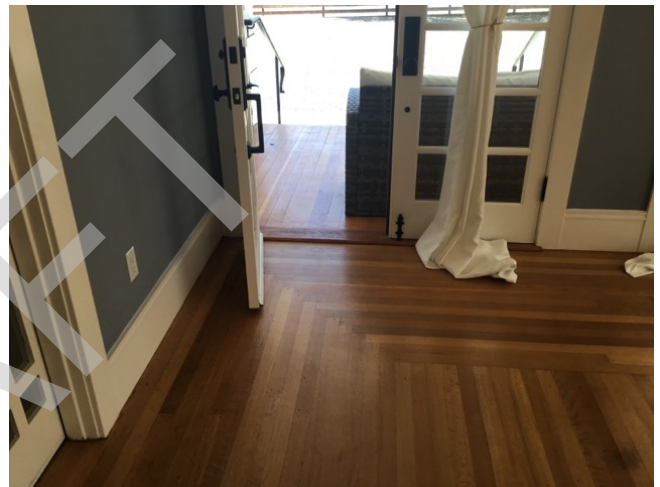
Item no., Rm no. and Name	Existing Architectural Barrier and Proposed Solution	Codes / Mitigation Info	Qty	Unit	Cost	Total
Door Threshold						
2376	<ul style="list-style-type: none"> • <i>As-Built Description:</i> Door inaccessible due to threshold or step at door exceeding 1/2". • <i>As-Built:</i> 1" • <i>Proposed Solution:</i> Modify threshold. 	PCODE ID02A ADAAG 91 4.13.8 ADA 2010 404.2.5 CBC 2007 1133B.2.4.1 CBC 2019 11B-404.2.5	8	JOB	\$1,200	\$9,600
						Priority 1 Severity 1

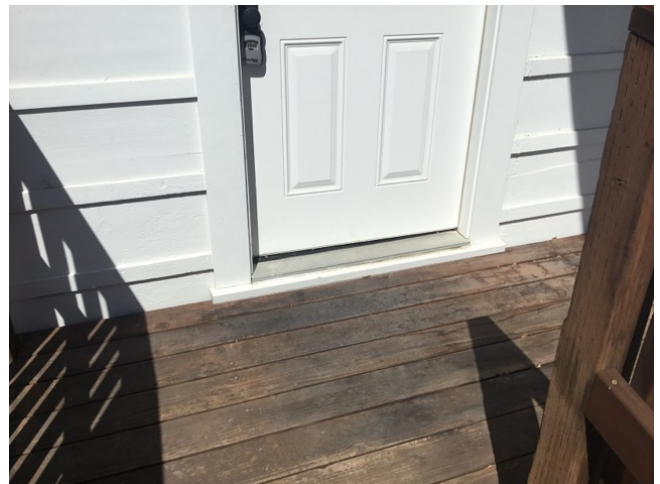
2411	<ul style="list-style-type: none"> • <i>As-Built Description:</i> Door inaccessible due to threshold or step at door exceeding 1/2". • <i>As-Built:</i> 2.5" • <i>Proposed Solution:</i> Modify threshold when providing access with ramps or other accessible routes. 	PCODE ID02A ADAAG 91 4.13.8 ADA 2010 404.2.5 CBC 2007 1133B.2.4.1 CBC 2019 11B-404.2.5	2	JOB	\$1,200	\$2,400
						Priority 1 Severity 1
