Facilities Access Compliance Survey Report for the Santa Clara Valley Open Space Authority

Santa Clara Valley Open Space Access Compliance Survey Report

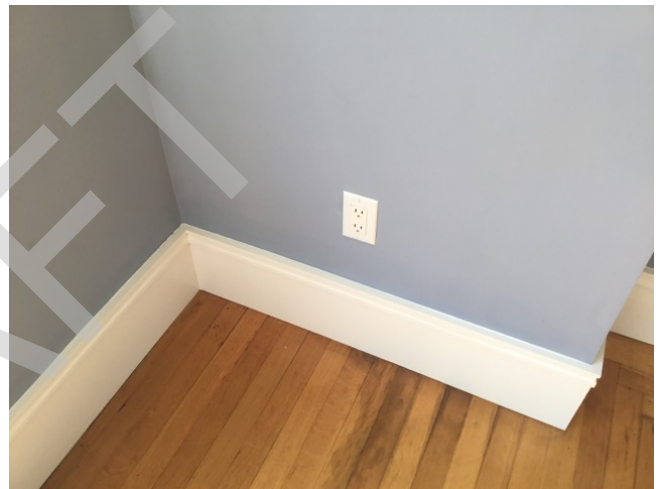
2373	<ul style="list-style-type: none"> • <i>As-Built Description:</i> Electric switch or control mounted less than 15" measured to the bottom of the outlet box or greater than 48 inches measured to the top of the outlet box. • <i>As-Built:</i> 14" to the bottom of the box. • <i>Proposed Solution:</i> Relocate light switches or control to between 15" and 48" height. • <i>Notes:</i> Includes upstairs. It appears the house was recently remodeled. Verify whether safe harbor applies. 	PCODE IC01 ADAAG 91 4.2.5 & 6 ADA 2010 308.2.1 & CBC 2007 1117B.6.3 CBC 2019 11B-308.2.1 & 11B-308.2.2	14	JOB	\$900	\$12,600
Priority 3						
Severity 3

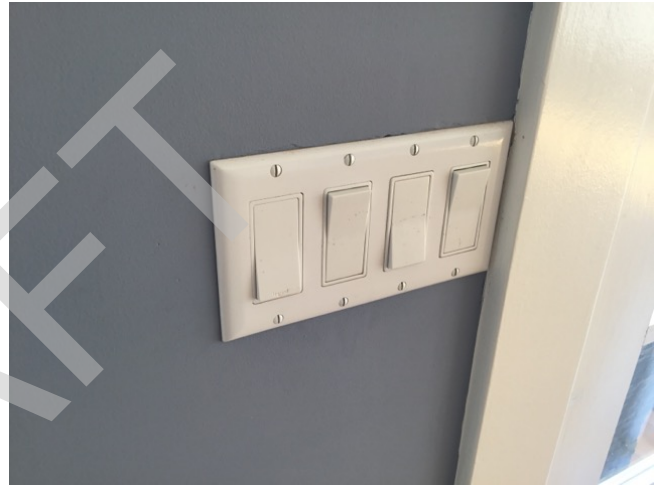
Item no., Rm no. and Name	Existing Architectural Barrier and Proposed Solution	Codes / Mitigation Info	Qty	Unit	Cost	Total
2374	<ul style="list-style-type: none"> • <i>As-Built Description:</i> Electric switch or control mounted less than 15" measured to the bottom of the outlet box or greater than 48 inches measured to the top of the outlet box. • <i>As-Built:</i> 50.5" to switch. 52" to top of the box. • <i>Proposed Solution:</i> Relocate light switches or control to between 15" and 48" height. • <i>Notes:</i> Includes upstairs. It appears the house was recently remodeled. Verify whether safe harbor applies. 	PCODE IC01 ADAAG 91 4.2.5 & 6 ADA 2010 308.2.1 & CBC 2007 1117B.6.3 CBC 2019 11B-308.2.1 & 11B-308.2.2	14	JOB	\$900	\$12,600
Priority 3						
Severity 3

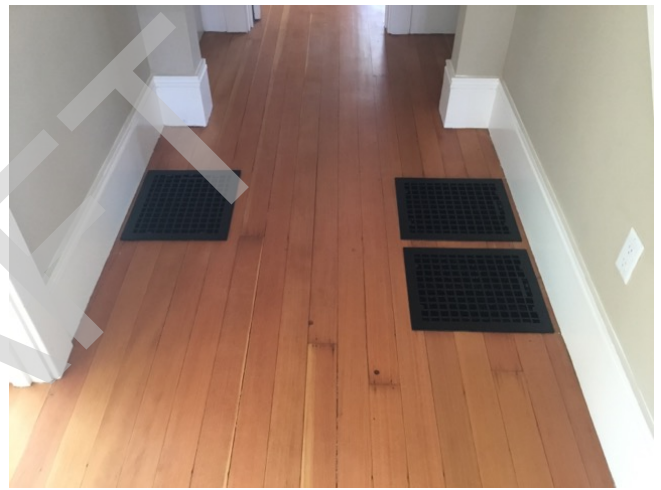
Item no., Rm no. and Name	Existing Architectural Barrier and Proposed Solution	Codes / Mitigation Info	Qty	Unit	Cost	Total
Floor or Ground Surface						
2379	<ul style="list-style-type: none"> • <i>As-Built Description:</i> Walk: Grating has grid openings greater than 1/2" along the line of traffic flow. • <i>As-Built:</i> 1" x 1" • <i>Proposed Solution:</i> Provide new grating, with grid openings 1/2" max. along the line of traffic flow. 	PCODE EF04 ADAAG 91 4.3.6; 4.5.4 ADA 2010 403.2; 302.3 CBC 2007 1133B.7.2 CBC 2019 11B-403.2; 11B-302.3	5	SF	\$240	\$1,200
						Priority 1 Severity 3

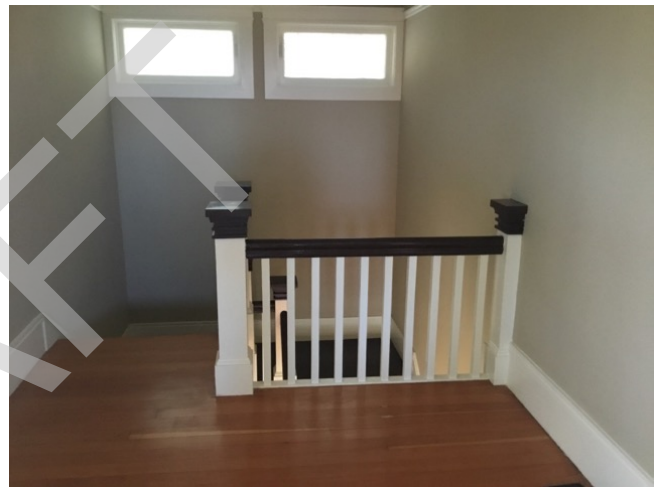
Item no., Rm no. and Name	Existing Architectural Barrier and Proposed Solution	Codes / Mitigation Info	Qty	Unit	Cost	Total
<u>Handrail</u>						
2385	<ul style="list-style-type: none"> • <i>As-Built Description:</i> Guards (42" high) not provided at side of ramp or landing where drop-off to adjacent grade or floor exceeds 30" height (California building code requirement only). • <i>Proposed Solution:</i> Provide new guards, including handrail at ramp. 	PCODE ED08 CBC 2007 1133B.5.7 CBC 2019 Section 1013.2; 1013.3	12	LF	\$360	\$4,320
						Priority 3 Severity 3

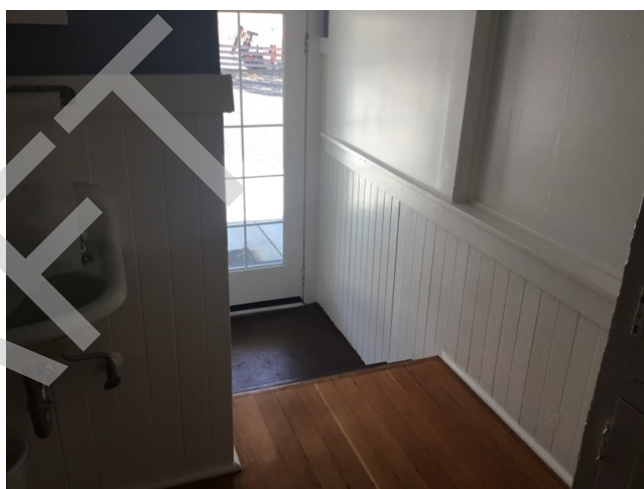
<i>Item no., Rm no. and Name</i>	<i>Existing Architectural Barrier and Proposed Solution</i>	<i>Codes / Mitigation Info</i>	<i>Qty</i>	<i>Unit</i>	<i>Cost</i>	<i>Total</i>
<u>Handrails</u>						
2401	<ul style="list-style-type: none"> • <i>As-Built Description:</i> Handrail not provided at stairs or ramp, required on both sides (not required at curb ramps or adjacent to seating areas). • <i>Proposed Solution:</i> Provide new handrail for each side including extensions. 	PCODE ED01 ADAAG 91 4.8.5 & 4.9.4 ADA 2010 505.2 CBC 2007 1133B.4.1.1 CBC 2019 & .5.5 11B-505.2	12	LF	\$285	\$3,420
						Priority 3 Severity 3

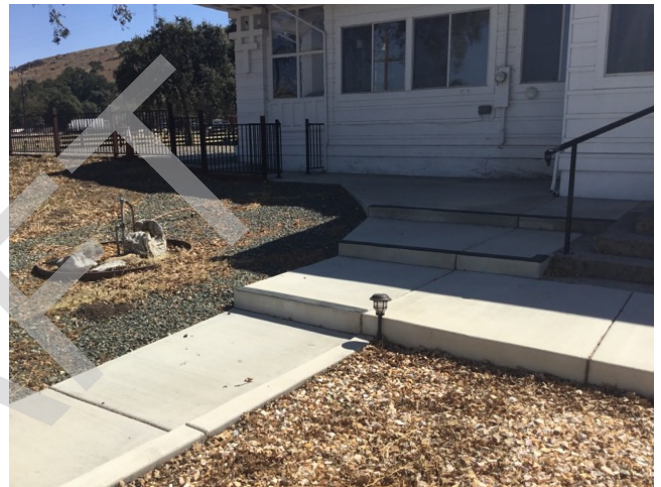
Item no., Rm no. and Name	Existing Architectural Barrier and Proposed Solution	Codes / Mitigation Info	Qty	Unit	Cost	Total
2405	<ul style="list-style-type: none"> • <i>As-Built Description:</i> Handrail not provided at stairs or ramp, required on both sides (not required at curb ramps or adjacent to seating areas). • <i>Proposed Solution:</i> Provide new handrail for each side including extensions. 	PCODE ED01 ADAAG 91 4.8.5 & 4.9.4 ADA 2010 505.2 CBC 2007 1133B.4.1.1 CBC 2019 & .5.5 11B-505.2	60	LF	\$285	\$17,100
						Priority 3 Severity 3

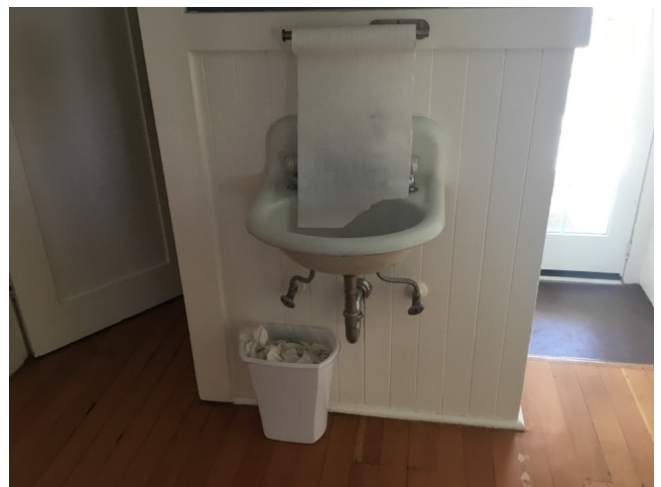
2391	<ul style="list-style-type: none"> • <i>As-Built Description:</i> Knee clearance 27" min. high starting 8" back from the front edge of the lavatory towards the wall is not provided. • <i>As-Built:</i> 26". 15" deep. • <i>Proposed Solution:</i> Provide new accessible lavatory. Remodel restroom as needed. 	PCODE WD04 ADAAG 91 Fig. 31 ADA 2010 306.3.3 CBC 2007 1115B.4.3 CBC 2019 11B-306.3.3	1	JOB	\$10,200	\$10,200
						Priority 2 Severity 3

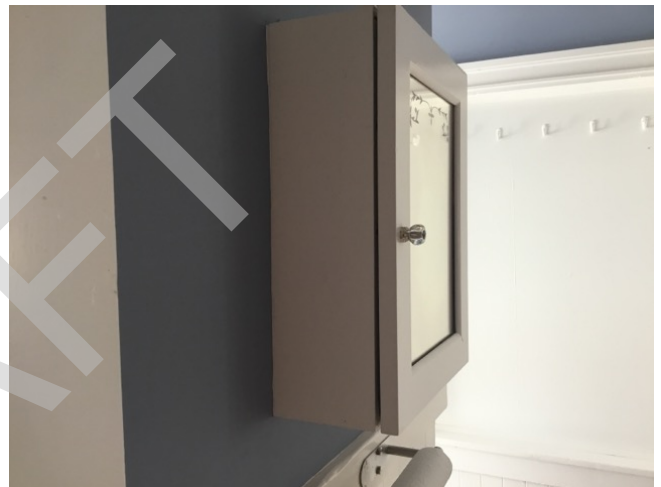
2393	<ul style="list-style-type: none"> • <i>As-Built Description:</i> Protruding objects more than 4" from wall, when bottom of object more than 27" or less than 80" above finished floor. • <i>As-Built:</i> 6.2" at 63" AFF. • <i>Proposed Solution:</i> Remove/relocate protruding object. Patch existing surface. 	PCODE EG04 ADAAG 91 4.4.1 ADA 2010 307.2 CBC 2007 1133B.8.6.1 CBC 2019 11B-307.2	1	JOB	\$300	\$300
------	--	--	---	-----	-------	-------

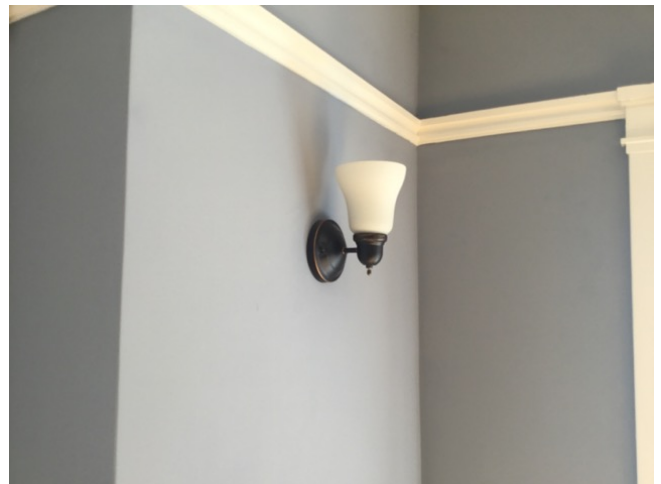
2412	<ul style="list-style-type: none"> • <i>As-Built Description:</i> Protruding objects more than 4" from wall, when bottom of object more than 27" or less than 80" above finished floor. • <i>As-Built:</i> 5" at 75". 6" at 78". • <i>Proposed Solution:</i> Remove/relocate protruding object. Patch existing surface. 	PCODE EG04 ADAAG 91 4.4.1 ADA 2010 307.2 CBC 2007 1133B.8.6.1 CBC 2019 11B-307.2	2	JOB	\$300	\$600
------	---	--	---	-----	-------	-------

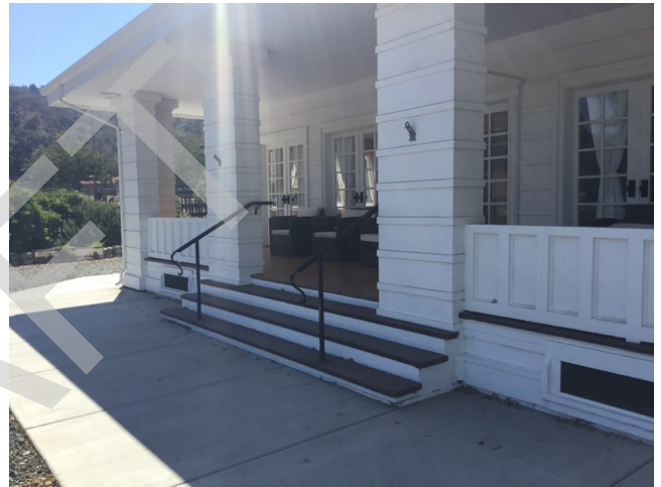
2407

Ramp needed to provide disabled access at steps or change of level along path of travel.

Provide new concrete ramp with handrails [slope more than 1:20 (5.0%) needed].

Consider ramps at each entrance or consider other methods to make all entrances and exits accessible.

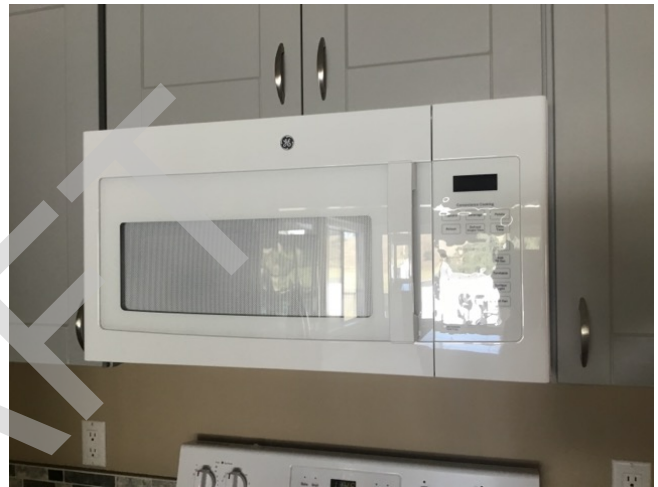
Item no., Rm no. and Name	Existing Architectural Barrier and Proposed Solution	Codes / Mitigation Info	Qty	Unit	Cost	Total
2382	<ul style="list-style-type: none"> • <i>As-Built Description:</i> Reach height to control or access point, where side approach is available, exceeds 48" or is less than 15" in height, or exceeds 10" in depth. • <i>As-Built:</i> 66" • <i>Proposed Solution:</i> Modify equipment or mounting. 	PCODE IE02 ADAAG 91 4.2.6 ADA 2010 308.3.1 CBC 2007 1118B.6 CBC 2019 11B-308.3	1	JOB	\$300	\$300
Priority 3						
Severity 3

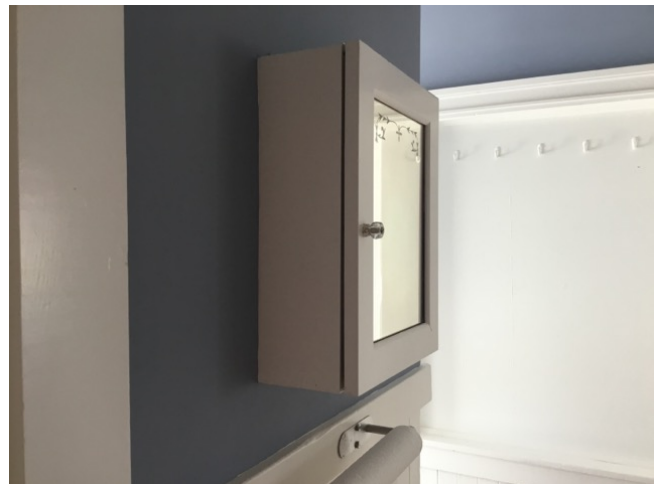
2392	<ul style="list-style-type: none"> • <i>As-Built Description:</i> Reach height to control or access point, where side approach is available, exceeds 48" or is less than 15" in height, or exceeds 10" in depth. • <i>As-Built:</i> 63" • <i>Proposed Solution:</i> Modify equipment or mounting. 	PCODE IE02 ADAAG 91 4.2.6 ADA 2010 308.3.1 CBC 2007 1118B.6 CBC 2019 11B-308.3	1	JOB	\$300	\$300
Priority 3						
Severity 3

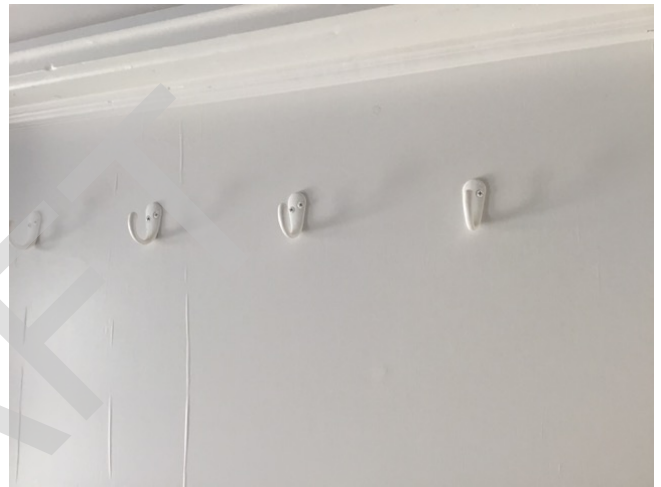
Item no., Rm no. and Name	Existing Architectural Barrier and Proposed Solution	Codes / Mitigation Info	Qty	Unit	Cost	Total
2394	<ul style="list-style-type: none"> • <i>As-Built Description:</i> Reach height to control or access point, where side approach is available, exceeds 48" or is less than 15" in height, or exceeds 10" in depth. • <i>As-Built:</i> 75" • <i>Proposed Solution:</i> Modify equipment or mounting. 	PCODE IE02 ADAAG 91 4.2.6 ADA 2010 308.3.1 CBC 2007 1118B.6 CBC 2019 11B-308.3	1	JOB	\$300	\$300
Priority 3 Severity 3

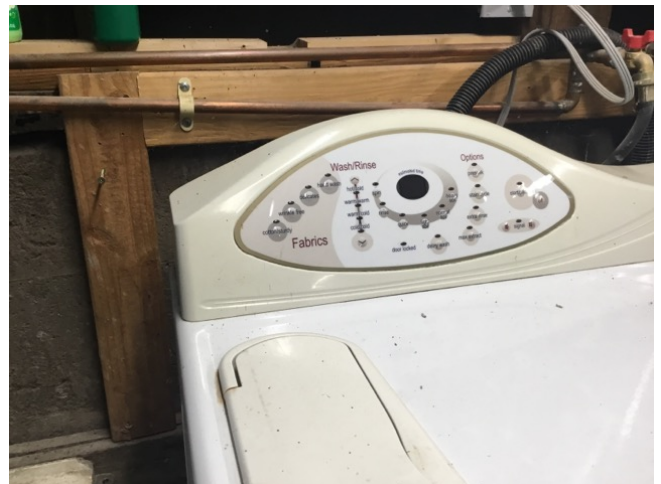
2400	<ul style="list-style-type: none"> • <i>As-Built Description:</i> Reach height to control or access point, where side approach is available, exceeds 48" or is less than 15" in height, or exceeds 10" in depth. • <i>As-Built:</i> 24" deep 52" AFF. • <i>Proposed Solution:</i> Modify equipment or mounting. 	PCODE IE02 ADAAG 91 4.2.6 ADA 2010 308.3.1 CBC 2007 1118B.6 CBC 2019 11B-308.3	1	JOB	\$300	\$300
Priority 3 Severity 3

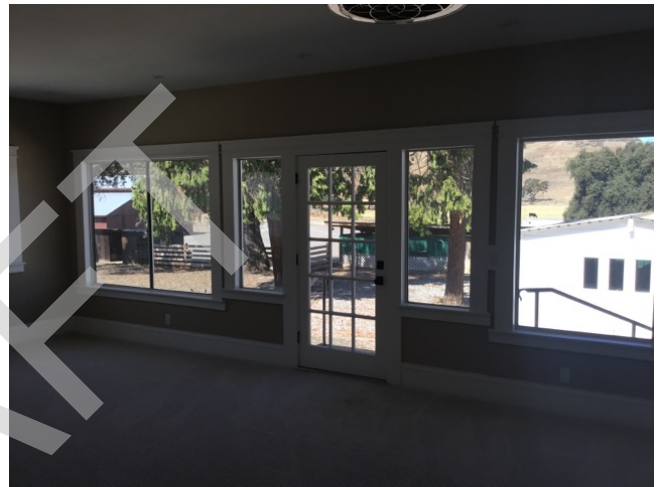
Item no., Rm no. and Name	Existing Architectural Barrier and Proposed Solution	Codes / Mitigation Info	Qty	Unit	Cost	Total
2395	<ul style="list-style-type: none"> • <i>As-Built Description:</i> At door leading into exit stairway: Where required exit signs are installed, signs to provide exiting information for people with vision impairment are not provided. • <i>Proposed Solution:</i> Provide raised letter/Braille "EXIT STAIR UP/DOWN" sign at door. 	PCODE SA10B ADAAG 91 4.1.3(16) ADA 2010 216.4.1 CBC 2007 1011.3 CBC 2019 11B-216.4.1	7	JOB	\$270	\$1,890
						Priority 1 Severity 3

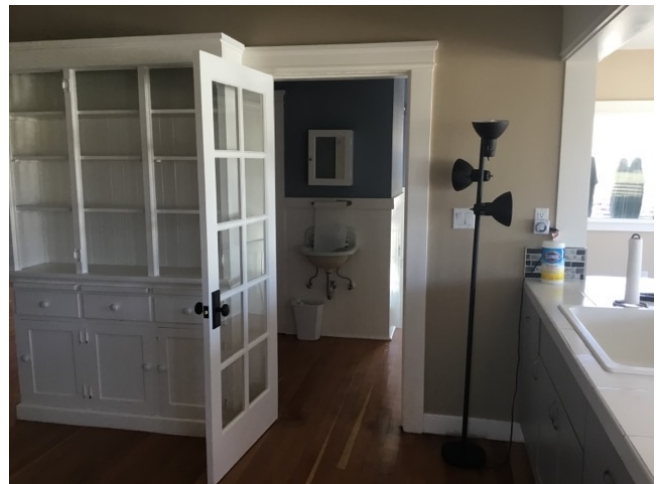
2434	<ul style="list-style-type: none"> • <i>As-Built Description:</i> At door leading into exit corridor: Where required exit signs are installed, signs to provide exiting information for people with vision impairment are not provided. • <i>Proposed Solution:</i> Provide raised letter/Braille "EXIT ROUTE" sign at door. 	PCODE SA10D ADAAG 91 4.1.3(16) ADA 2010 216.4.1 CBC 2007 1011.3 CBC 2019 11B-216.4.1	7	JOB	\$270	\$1,890
						Priority 1 Severity 3

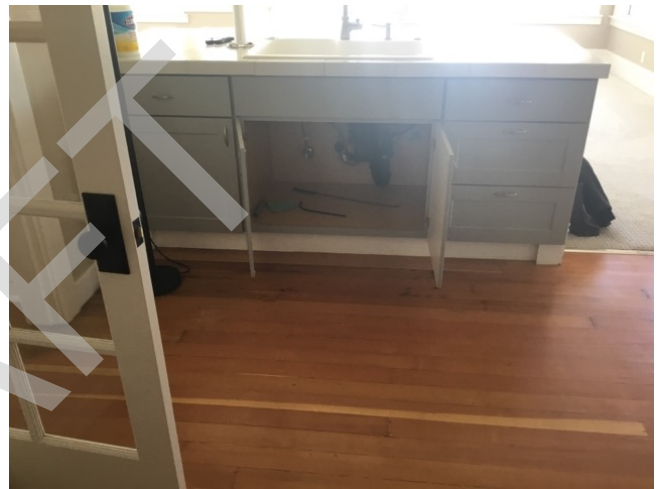
Item no., Rm no. and Name	Existing Architectural Barrier and Proposed Solution	Codes / Mitigation Info	Qty	Unit	Cost	Total
<u>Sink</u>						
2369	<ul style="list-style-type: none"> • <i>As-Built Description:</i> Sink does not have knee space min. 27" high x 19" deep x 30" wide. • <i>Proposed Solution:</i> Remodel sink cabinet. • <i>Notes:</i> Occurs in the kitchen. There is a stove top. 	PCODE IN06A ADAAG 91 4.24.3 ADA 2010 606.2 CBC 2007 1115B.4.7.1 CBC 2019 11B-606.2	1	JOB	\$5,250	\$5,250
						Priority 3 Severity 3

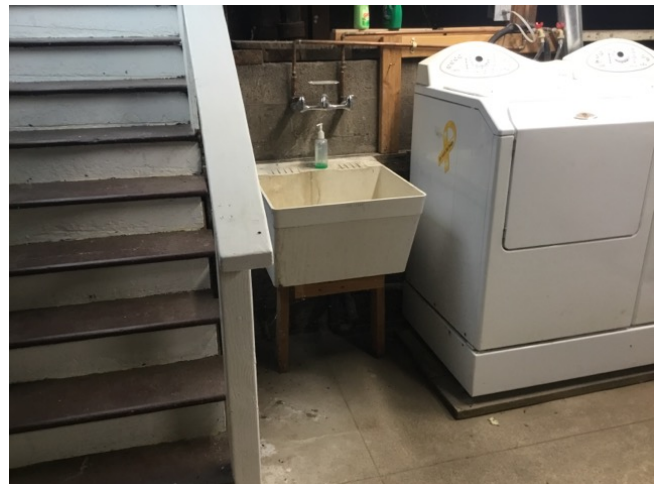
2398	<ul style="list-style-type: none"> • <i>As-Built Description:</i> Sink does not have knee space min. 27" high x 19" deep x 30" wide. • <i>Proposed Solution:</i> Remodel sink cabinet. 	PCODE IN06A ADAAG 91 4.24.3 ADA 2010 606.2 CBC 2007 1115B.4.7.1 CBC 2019 11B-606.2	1	JOB	\$5,250	\$5,250
						Priority 3 Severity 3

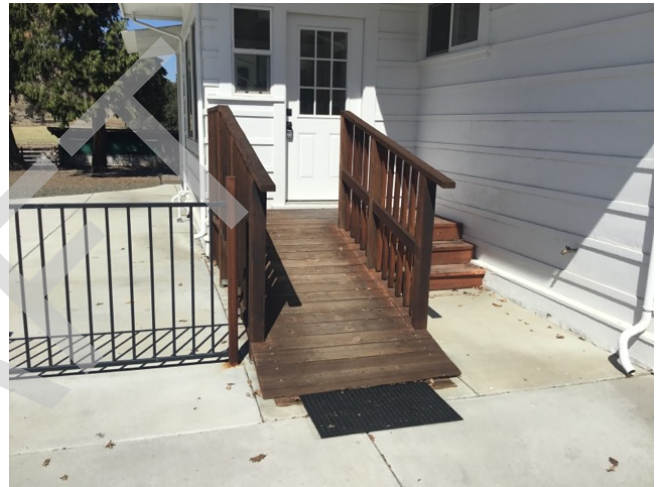
Item no., Rm no. and Name	Existing Architectural Barrier and Proposed Solution	Codes / Mitigation Info	Qty	Unit	Cost	Total
Slope						
2410	<ul style="list-style-type: none"> As-Built Description: Slope greater than 1:12 (8.3%). As-Built: 22% Proposed Solution: Demolish existing and provide new ramp with handrails. Notes: Multiple barriers at the main entrance ramp and stairs. 	PCODE EB02 ADAAG 91 4.8.2 ADA 2010 405.2 CBC 2007 1133B.5.3 CBC 2019 11B-405.2	100	SF	\$300	\$30,000
						Priority 3 Severity 3

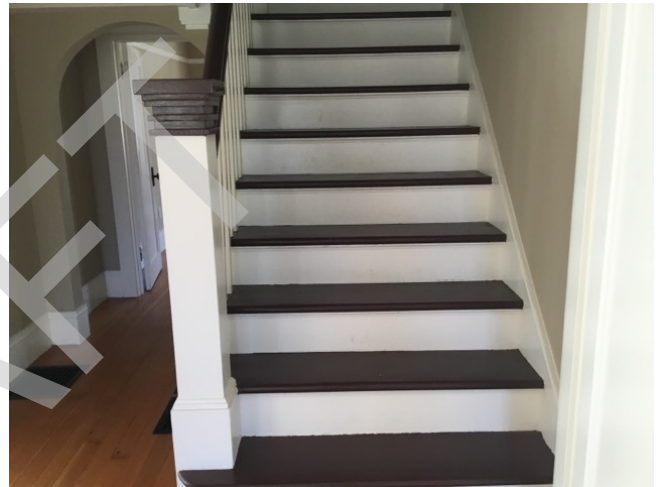
Item no., Rm no. and Name	Existing Architectural Barrier and Proposed Solution	Codes / Mitigation Info	Qty	Unit	Cost	Total
<u>Stairs</u>						
2386	<ul style="list-style-type: none"> • <i>As-Built Description:</i> Stair tread width less than 11", measured horizontally from nosing to nosing. • <i>Proposed Solution:</i> Rebuild stair as needed. • Notes: Consider whether technically feasible. 	PCODE EC06 ADAAG 91 4.9.2 ADA 2010 504.2 CBC 2007 1133B.4.5.3 CBC 2019 11B-504.2	80	LF	\$225	\$18,000
						Priority 3
						Severity 3

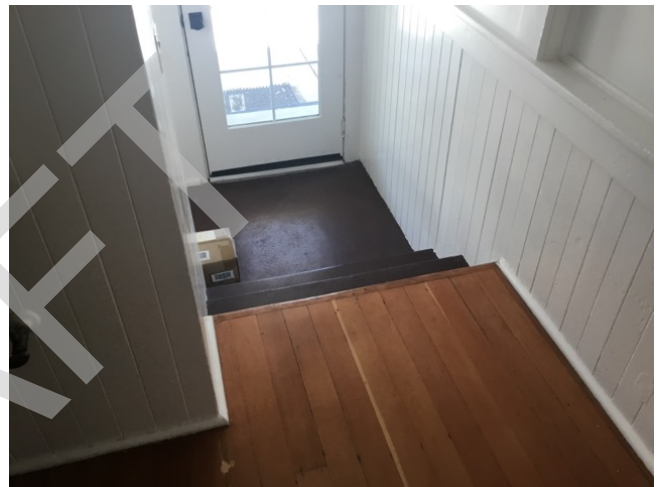
Stairway

2402	<ul style="list-style-type: none"> • <i>As-Built Description:</i> The leading 2" of the tread does not have visual contrast of dark-on-light or light-on-dark from the remainder of the tread. • <i>Proposed Solution:</i> Provide 2" min., 4" max. wide contrasting color strip 1" max. from nosing on top & bottom treads when altering area. 	PCODE II02B ADA 2010 504.4 CBC 2007 1133B.4.4 CBC 2019 11B-504.4.1	8	LF	\$42	\$336
------	---	---	---	----	------	-------

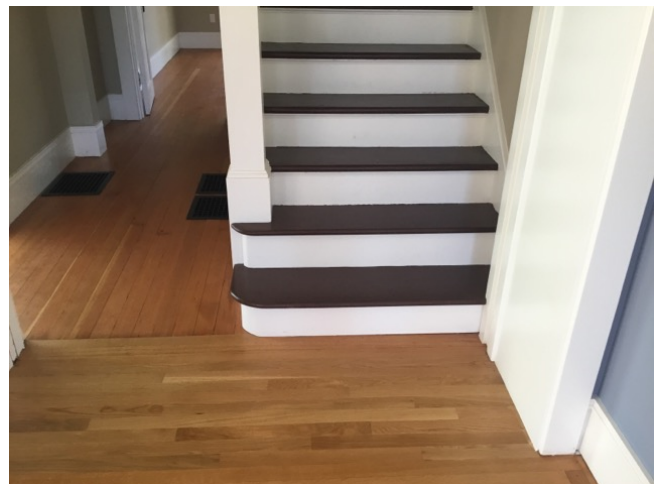
2403	<ul style="list-style-type: none"> • <i>As-Built Description:</i> The leading 2" of the tread does not have visual contrast of dark-on-light or light-on-dark from the remainder of the tread. • <i>Proposed Solution:</i> Provide 2" min., 4" max. wide contrasting color strip 1" max. from nosing on top & bottom treads when altering area. 	PCODE II02B ADA 2010 504.4 CBC 2007 1133B.4.4 CBC 2019 11B-504.4.1	16	LF	\$42	\$672
------	---	---	----	----	------	-------

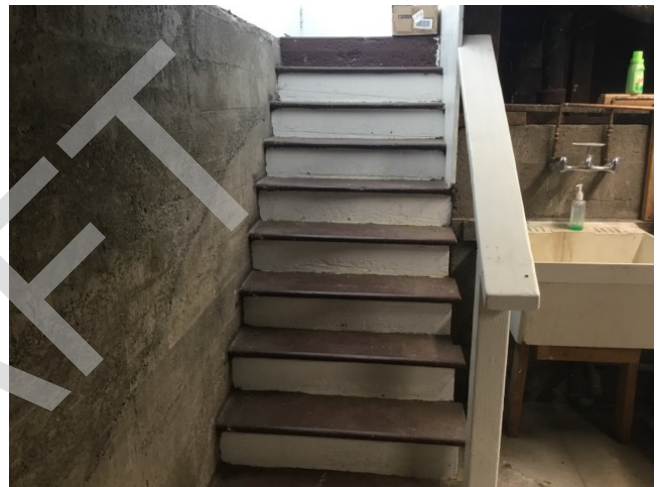
Item no., Rm no. and Name	Existing Architectural Barrier and Proposed Solution	Codes / Mitigation Info	Qty	Unit	Cost	Total
Stairways						
2397	<ul style="list-style-type: none"> As-Built Description: Exterior stair substantially out of compliance. As-Built: Consider technical feasibility. Proposed Solution: Provide complete new stair, 4 ft. wide with landing and handrails. 	PCODE EC09 ADAAG 91 4.9 ADA 2010 504 CBC 2007 1133B.4 CBC 2019 11B-504	100	IN	\$270	\$27,000
						Priority 3 Severity 3

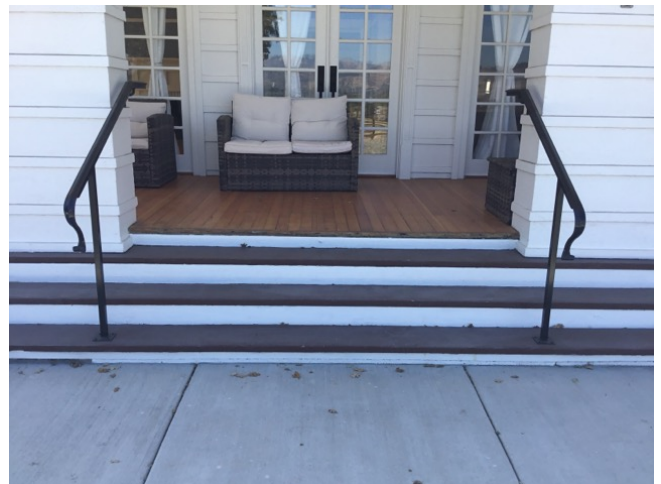
2406	<ul style="list-style-type: none"> As-Built Description: Exterior stair substantially out of compliance. Proposed Solution: Provide complete new stair, 4 ft. wide with landing and handrails. Notes: The surveyor did not find any compliant stairs on the exterior or interior of the building. There are no compliant accessible routes between the levels. 	PCODE EC09 ADAAG 91 4.9 ADA 2010 504 CBC 2007 1133B.4 CBC 2019 11B-504	400	IN	\$270	\$108,000
						Priority 3 Severity 3

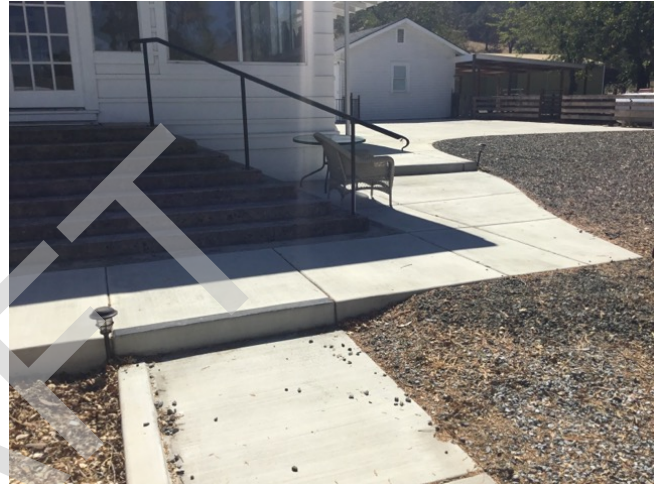
Item no., Rm no. and Name	Existing Architectural Barrier and Proposed Solution	Codes / Mitigation Info	Qty	Unit	Cost	Total
2404	<ul style="list-style-type: none"> As-Built Description: Landing at the top or bottom of stairway is not level or not provided. As-Built: To 4% Proposed Solution: Remodel landings to provide a level clear floor space that extends the entire width of the ramp. 	PCODE EC10 CBC 2019 1009.8	4	JOB	\$1,500	\$6,000

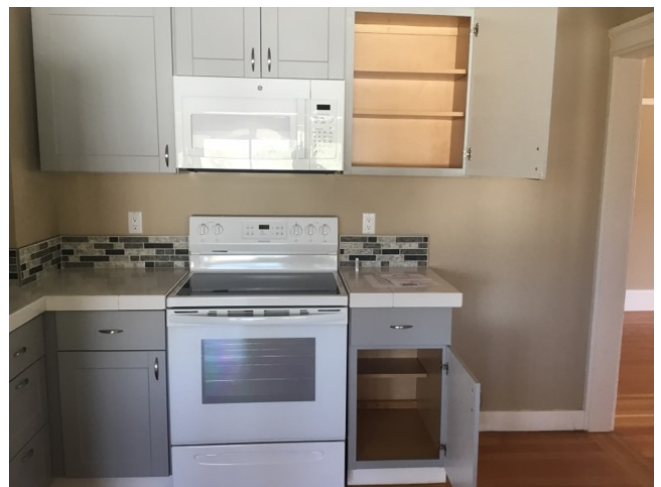
**Storage Areas**

2371	<ul style="list-style-type: none"> As-Built Description: At least one of each type of fixed or built-in storage facility, including cabinets, shelves, closets, and drawers is not accessible. (50% of shelf space) As-Built: 5" and 59" to low shelves. Approximately 20% accessible storage. Proposed Solution: Provide accessible storage areas as required. 	PCODE KC05 ADAAG 91 13.3.2(8) ADA 2010 804.5 CBC 2007 1111B.5.1 CBC 2019 11B-804.5	1	JOB	\$18,000	\$18,000
------	---	--	---	-----	----------	-----------------

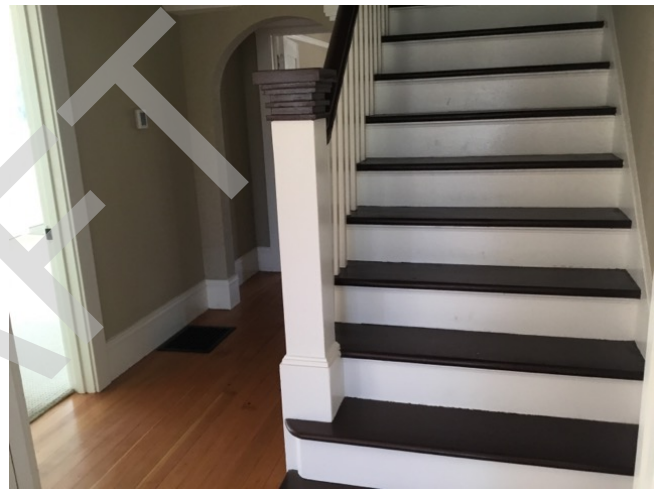
Top & Bottom Extension at Stairs

2387	<ul style="list-style-type: none"> • <i>As-Built Description:</i> Stair handrail does not extend horizontally 12" minimum beyond top nosing, and one tread width sloped, plus 12" minimum horizontally beyond the bottom nosing. • <i>Proposed Solution:</i> Extend stair handrail at top and bottom (cost for each extension piece). • <i>Notes:</i> Consider whether technically feasible. 	PCODE ED06 ADAAG 91 4.9.4(2) ADA 2010 505.10.2; CBC 2007 1133B.4.2.2 CBC 2019 11B-505.10.2; 11B-505.10.3	2	JOB	\$510	\$1,020
Priority 3						
Severity 3

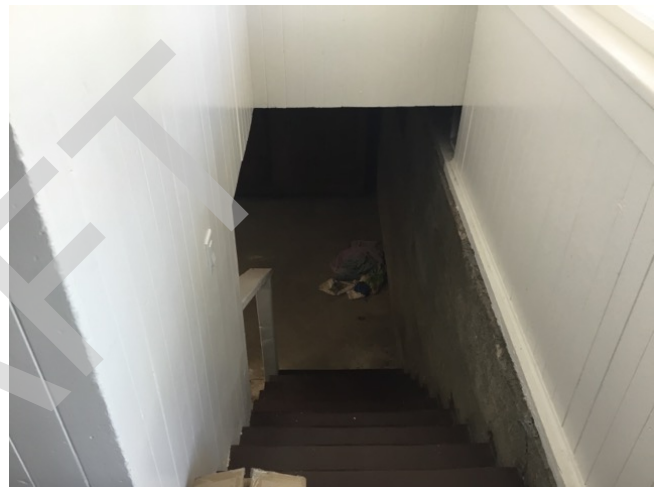
Vertical Clearance

2396	<ul style="list-style-type: none"> • <i>As-Built Description:</i> Overhead clearance less than 80" above finished floor. • <i>As-Built:</i> 68.5" • <i>Proposed Solution:</i> Alter headroom. • <i>Notes:</i> Consider technical feasibility. Consider equivalent facilitation. Occurs at stairs to basement. 	PCODE EG01A ADAAG 91 4.4.2 ADA 2010 307.4 CBC 2007 1133B.8.6.2 CBC 2019 11B-307.4	8	LF	\$300	\$2,400
						Priority 3 Severity 3

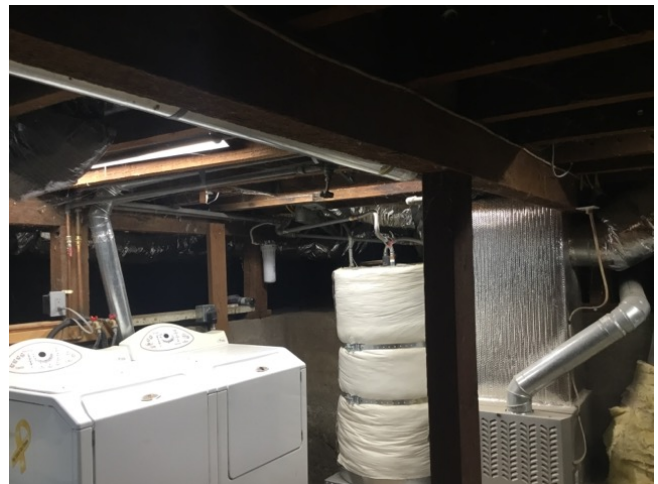
2399	<ul style="list-style-type: none"> • <i>As-Built Description:</i> Overhead clearance less than 80" above finished floor. • <i>As-Built:</i> 73" • <i>Proposed Solution:</i> Dig out the basement. • <i>Notes:</i> Consider technical feasibility. 	PCODE EG01A ADAAG 91 4.4.2 ADA 2010 307.4 CBC 2007 1133B.8.6.2 CBC 2019 11B-307.4	1	JOB	?	\$120,000
						Priority 3 Severity 3

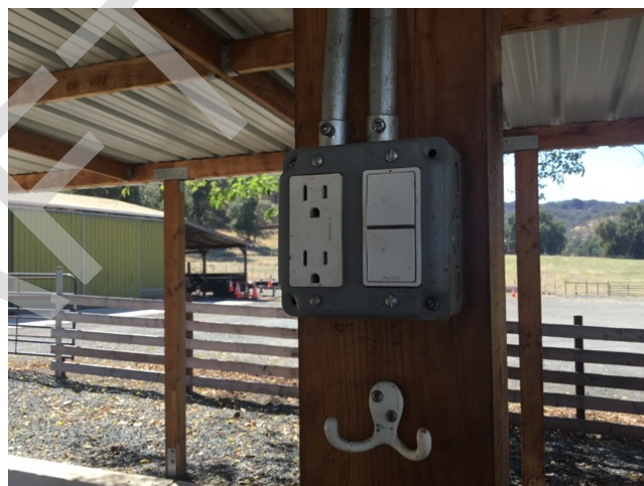
Electrical

Electric switch or control mounted less than 15" measured to the bottom of the outlet box or greater than 48 inches measured to the top of the outlet box.

- *As-Built:* **67"**

Relocate light switches or control to between 15" and 48" height.

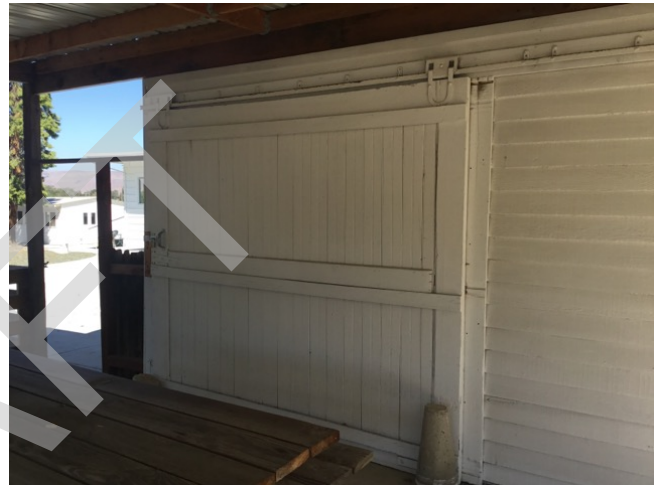
Existing Facility

At time of survey, room was locked and could not be accessed.

Door appears to require over 15lbs to operate.

Verify elements in room are compliant with ADA.

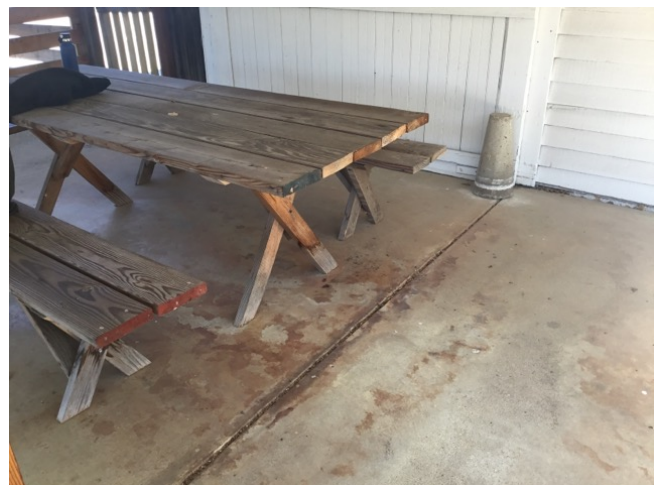
**Non-Fixed Desk**

Accessible non-fixed table or desk (top 28" to 34" high; knee space at least 27" high x 19" deep x 30" wide) not provided.

Severity **3**• *As-Built:* **17" deep.**• *Proposed Solution:*

Provide table or desk with accessible dimensions when purchasing new furniture.

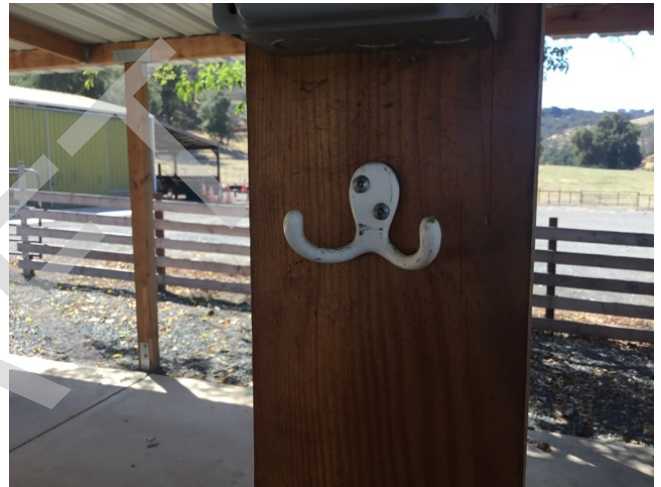
Item no., Rm no. and Name	Existing Architectural Barrier and Proposed Solution	Codes / Mitigation Info	Qty	Unit	Cost	Total
Reach Range						
2416	<ul style="list-style-type: none"> • <i>As-Built Description:</i> Reach height to control or access point, where side approach is available, exceeds 48" or is less than 15" in height, or exceeds 10" in depth. • <i>As-Built:</i> 61" • <i>Proposed Solution:</i> Modify equipment or mounting. 	<i>PCODE</i> IE02 <i>ADAAG 91</i> 4.2.6 <i>ADA 2010</i> 308.3.1 <i>CBC 2007</i> 1118B.6 <i>CBC 2019</i> 11B-308.3	1	JOB	\$300	\$300
						Priority 3 Severity 3

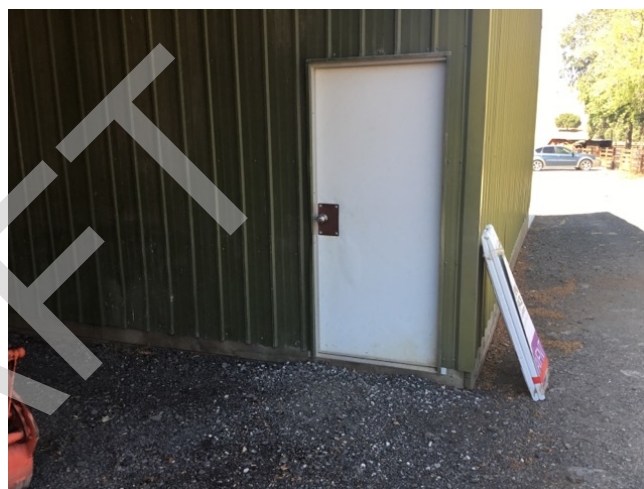
Door Threshold

2419	<ul style="list-style-type: none"> • <i>As-Built Description:</i> Door inaccessible due to threshold or step at door exceeding 1/2". • <i>As-Built:</i> 4" • <i>Proposed Solution:</i> Modify threshold to be no more than 1/2" by removing existing paving at door and providing landing with edge ramping (slope 1:20 max). • <i>Notes:</i> See exceptions for machinery spaces. Verify whether this is to remain a machinery space/maintenance facility and whether there is public access. 	PCODE ID02A ADAAG 91 4.13.8 ADA 2010 404.2.5 CBC 2007 1133B.2.4.1 CBC 2019 11B-404.2.5	1	JOB	\$1,200	\$1,200
						Priority 1 Severity 1

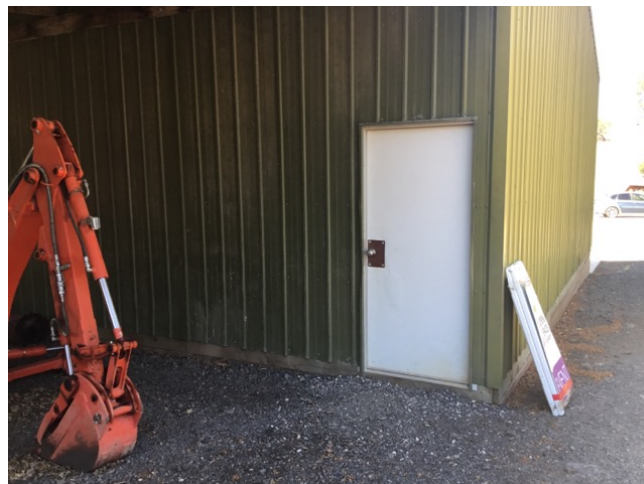
**Existing Facility**

2418	<ul style="list-style-type: none"> • <i>As-Built Description:</i> At time of survey, room was locked and could not be accessed. • <i>Proposed Solution:</i> Verify elements in room are compliant with ADA. 	PCODE XA03 CBC 2019 11B-403.5.1.3		REF		
						Priority 3 Severity 3

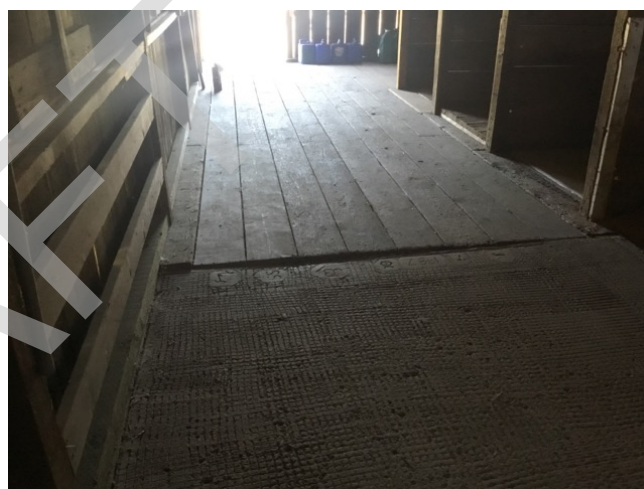
8 Stables

CBC 2019 11B-403.4

Priority **1****Severity** **3**

Remove, replace or repair area of pavement sufficient to correct abrupt change in level.

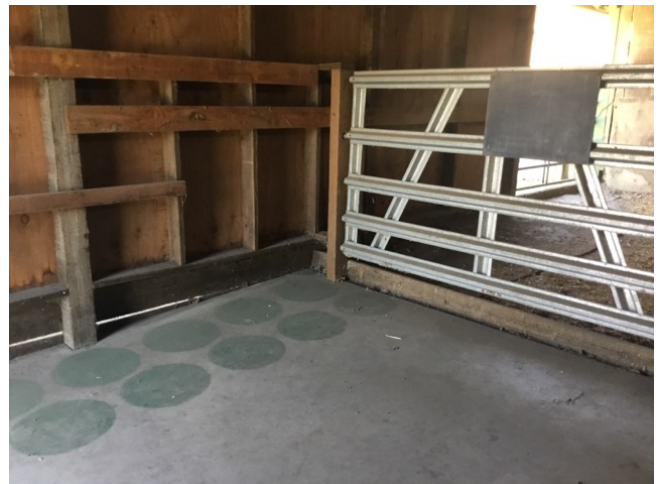
**Door**

2424	<ul style="list-style-type: none"> As-Built Description: Surface of required maneuvering clearance at door slopes more than 1/4":12" (2.0%). As-Built: 4.3% Proposed Solution: Modify surface slope at door. 	PCODE ID11 ADAAG 91 4.13.6 ADA 2010 404.2.4.4 CBC 2007 1133B.2.4 CBC 2019 11B-404.2.4	60	SF	\$120	\$7,200
						Priority 1
						Severity 3

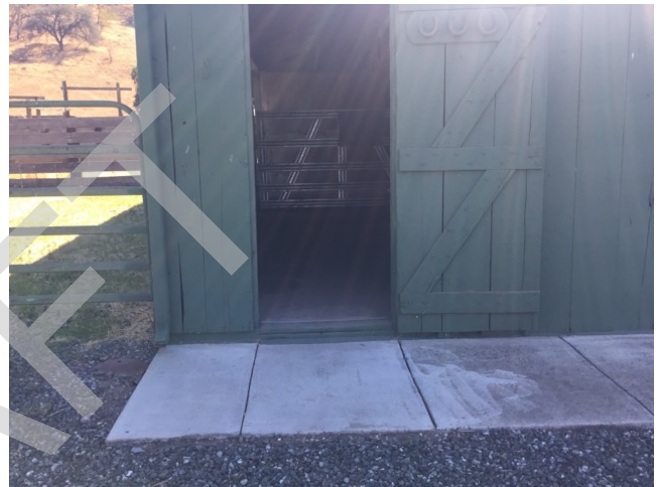
Item no., Rm no. and Name	Existing Architectural Barrier and Proposed Solution	Codes / Mitigation Info	Qty	Unit	Cost	Total
2425	<ul style="list-style-type: none"> • <i>As-Built Description:</i> Surface of required maneuvering clearance at door slopes more than 1/4":12" (2.0%). • <i>As-Built:</i> 2.8%-4% • <i>Proposed Solution:</i> Modify surface slope at door. 	PCODE ID11 ADAAG 91 4.13.6 ADA 2010 404.2.4.4 CBC 2007 1133B.2.4 CBC 2019 11B-404.2.4	20	SF	\$120	\$2,400
						Priority 1
						Severity 3

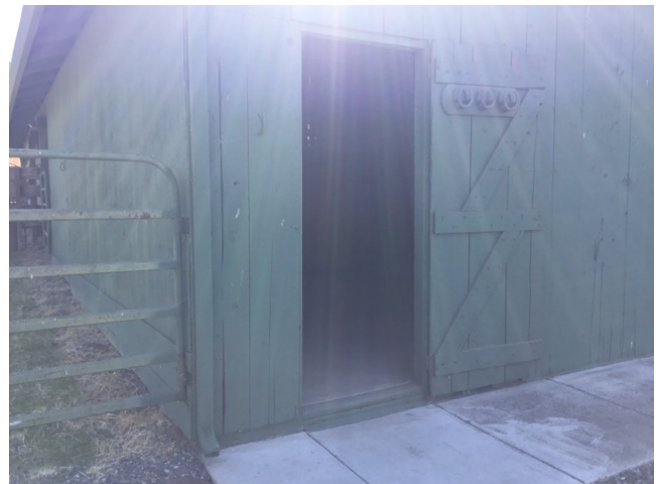
**Door Threshold**

2422	<ul style="list-style-type: none"> • <i>As-Built Description:</i> Door inaccessible due to threshold or step at door exceeding 1/2". • <i>As-Built:</i> 5" • <i>Proposed Solution:</i> Modify threshold to be no more than 1/2" by removing existing paving at door and providing landing with edge ramping (slope 1:20 max). 	PCODE ID02A ADAAG 91 4.13.8 ADA 2010 404.2.5 CBC 2007 1133B.2.4.1 CBC 2019 11B-404.2.5	1	JOB	\$1,200	\$1,200
						Priority 1
						Severity 1

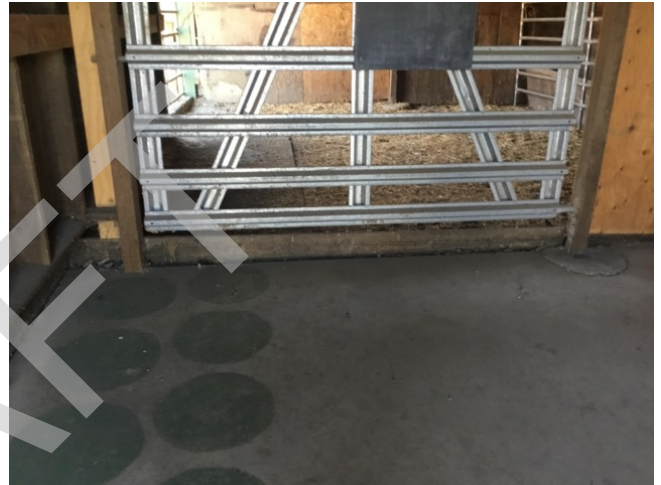
Item no., Rm no. and Name	Existing Architectural Barrier and Proposed Solution	Codes / Mitigation Info	Qty	Unit	Cost	Total
2423	<ul style="list-style-type: none"> • <i>As-Built Description:</i> Door inaccessible due to threshold or step at door exceeding 1/2". • <i>Proposed Solution:</i> Modify threshold. 	PCODE ID02A ADAAG 91 4.13.8 ADA 2010 404.2.5 CBC 2007 1133B.2.4.1 CBC 2019 11B-404.2.5	1	JOB	\$1,200	\$1,200
Priority 1						
Severity 1

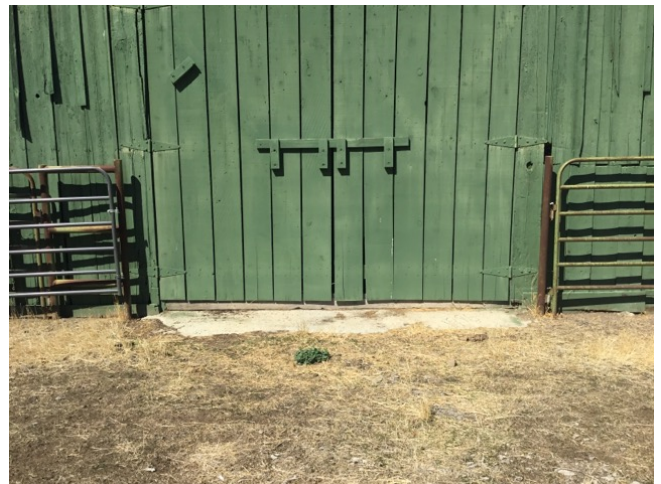
2430	<ul style="list-style-type: none"> • <i>As-Built Description:</i> Door inaccessible due to threshold or step at door exceeding 1/2". • <i>As-Built:</i> 7" • <i>Proposed Solution:</i> Modify threshold. 	PCODE ID02A ADAAG 91 4.13.8 ADA 2010 404.2.5 CBC 2007 1133B.2.4.1 CBC 2019 11B-404.2.5	1	JOB	\$1,200	\$1,200
Priority 1						
Severity 1

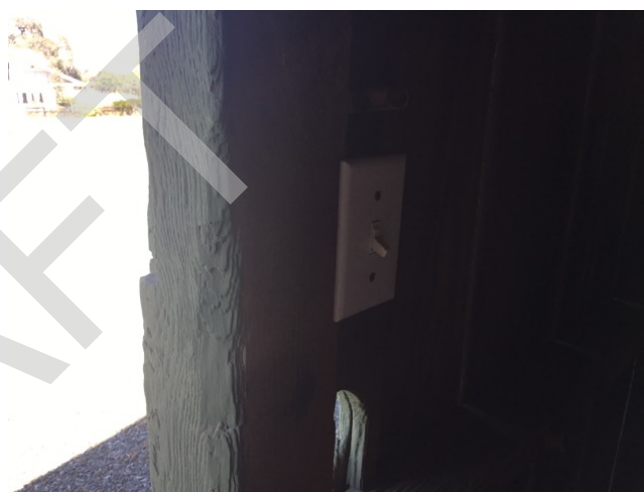
11B-203.12 Animal containment areas Recommendation.

PCODE IC011 JOB \$900 **\$900***ADAAG 91* 4.2.5 & 6*ADA 2010* 308.2.1 &*CBC 2007* 1117B.6.3*CBC 2019* 11B-308.2.1 &
11B-308.2.2**Priority** **3****Severity** **3**

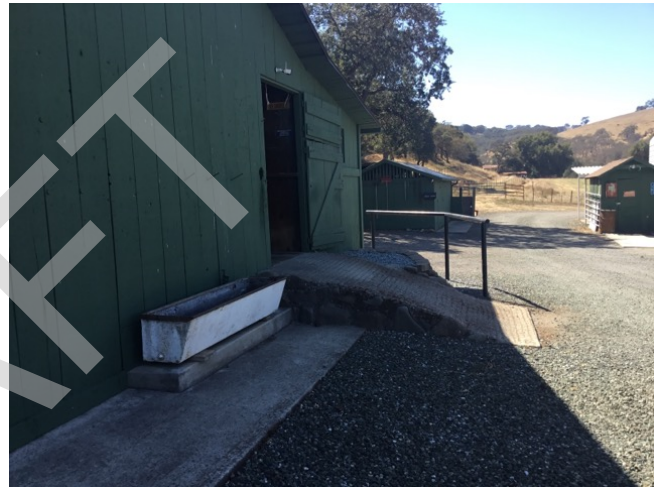
Item no., Rm no. and Name	Existing Architectural Barrier and Proposed Solution	Codes / Mitigation Info	Qty	Unit	Cost	Total
Slope						
2426	<ul style="list-style-type: none"> As-Built Description: Slope greater than 1:12 (8.3%). As-Built: 29% Proposed Solution: Demolish existing and provide new ramp with handrails. 	PCODE EB02 ADAAG 91 4.8.2 ADA 2010 405.2 CBC 2007 1133B.5.3 CBC 2019 11B-405.2	180	SF	\$300	\$54,000
						Priority 3 Severity 3
